***PUMP JACK/LADDER JACK SCAFFOLD
PHOTO COMPLIANCE GUIDE***

March 1998

John Newquist
U.S. Department of Labor-OSHA
344 Smoke Tree Business Park
North Aurora, IL 60542

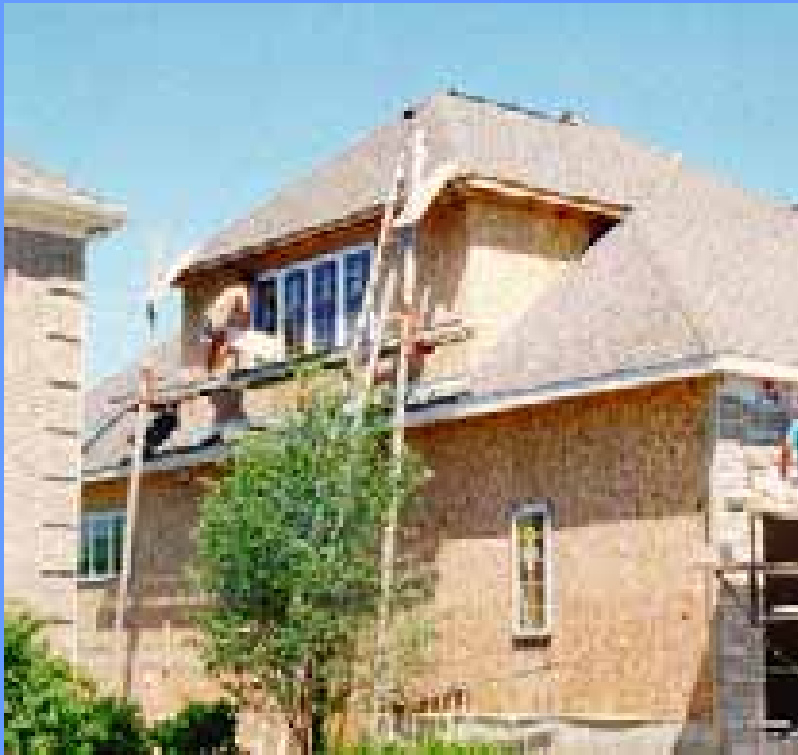
Aurora Area Office 1997 Scaffold of the Year

Judged the Worst Scaffold of the Year
By Our Compliance Staff

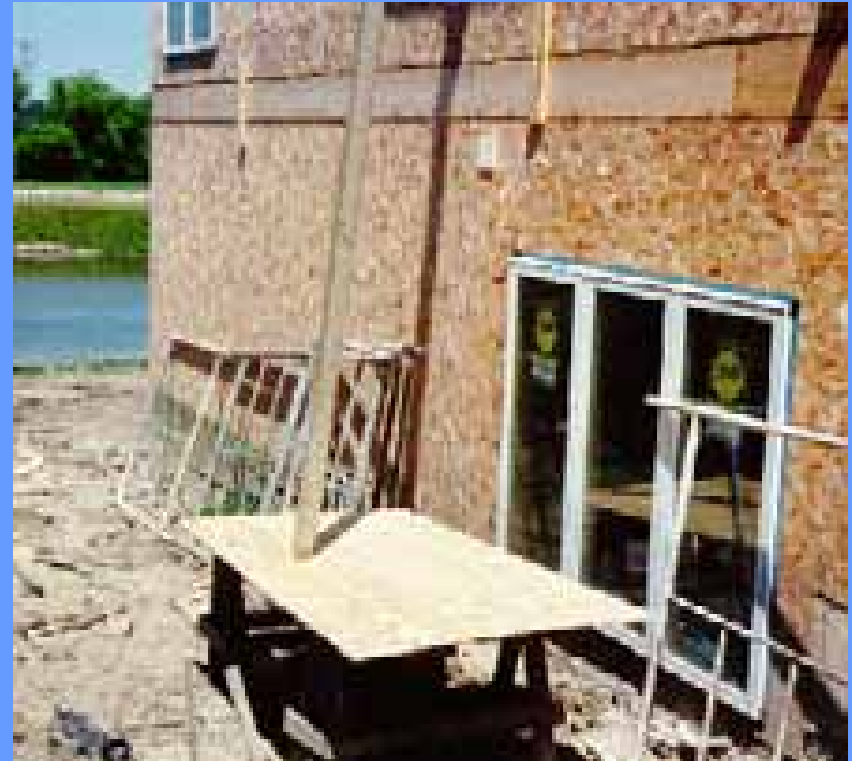
20' high -- No Guardrails

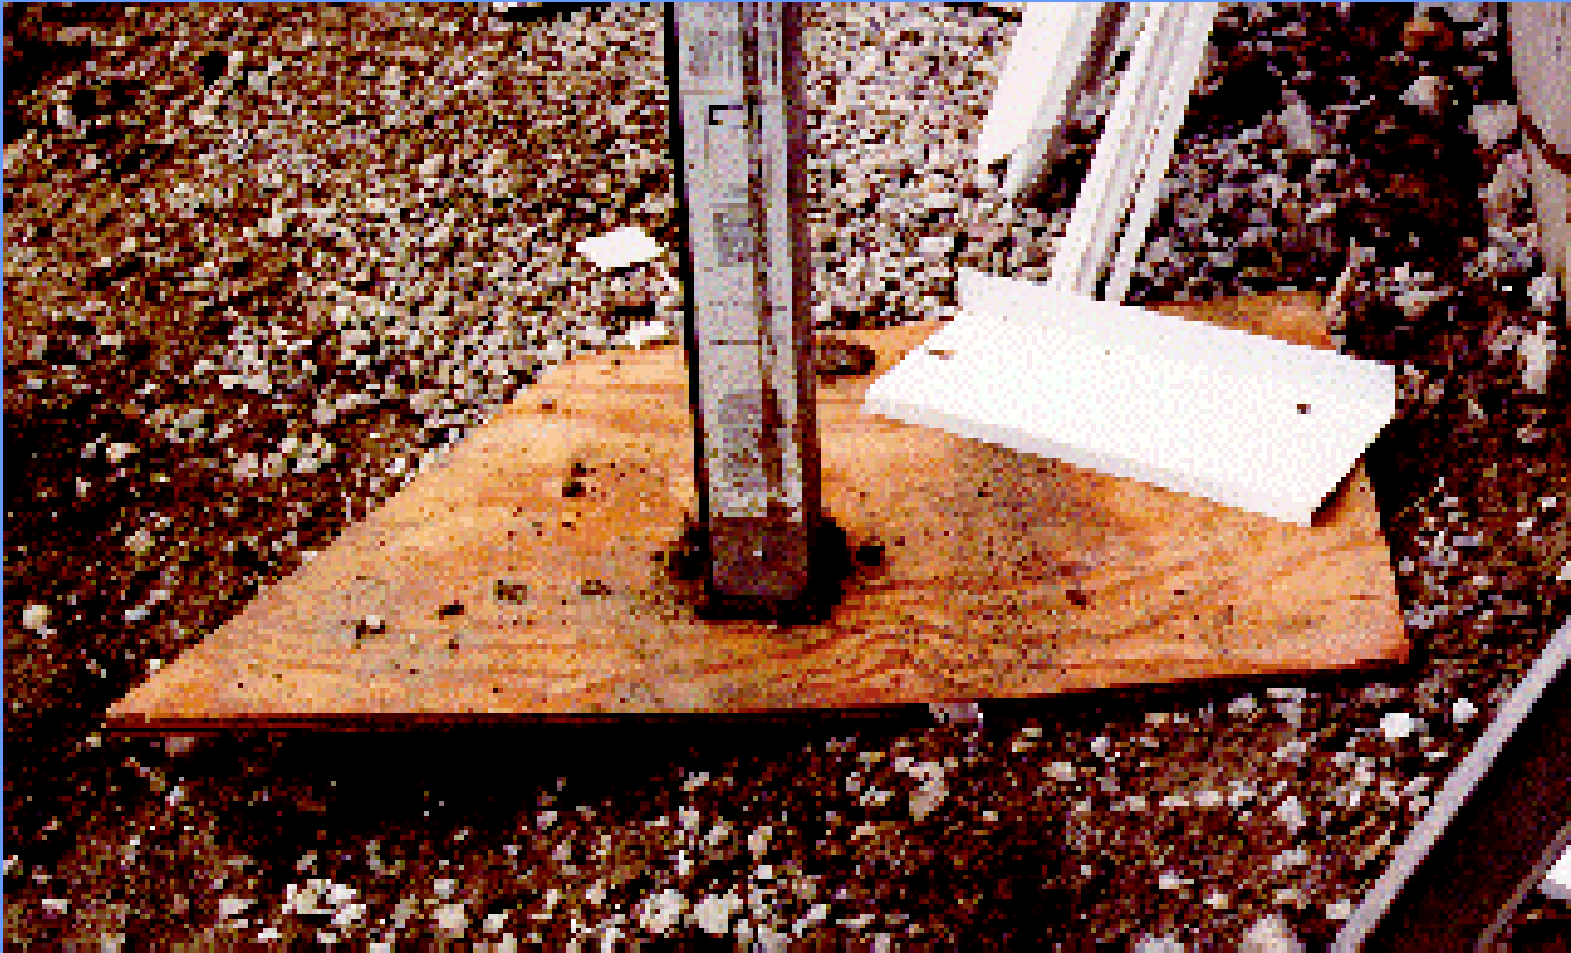
1926.451(c)(2)(i): Footing shall be capable of preventing displacement. Siding contractor putting a wood pump jack leg onto a welded frame scaffold.

Violation: Use of another scaffold as a footing can cause displacement by allowing scaffold planks to shift out from under the left leg resulting in its collapse.

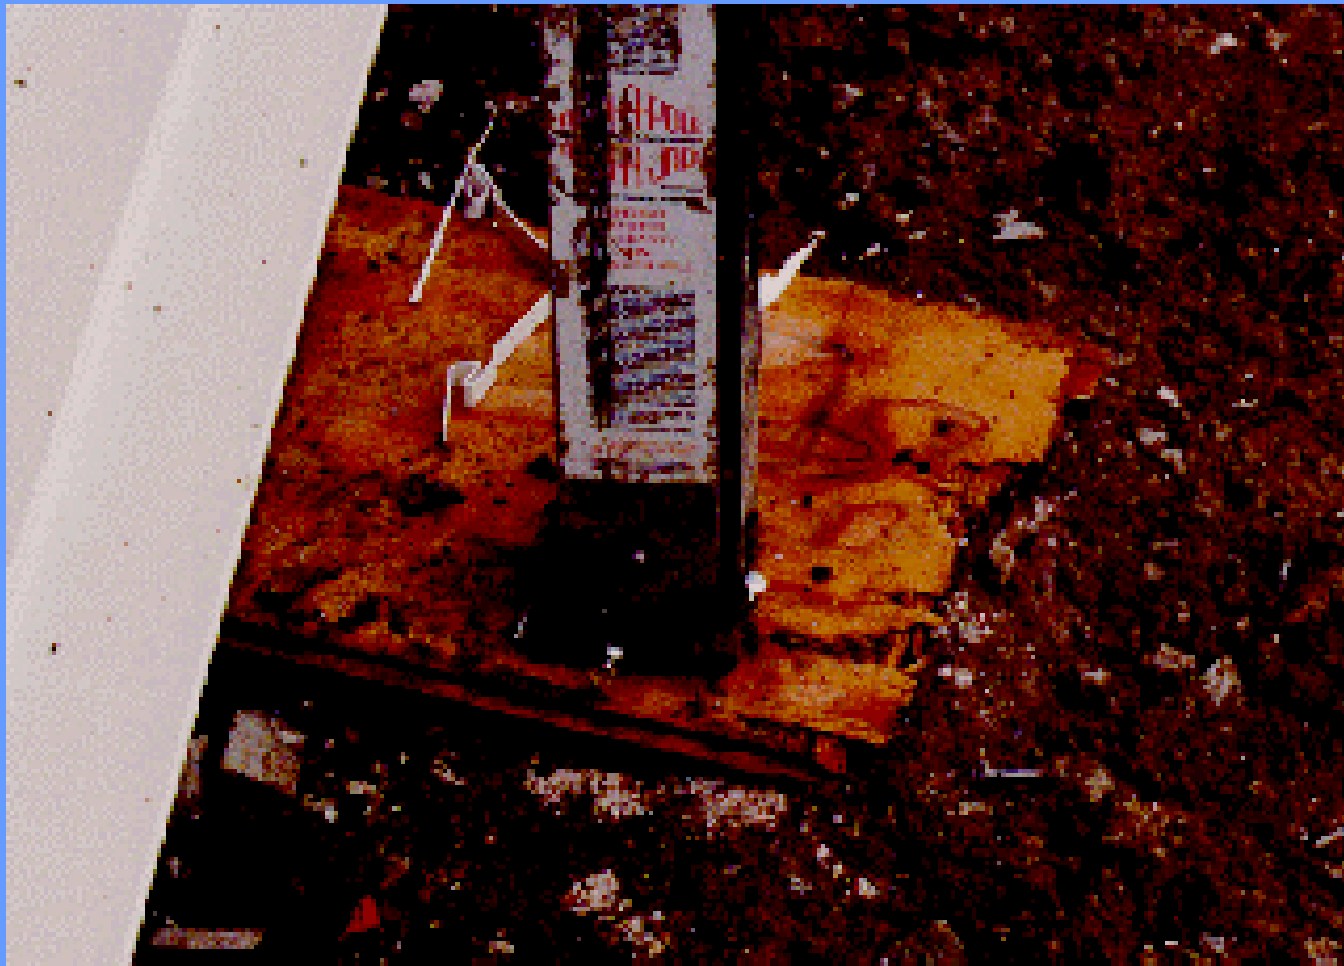
1926.451(c)(2)(i): Footing shall be sound, rigid, and capable of supporting the loaded scaffold without settling or displacement.

Violation: Soil is undercutting beneath the plywood because it was not compacted and protected from water.

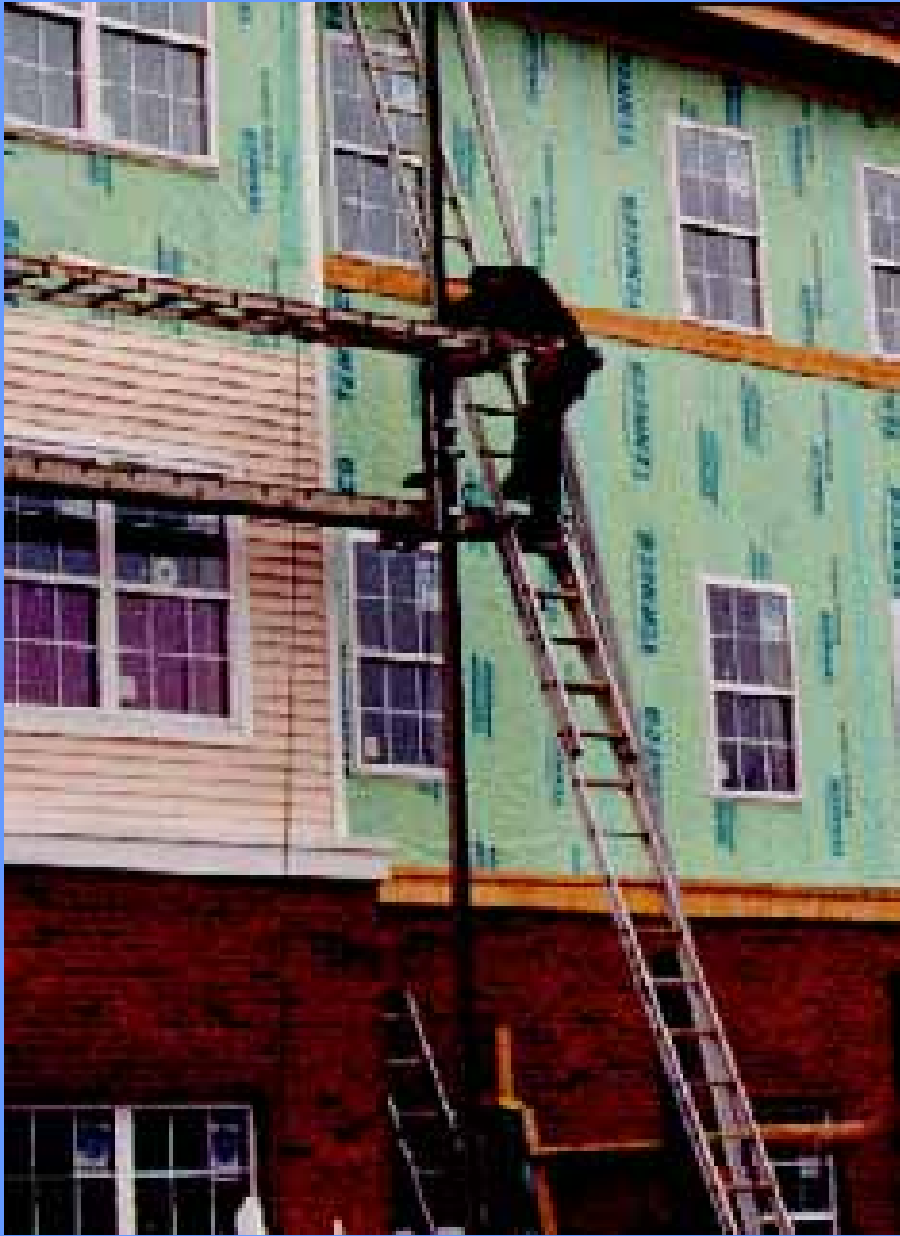
1926.451(c)(4)(i): Footing shall be level, sound, rigid, and capable of supporting the loaded scaffold without settling or displacement.

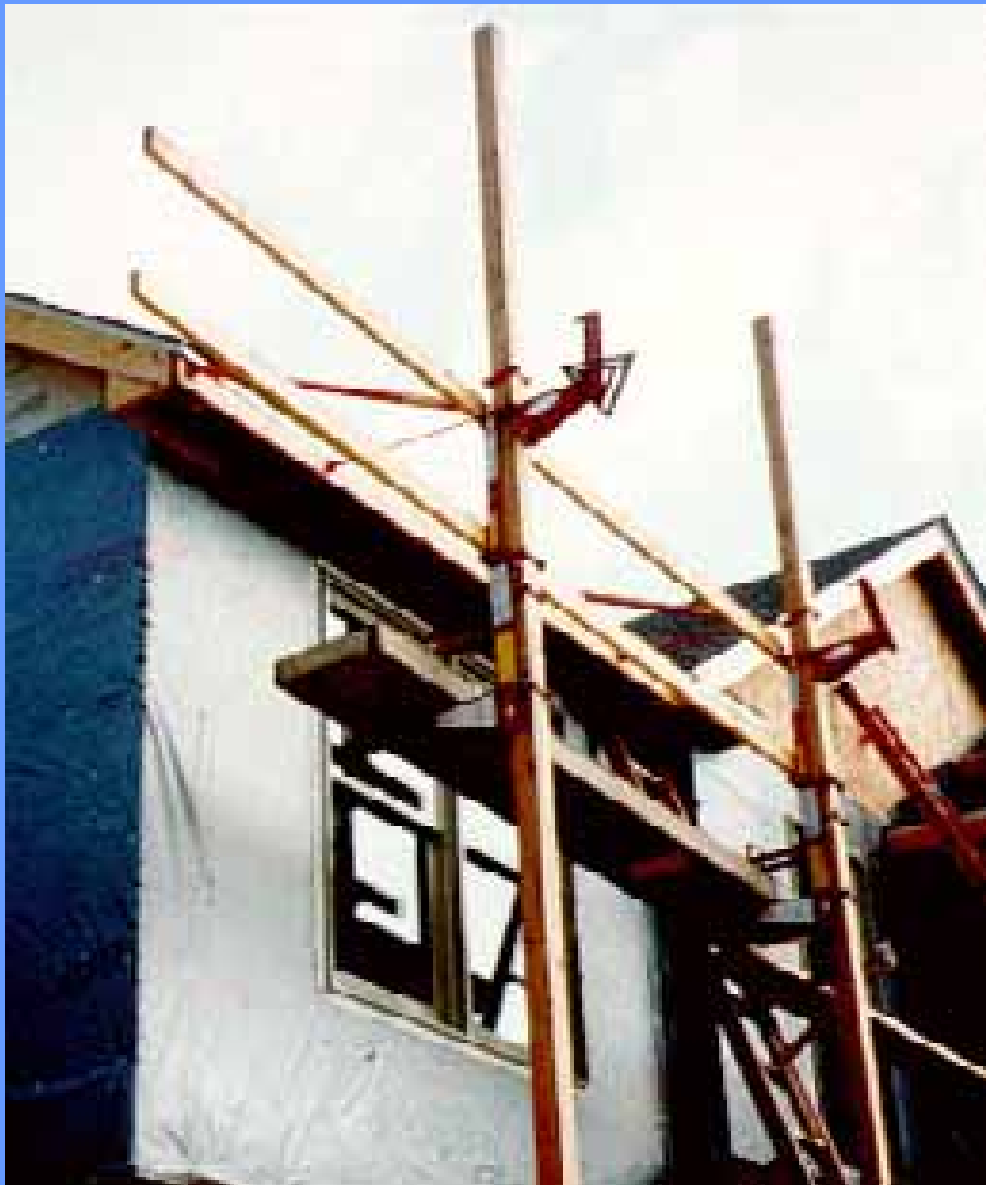
1926.451(e)(1): Safe access shall be provided to scaffolds.

No violation: Ladder arranged so that worker can step onto scaffold directly from the ladder.

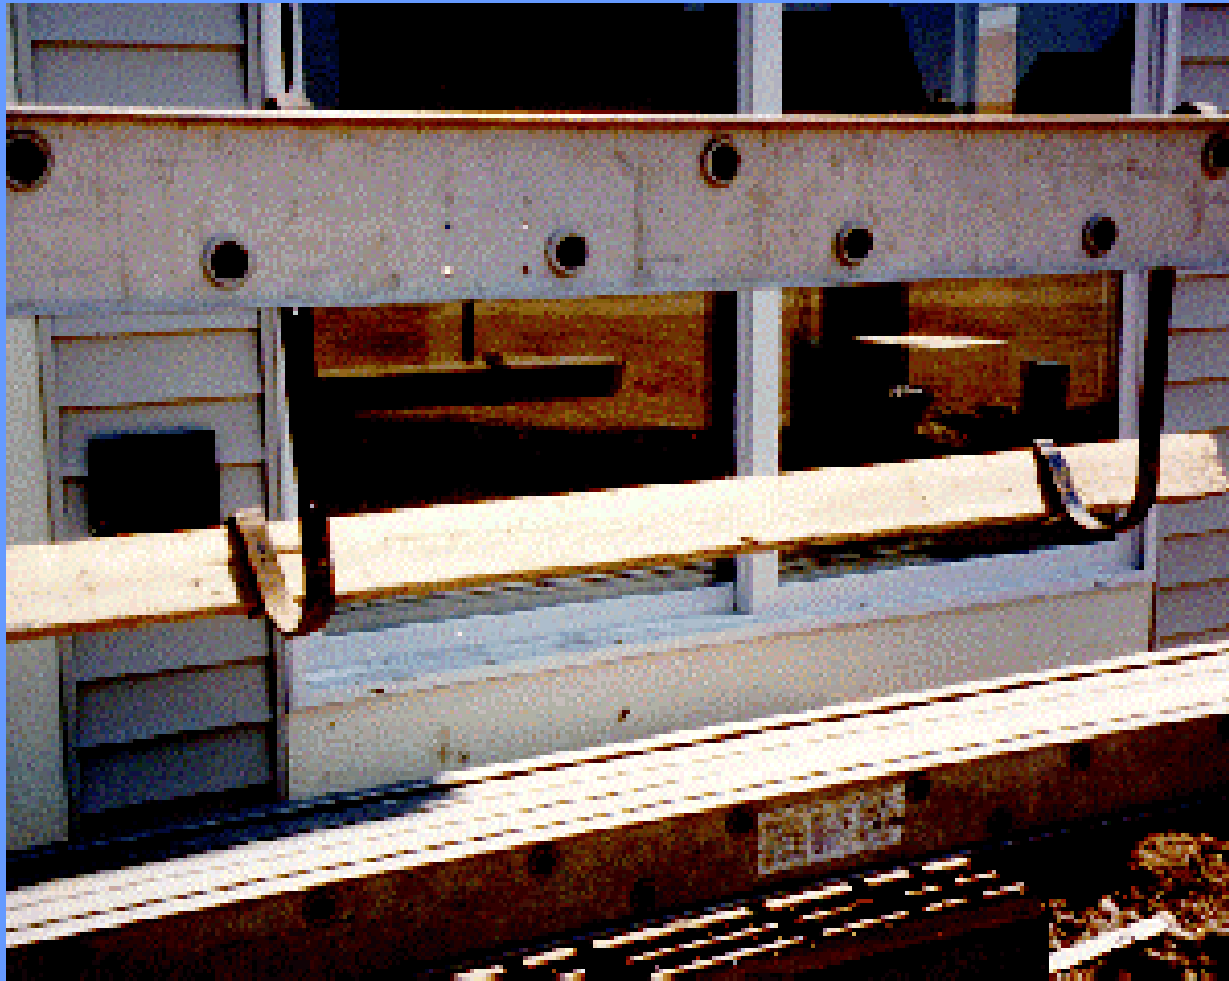
1926.451(g)(1):
Guardrails are
required at all open
sides and ends of
scaffolds.

Violation: Ends are
not guarded on this
narrow scaffold.

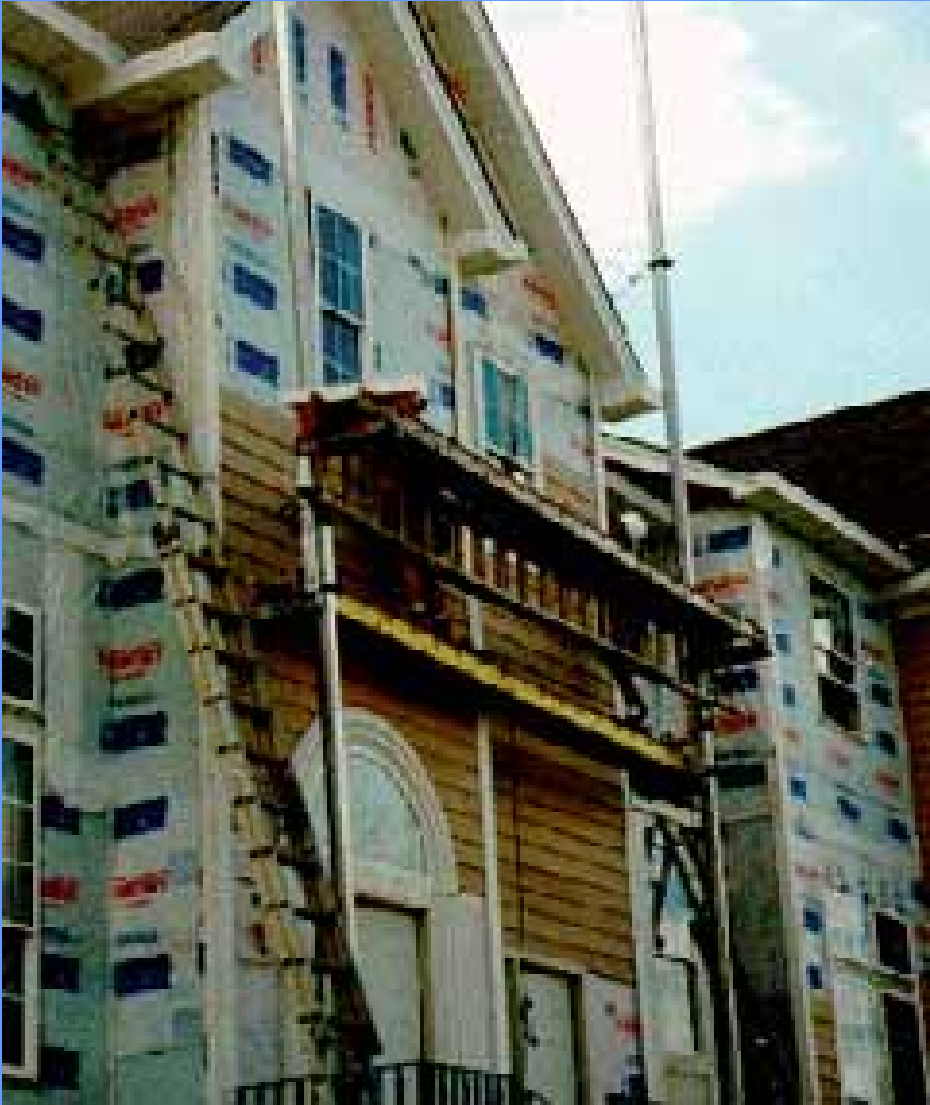
1926.451(g)(4)(iv): When midrails are used, they shall be installed between the top edge of the guardrail system and the platform surface.

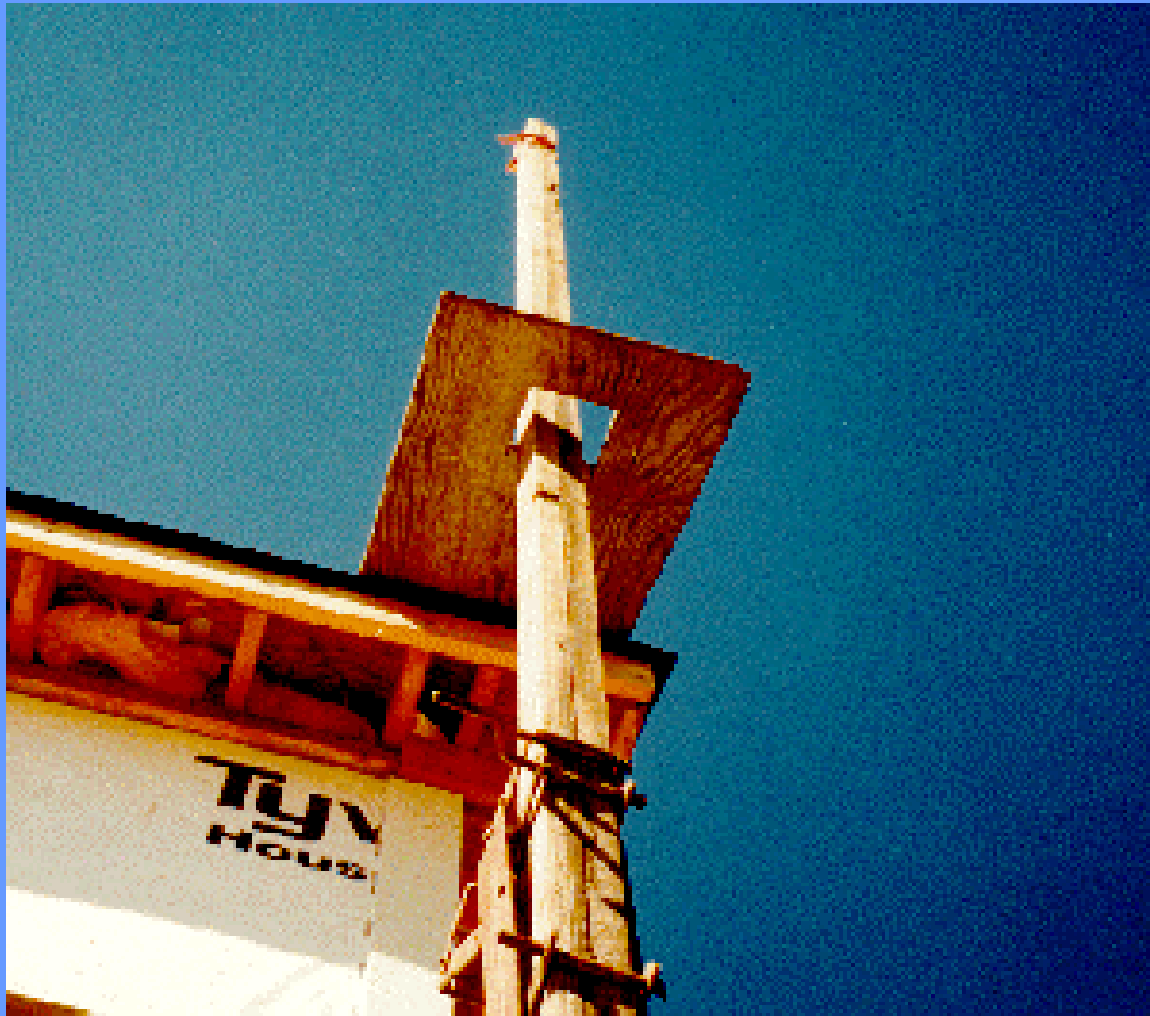
1926.452(j)(2):
Pumpjack poles shall be secured to the structure at the bottom by the rigid triangular bracing or equivalent.

No violation: Pump jack pole is secured to mudsill of 3/4 inch plywood which is staked into the ground.

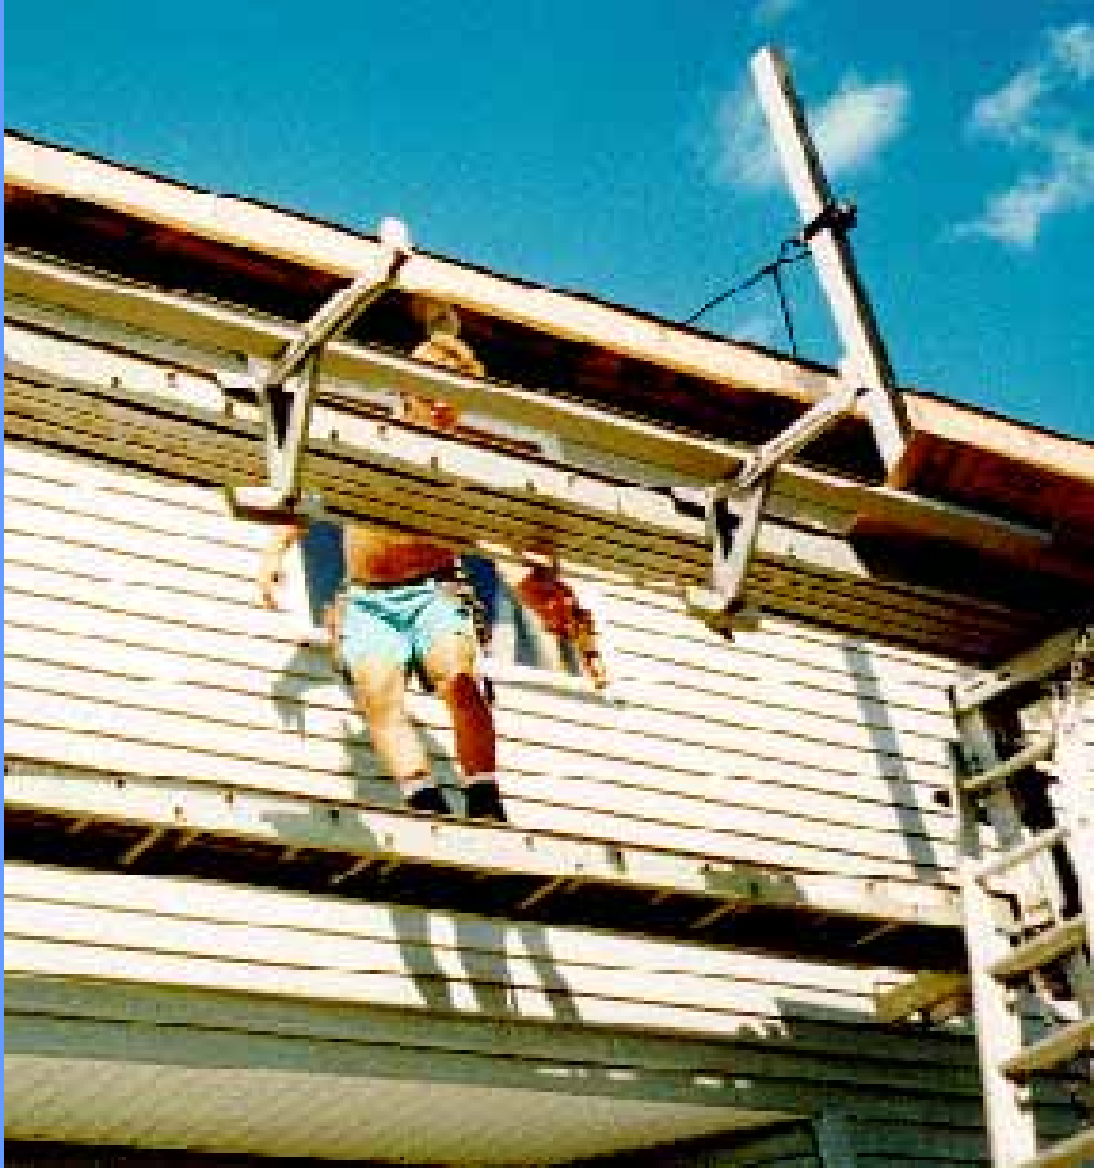
1926.452(j)(2):
Poles shall be secured
at the top by rigid
triangular bracing or
equivalent.

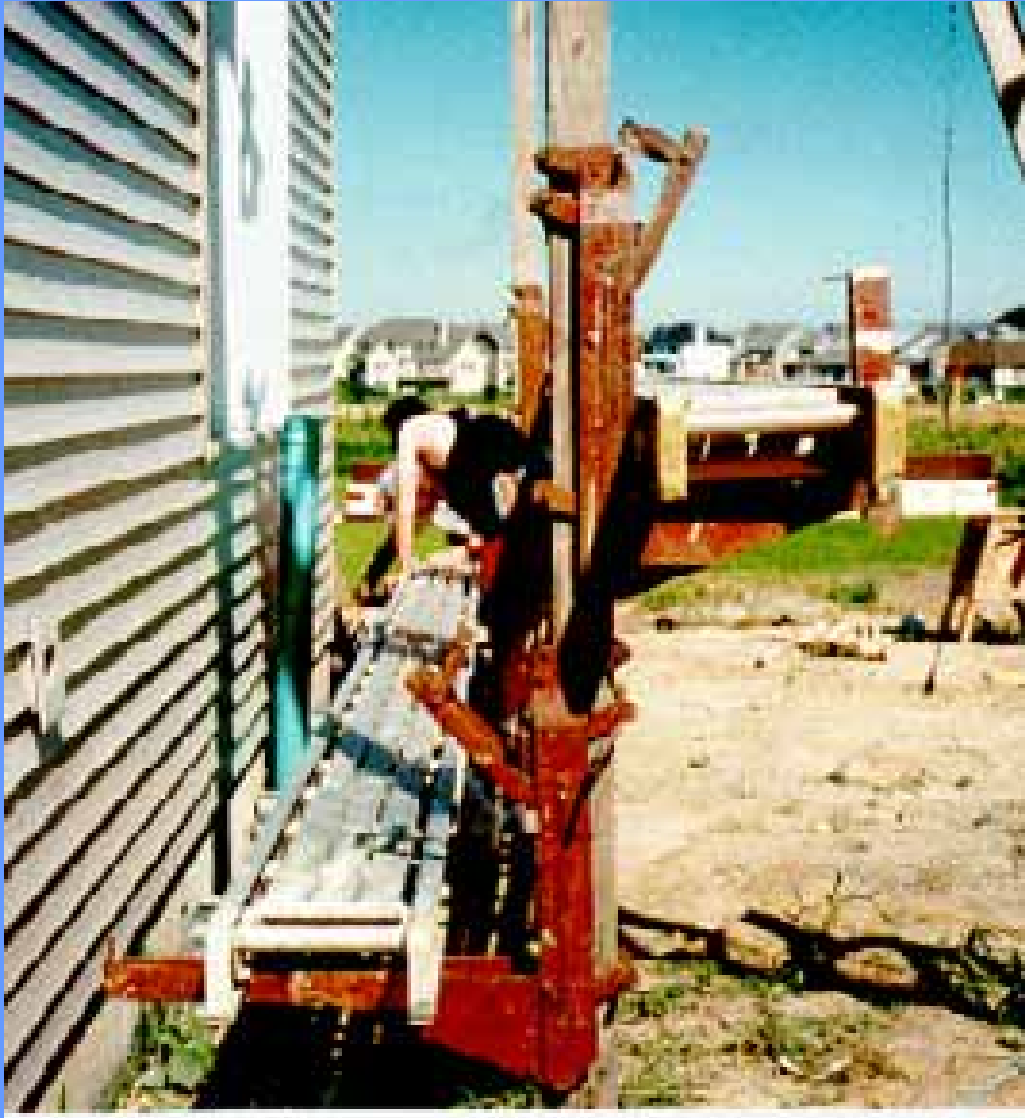
1926.452(j)(3): When work benches are used for fall protection, they must meet requirements of 1926.451(g):

No violation: No midrail is needed because gap between platforms is 23 inches. The work bench can serve as a top rail because the vertical distance from the platform is 23 inches + 4 inch thick platform + 12 inch horizontal plank width = 39 inches.

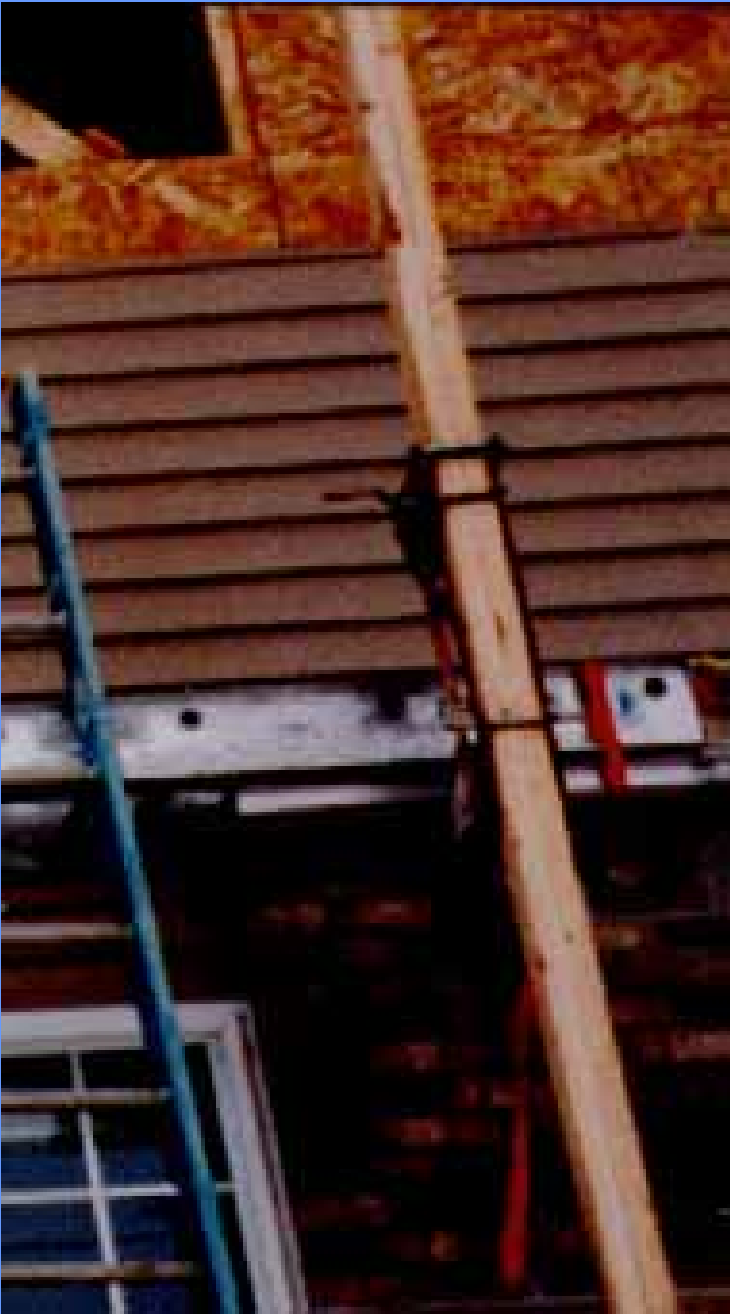
1926.452(j)(3):
Workbench may be used as a top rail if it meets the requirements for guardrails in 1926.451(g)(4).

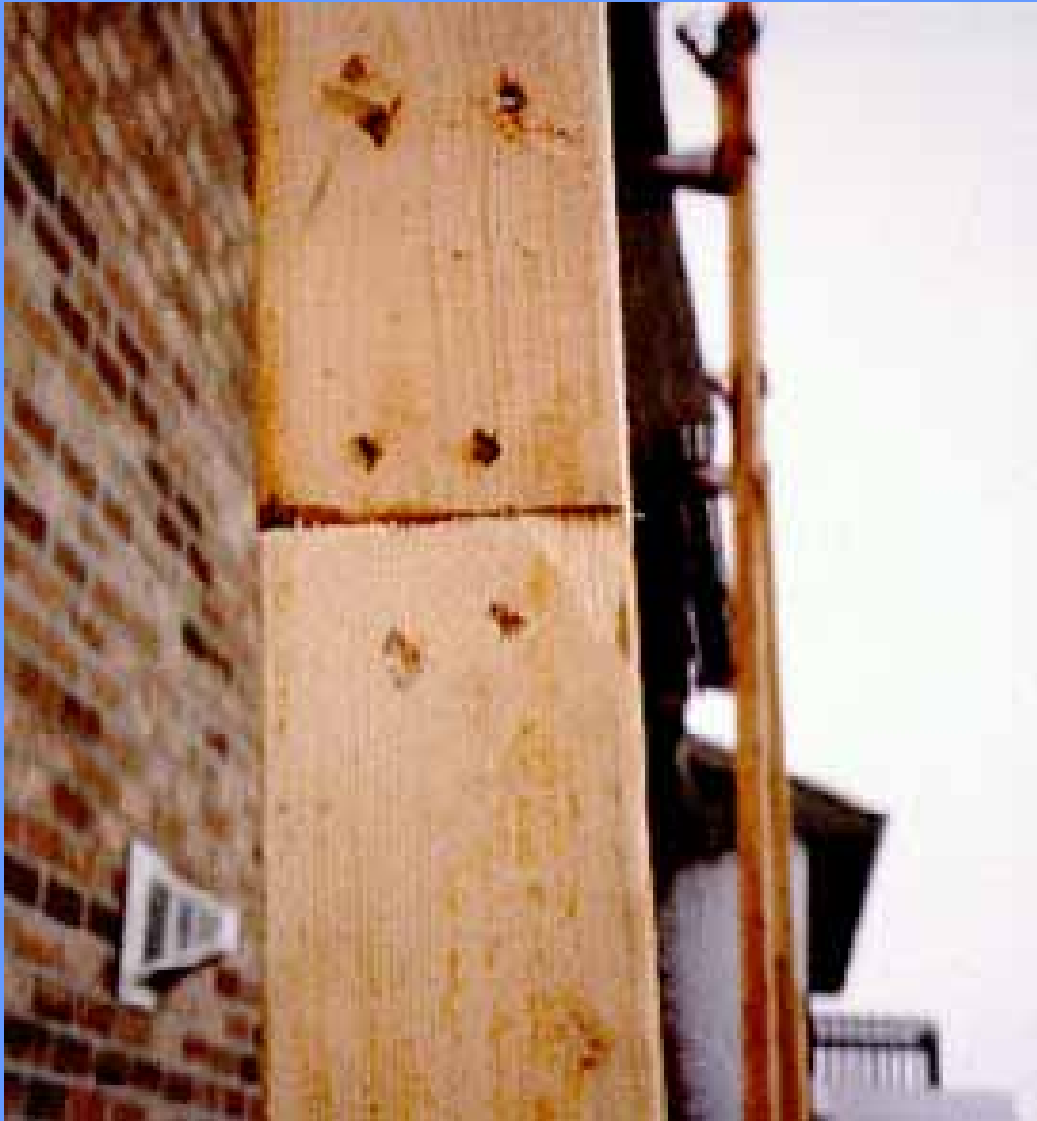
1926.452(j)(6): When wood poles are constructed of two continuous lengths, they shall be joined together with the seam parallel to the bracket.

No violation: Seams are parallel to the bracket.

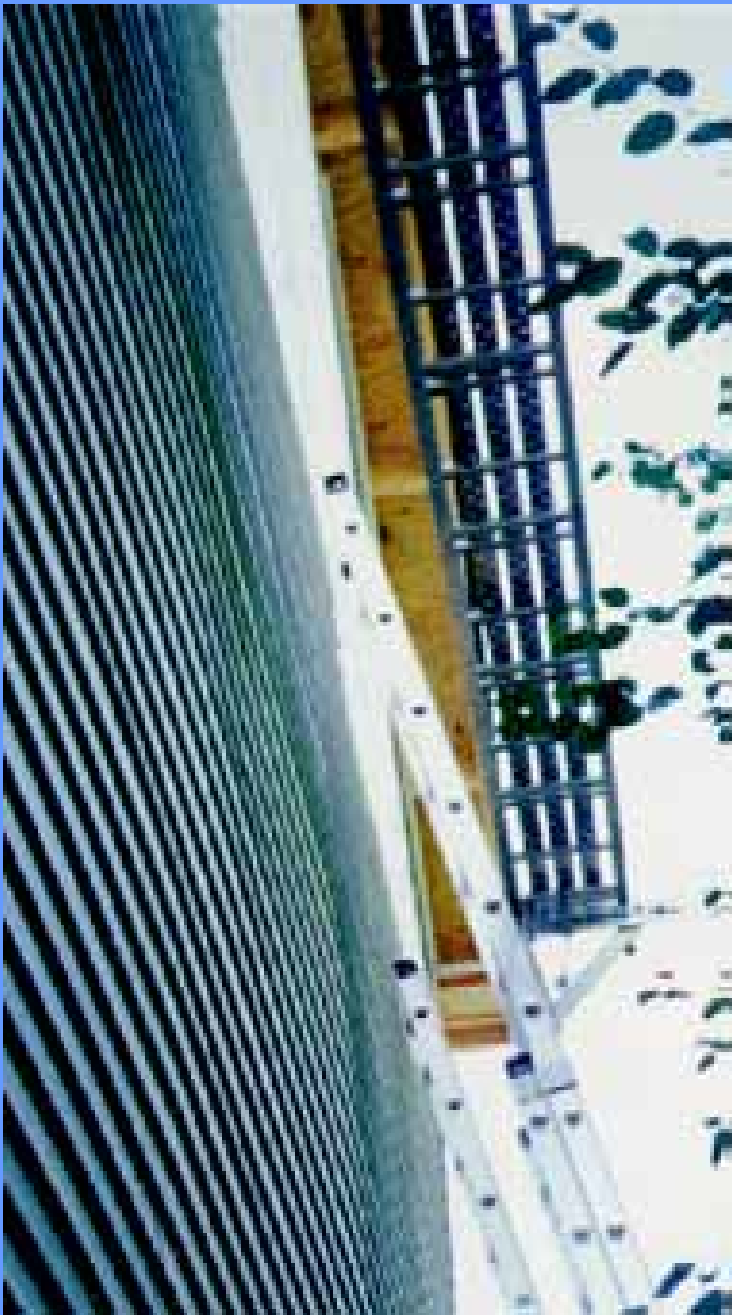
1926.452(j)(3): When two by fours are spliced together to make a pole, mending plates shall be installed at all splices to develop the full strength of the member.

Violation: No mending plate at the splice.

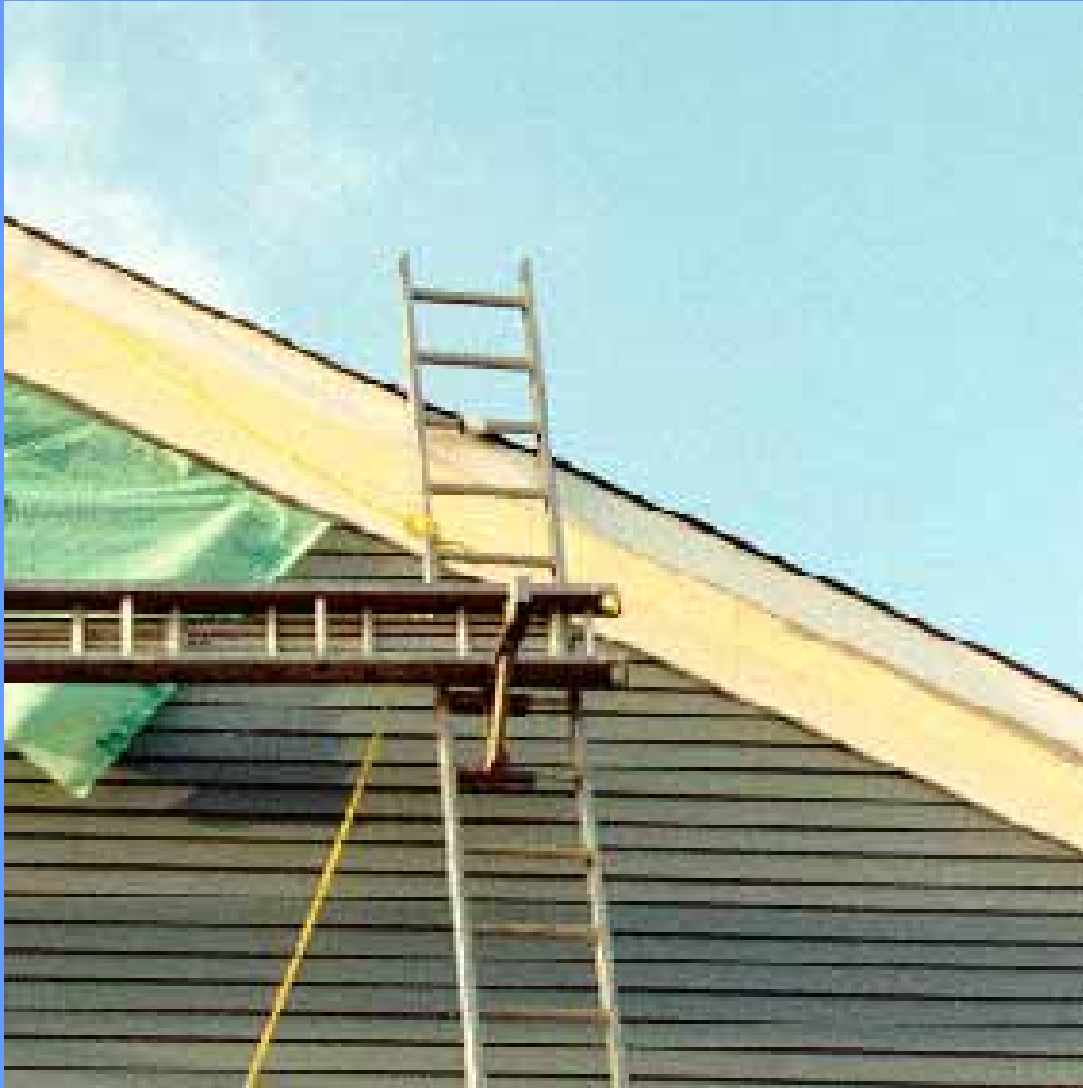
1926.451 (b) (3): Scaffold platform must be within 14 inches to the structure.

No violation: Scaffold is within 14 inches from the building.

1926.451 (e) (1): Safe access to scaffold shall be provided

Violation: Safe access to scaffold not provided.

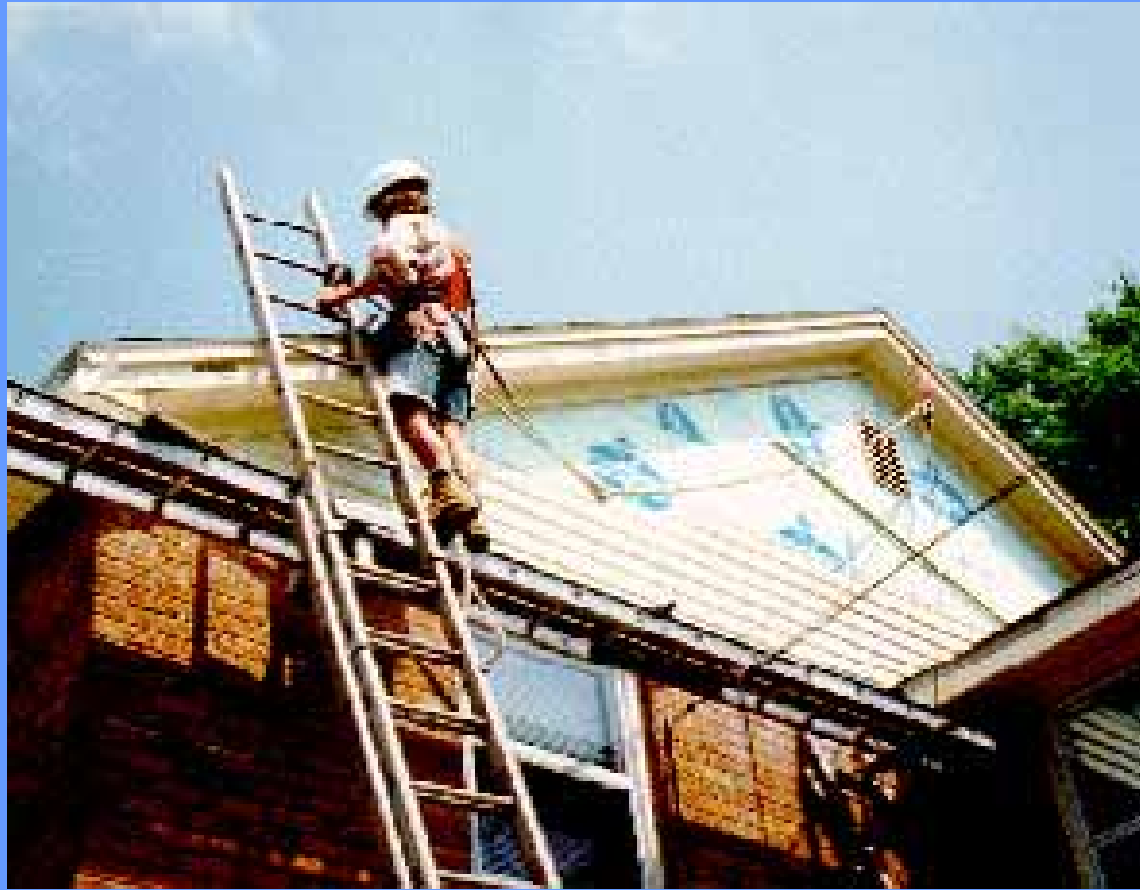
1926.451(e)(1): Safe access to scaffold shall be provided.

Violation: Scaffold not set up to give safe access.

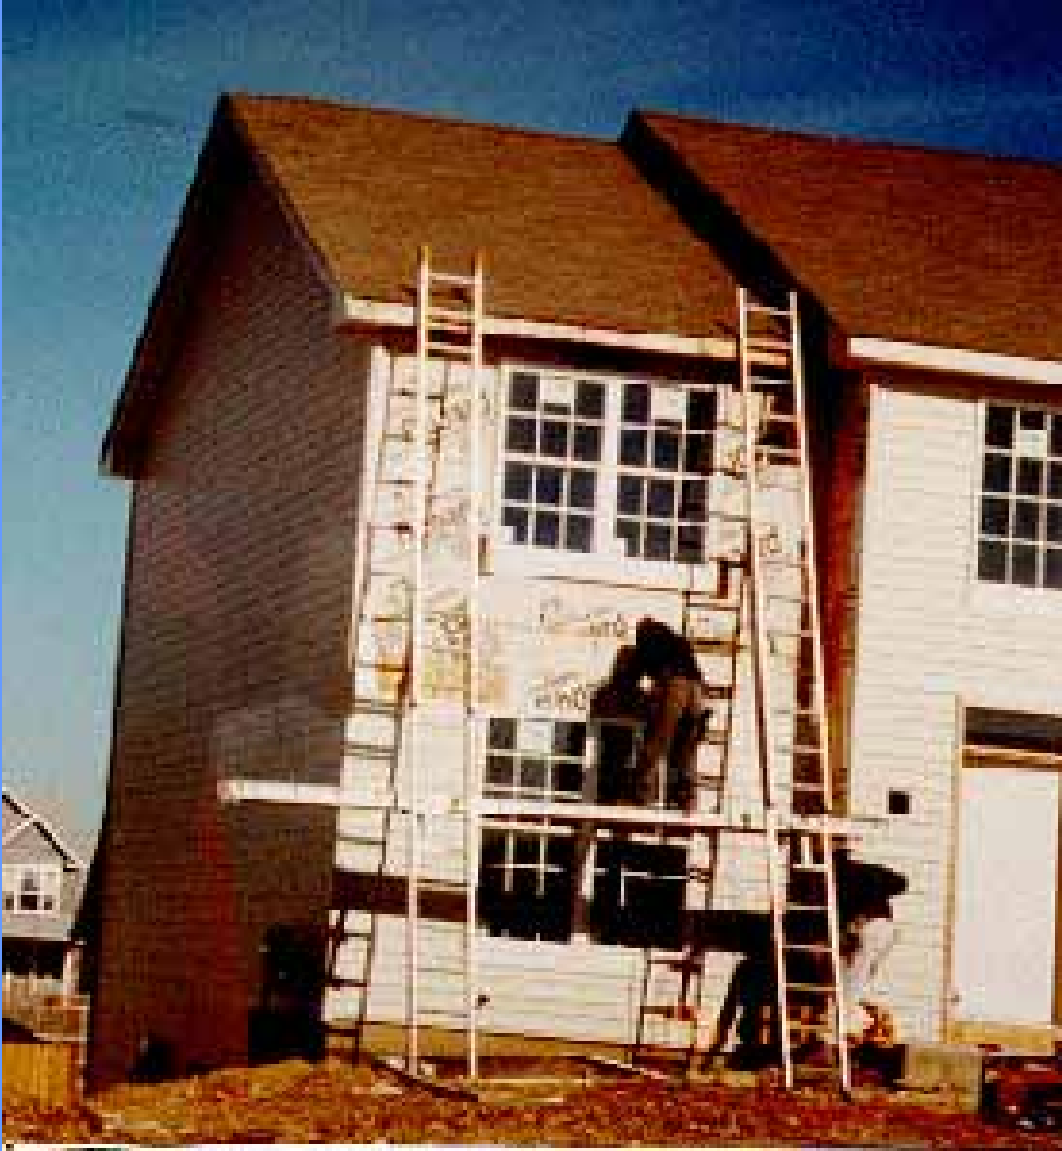
1926.451(e)(1): Safe access shall be provided to scaffolds over 2 feet in height.

No violation of access requirement: Ladderjack scaffold ladder is set up so that worker steps from ladder to scaffold plank with no interference.

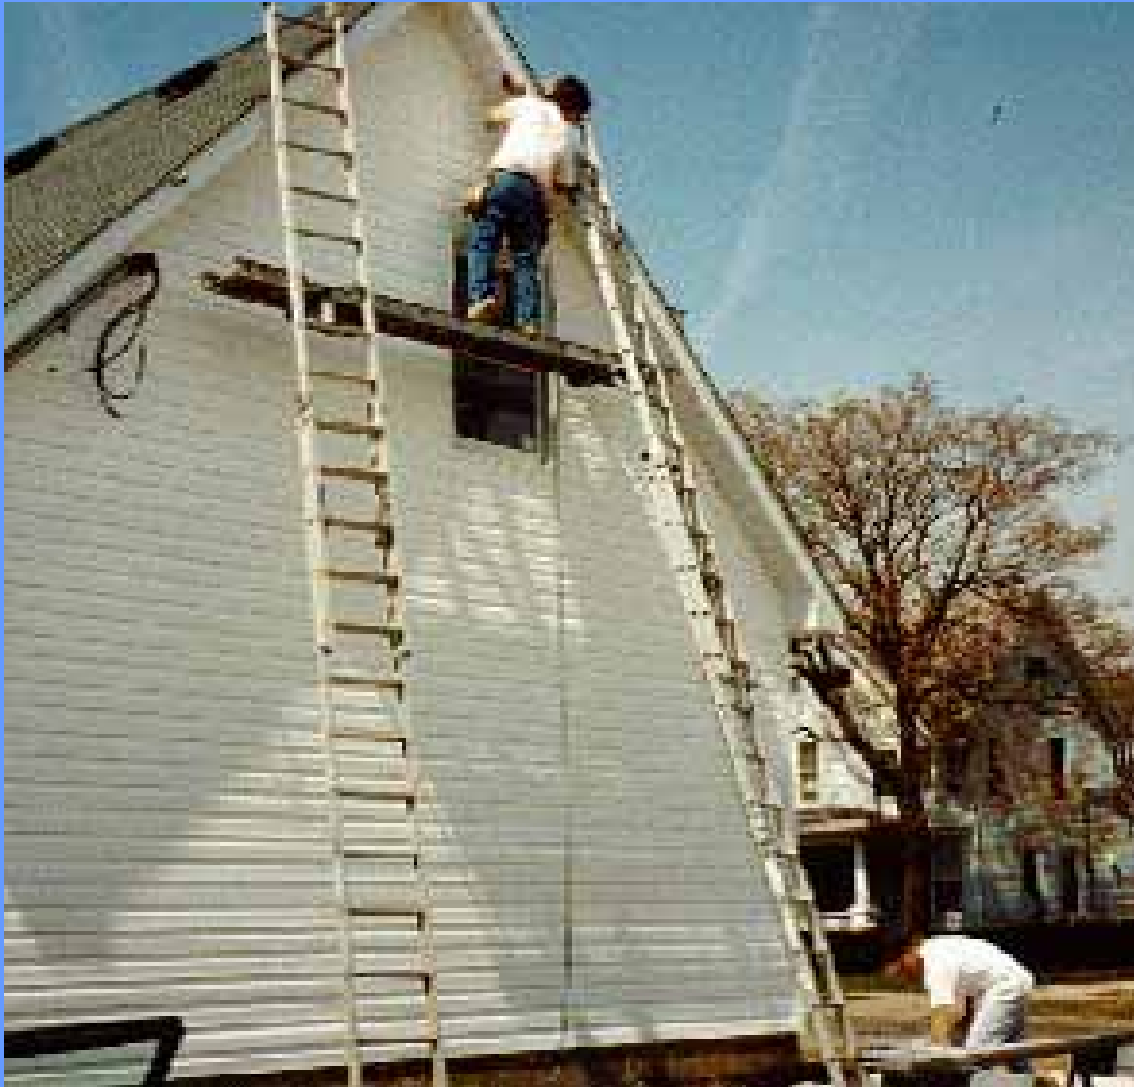
1926.451(g)(1): Fall protection is required for each employee on a scaffold above 10 feet.

No violation: Ladder jack used at 5 feet.

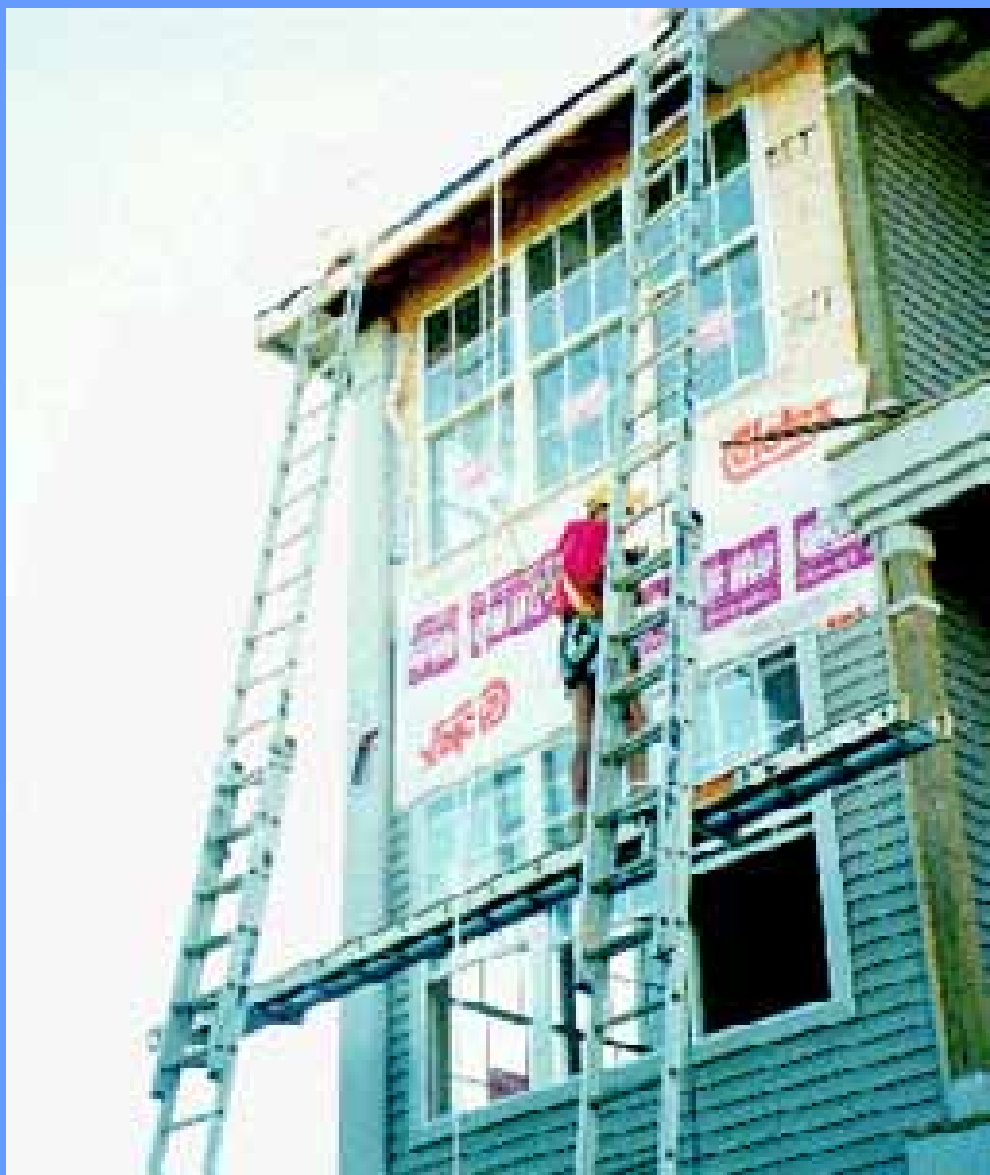
1926.451(g)(1)(i):
Employees on a ladder
jack scaffold shall be
protected by a personal
fall arrest system when
working above 10 feet.

Violation: No fall arrest
on the 14 foot high
scaffold.

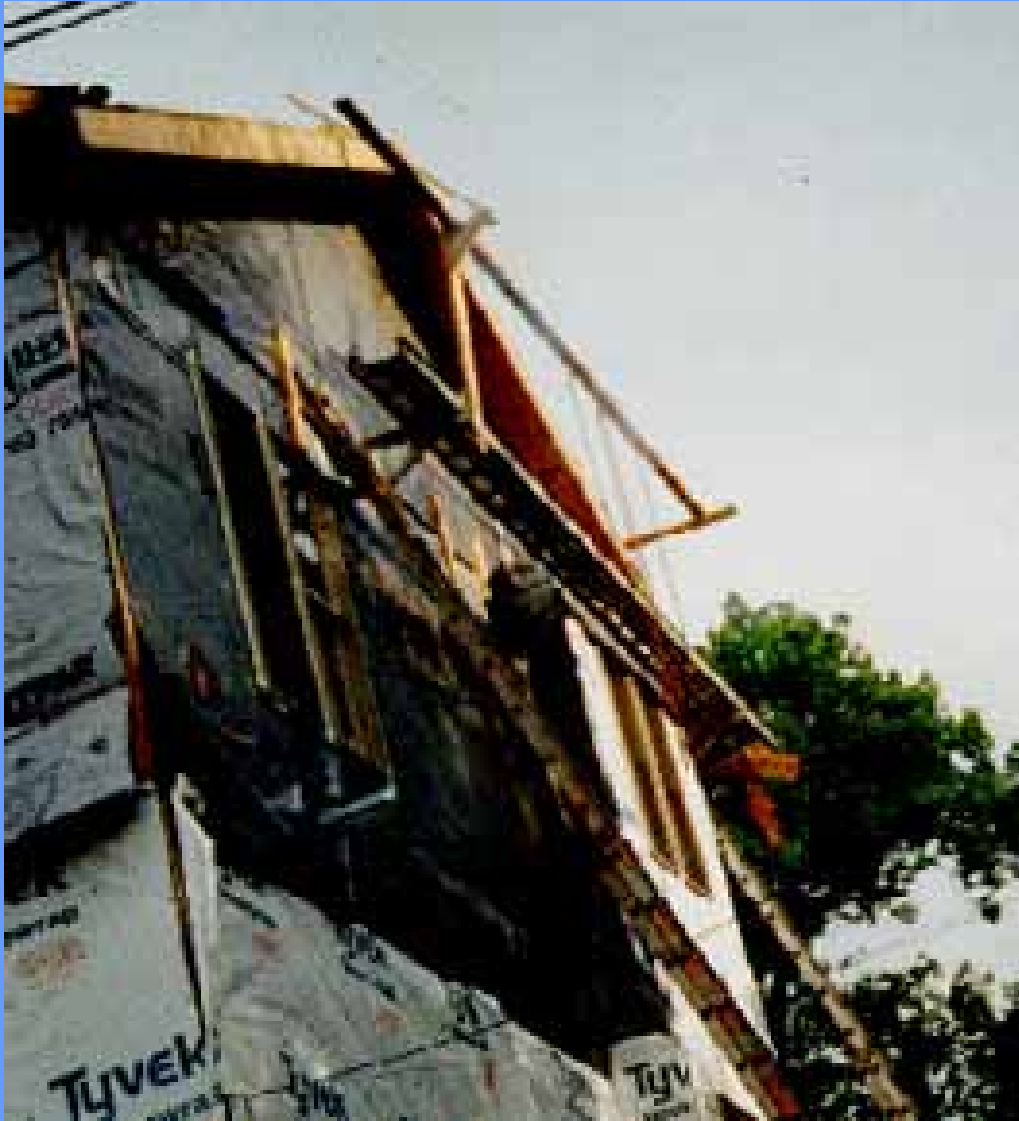
1926.451(g)(1)(i):
Employees on ladder jack scaffold shall wear fall arrest.

No violation: Employee wearing fall arrest while siding on the ladder jack.
