***PUMP JACK/LADDER JACK SCAFFOLD
PHOTO COMPLIANCE GUIDE***

March 1998

John Newquist
U.S. Department of Labor-OSHA
344 Smoke Tree Business Park
North Aurora, IL 60542

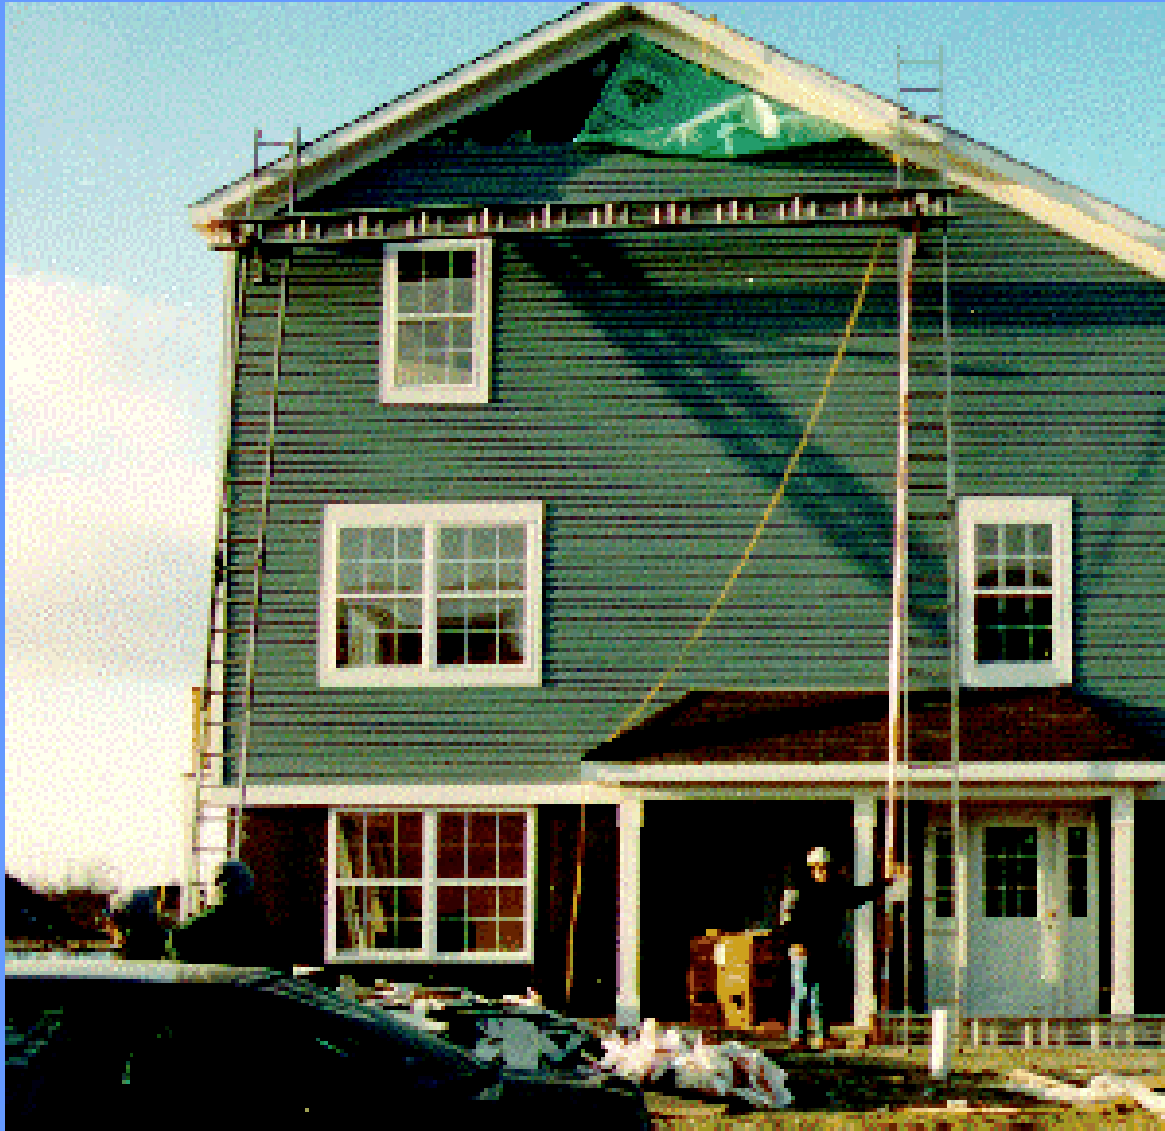
1926.451(g)(1)(i): Each employee on a ladder jack scaffold shall be protected by a fall arrest system.

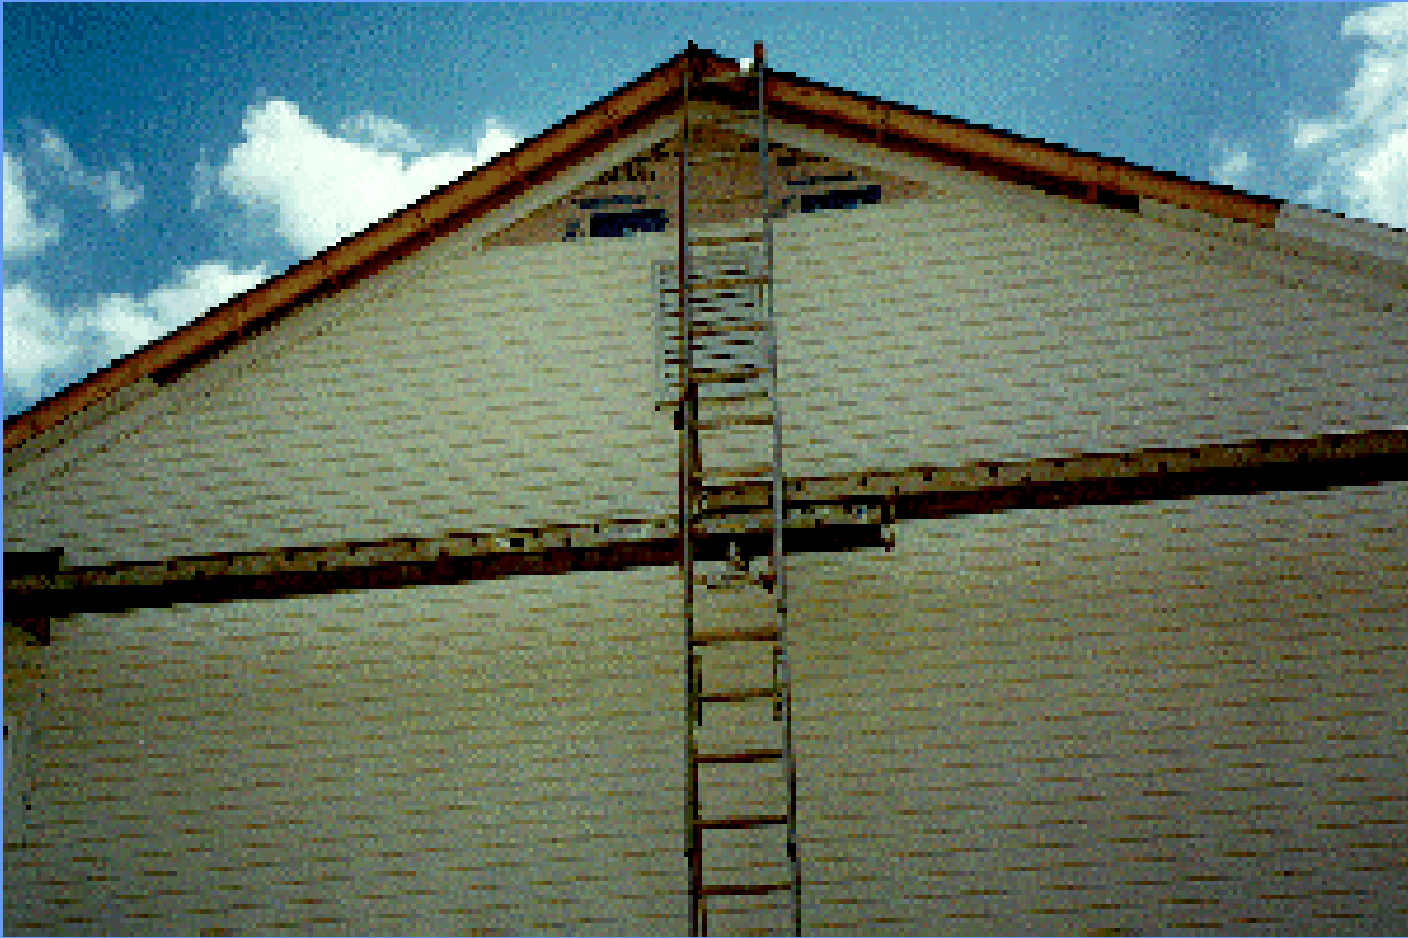
1926.453(k)(1):
Ladder jack scaffolds shall not exceed a height of 20 feet.

Violation: Scaffold was 26 feet high.

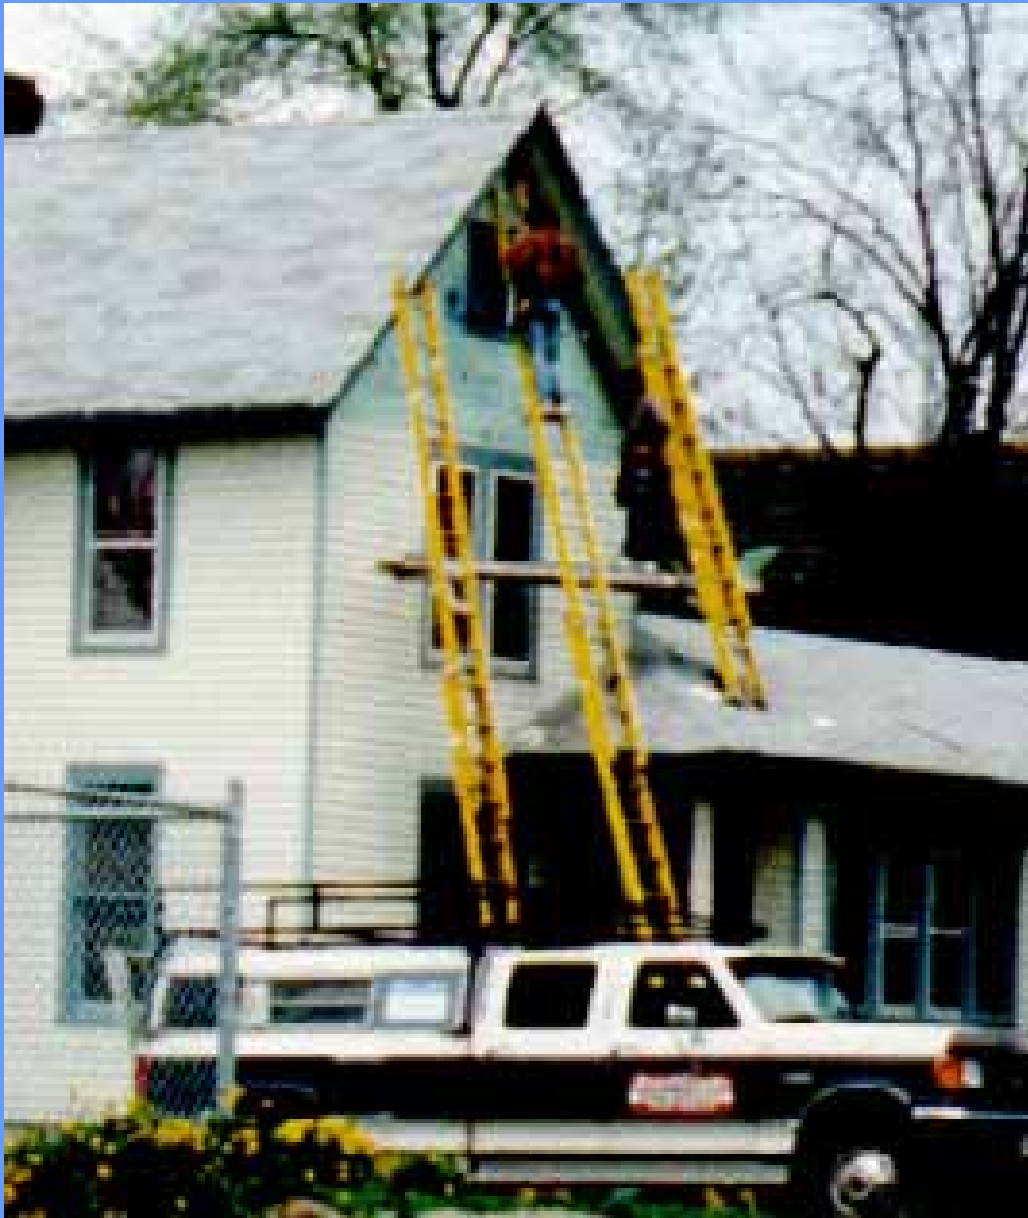
1926.452(k)(5): Ladder jack scaffold platforms shall not be bridged one to another.

Violation: Both metal planks resting on a single ladder jack bracket.

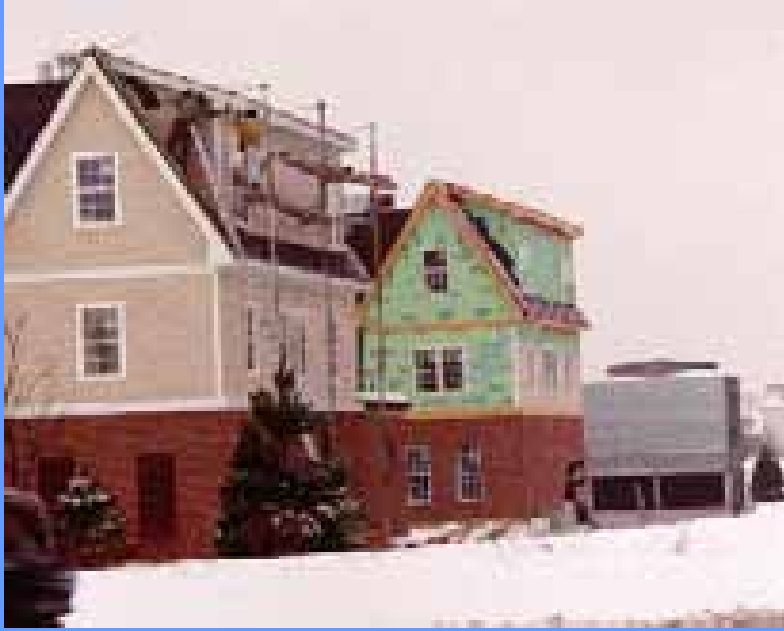
1926.1053(b)(6):
Ladders must be used on level surfaces unless secured to prevent displacement.

Violation: Ladder feet not stable on a sloped roof.

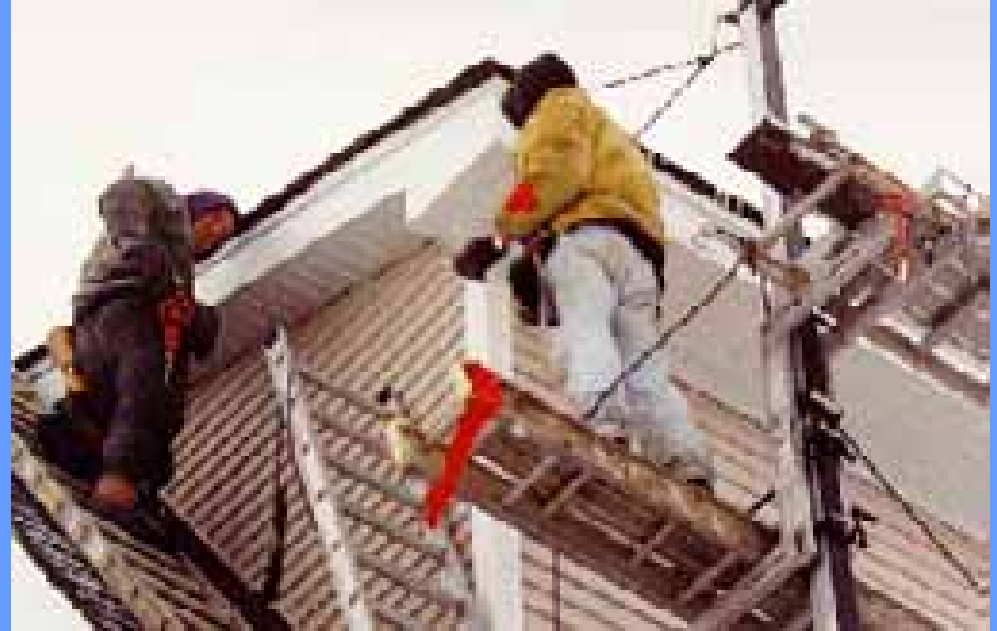
*Expanded View - 30' high
No intermediate
tie-ins from pump jack.*

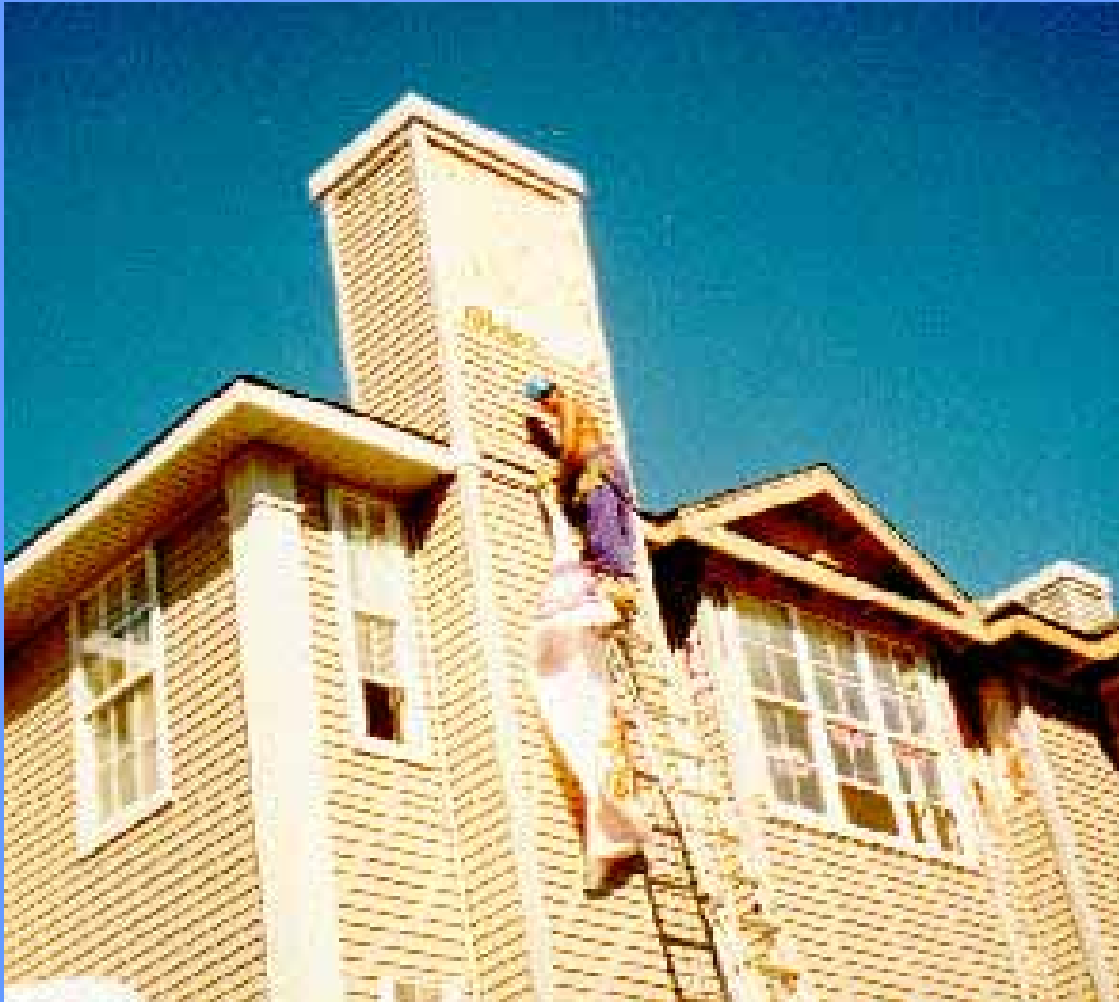
*Chicken ladder
used in lieu of fall arrest on roof.*

1926.451 (g) (1) (iii): Each employee on a crawling board (chicken ladder) shall be protected by personal fall arrest, guardrails, or by 3/4 inch grabline or equivalent handhold securely fastened beside each crawling board.

Violation: No fall protection at edge of pump jack or on chicken ladder. No midrail on scaffold.

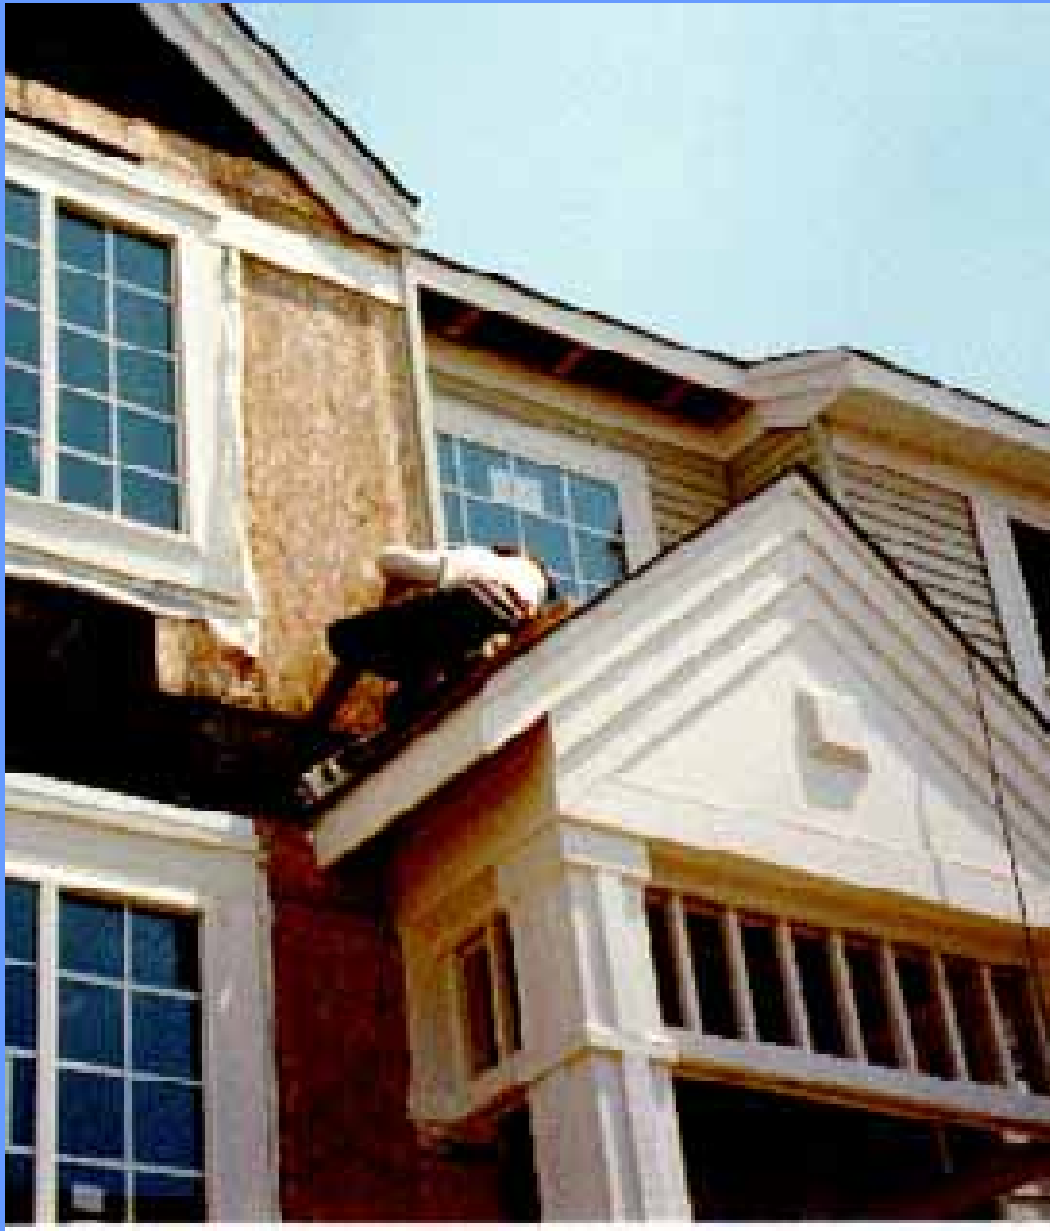
1926.21(b)(2):
Employees shall be trained to avoid hazards.

No violation: In this instance the use of scaffolding is not feasible for employees applying siding. Employees have been trained in adequate ladder use.

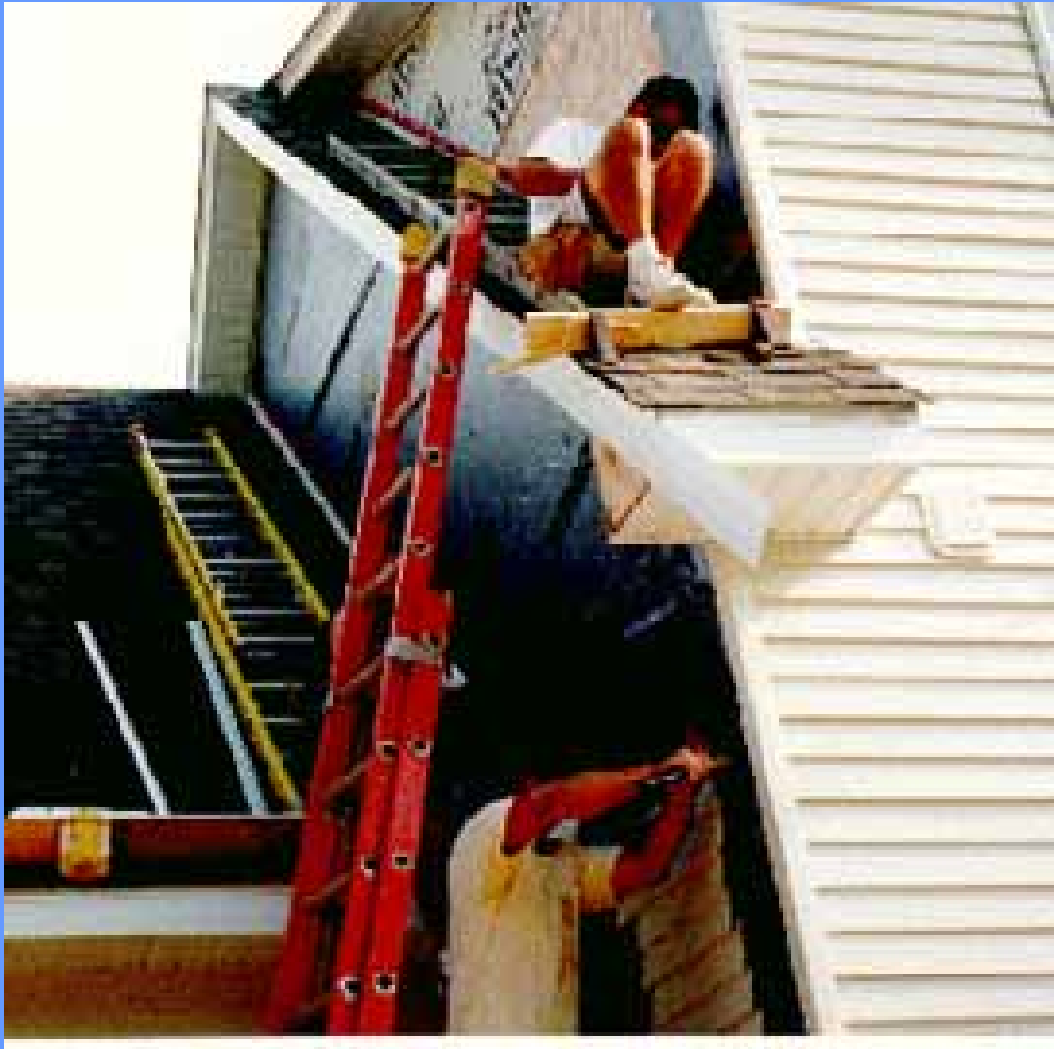
1926.501(b)(11):
Employees on steep roofs
over 6 feet shall have fall
protection.

Violation: Sider on 18 foot
roof with no fall or slide
protection.

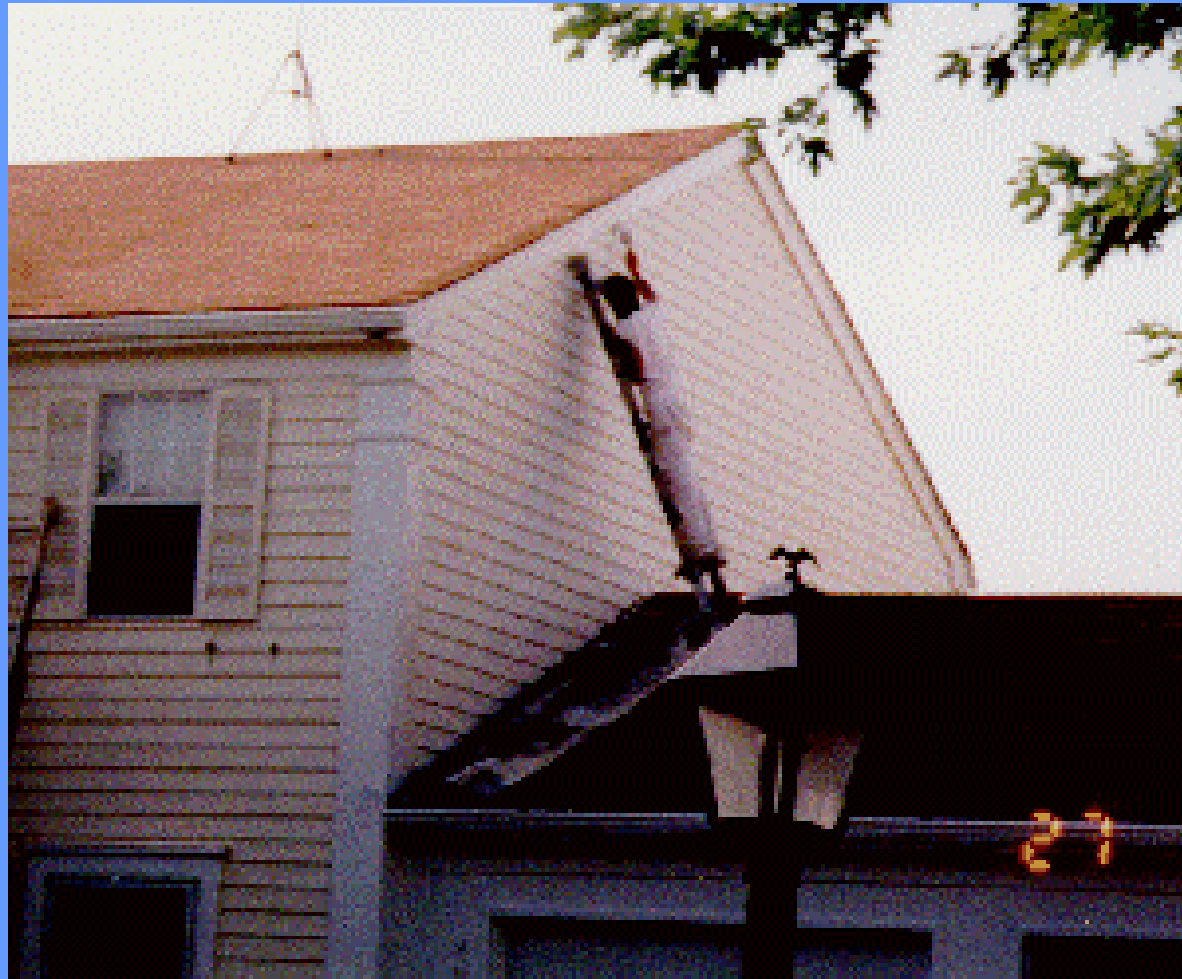
1926.501(b)(11): Fall protection is required for sloped roofs over 6 feet high.

No violation: Adequate fall protection (2x4 inch slideguards) is used on this roof.

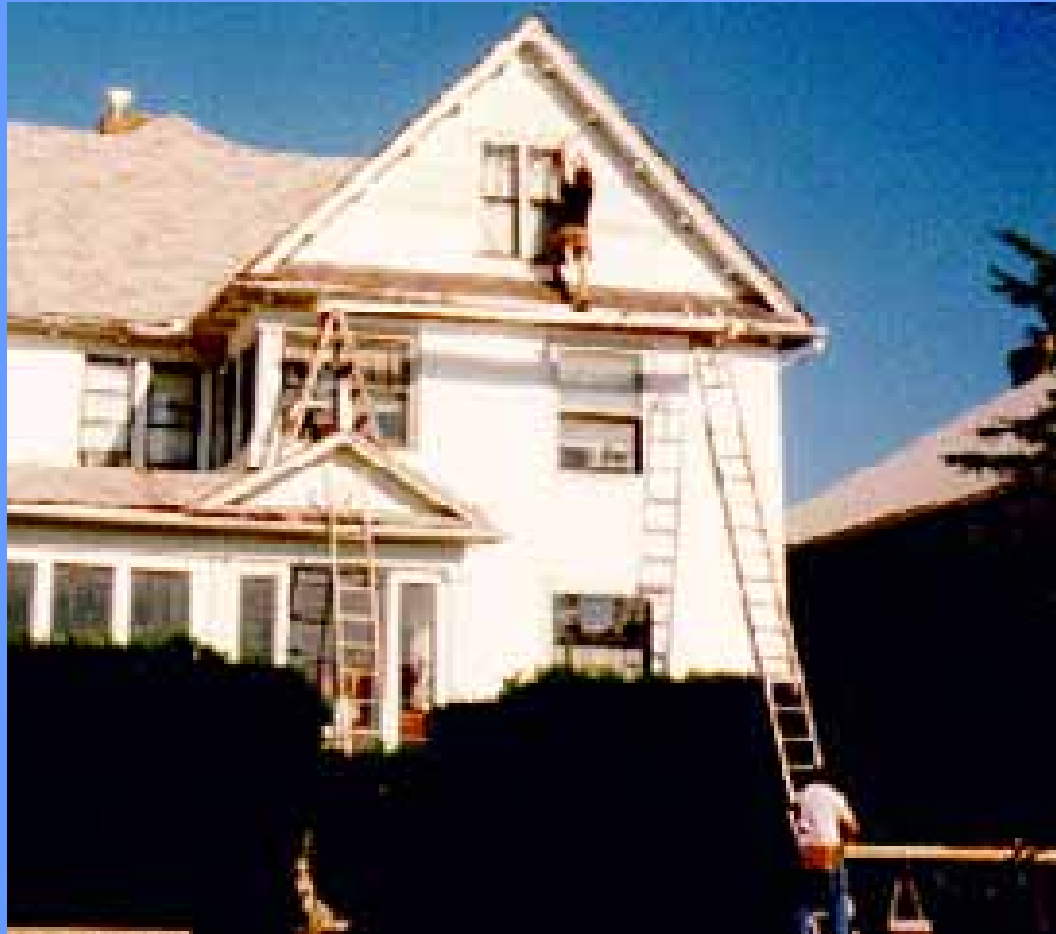
1926.1053(b)(6): Ladders shall be used on stable and level surfaces.

Violation: Ladder is not stabilized and is also on the slope (unlevel) portion of the roof.
