PARK MANOR ESTATES SECTIONS 11-12 UNDERDRAIN IMPROVEMENTS

TECHNICAL PROVISIONS

ORANGE COUNTY, FLORIDA

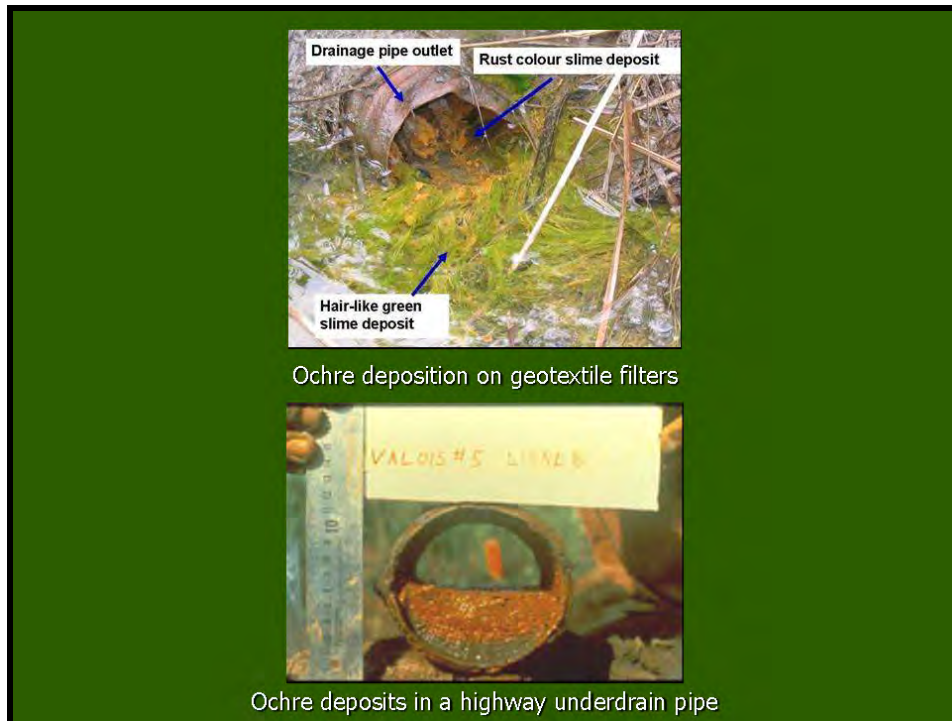
Exhibit 3.b Photos of ochre deposits on pipe as well as on fabric

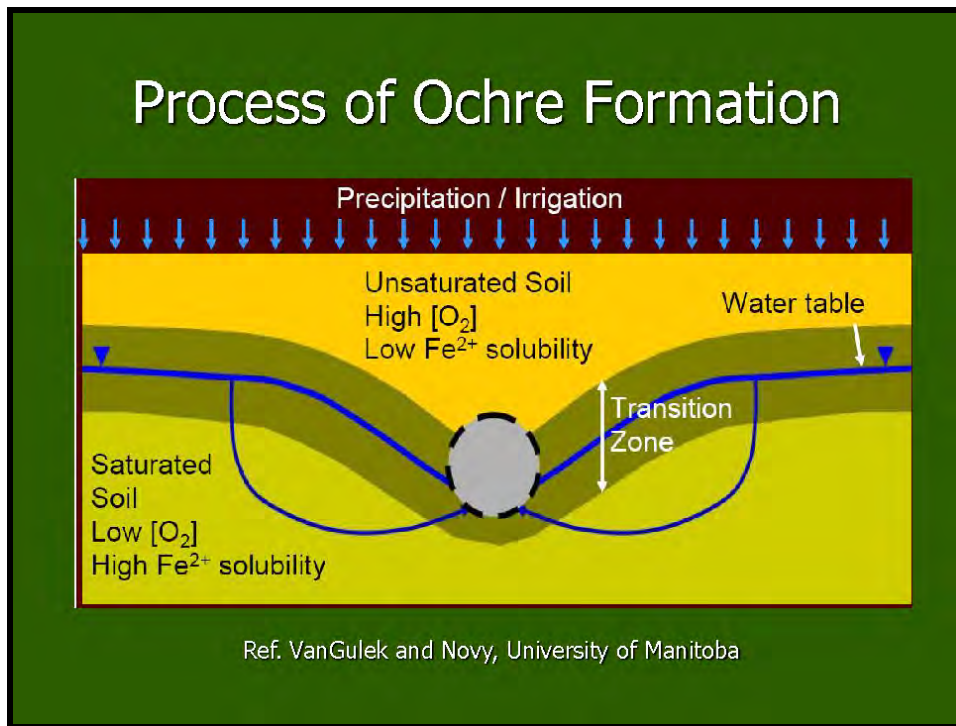
Exhibit 3.c shows the zone of fluctuating saturation at an underdrain pipe where conditions (moisture & oxygen) allow growth of iron ochre bacteria. If the soil were mostly dry or always inundated, the conditions will not allow growth of the bacteria so the focus is on the dynamic moisture zone. The soil matrix must contain iron producing bacteria and the soil must be sandy with hardpan type layers (dark reddish brown sands or organics). These conditions are typically found in east Orange County near or overlying wetlands and in zones with iron-rich hardpan. The ochre develops to maturity within a year after installation and then does not grow further as the iron source generally diminishes. However, if the underdrain is on a long slope with a good fetch of groundwater capture, the feed of iron-rich seepage can be extended for many years with continual regrowth.

Within this particular subdivision some of the existing underdrain runs are long and although it has been about three years since the majority of underdrains were installed, some ochre growth can likely continue.

Exhibit 3.c Ochre formation process and zone of interest

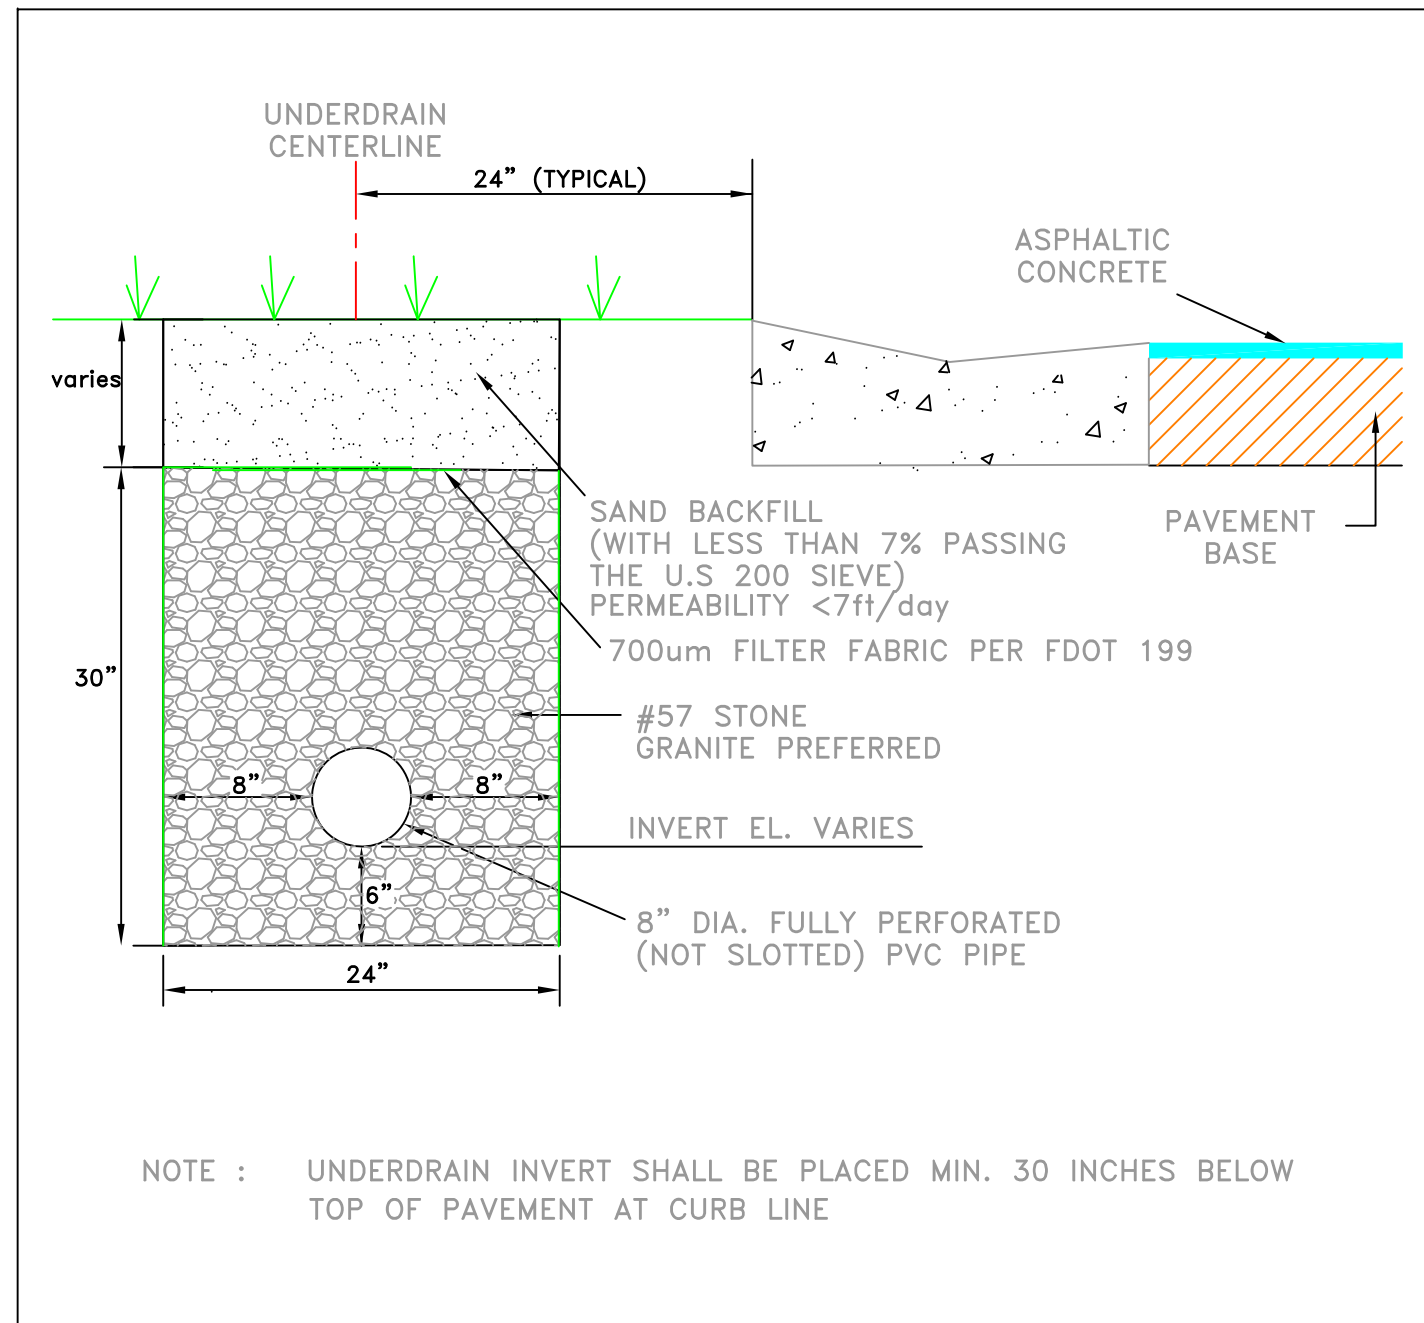
Figure Name:	
UNDERDRAIN DETAILS AREAS OF TANNIC GROUND WATER	
Project Name:	
PARK MANOR SUBDIVISION UNDERDRAIN ASSESSMENT	
Checked & Approved by:	DS
Drawn By:	LA
Date:	10-26-15
Scale:	Noted
Proj. #	15-610.65
Figure 3.2

As a result of the presence of tannic ground water and associated ochre deposits noted in several areas, we have proposed a modified roadway underdrain detail to address the ochre problem.

CROSS-SECTION CURB LINE ROADWAY UNDERDRAIN IN AREAS OF TANNIC GROUND WATER

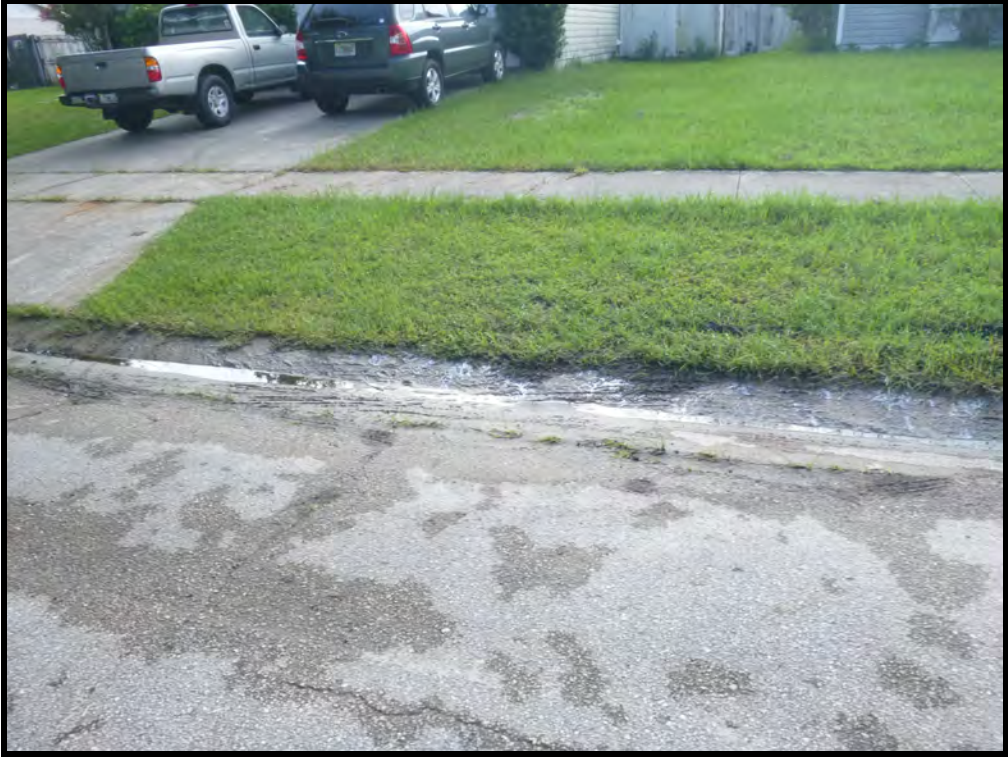
Photo #1. Seepage on Grayson Drive

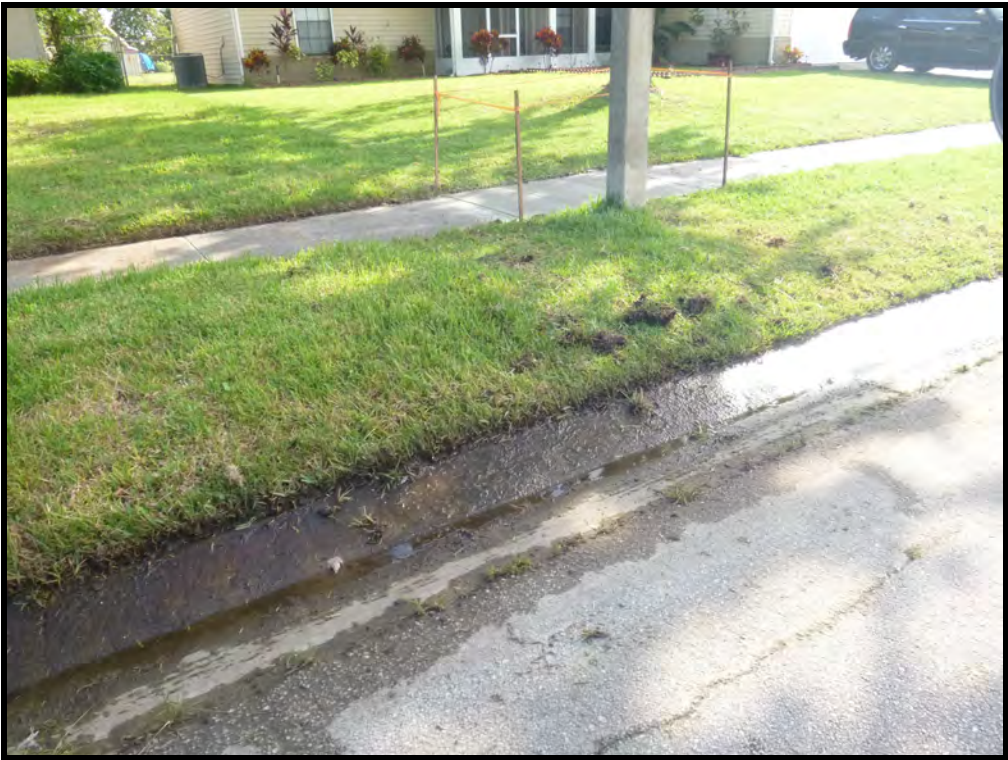
Photo #2. Seepage on Bridlewood Avenue

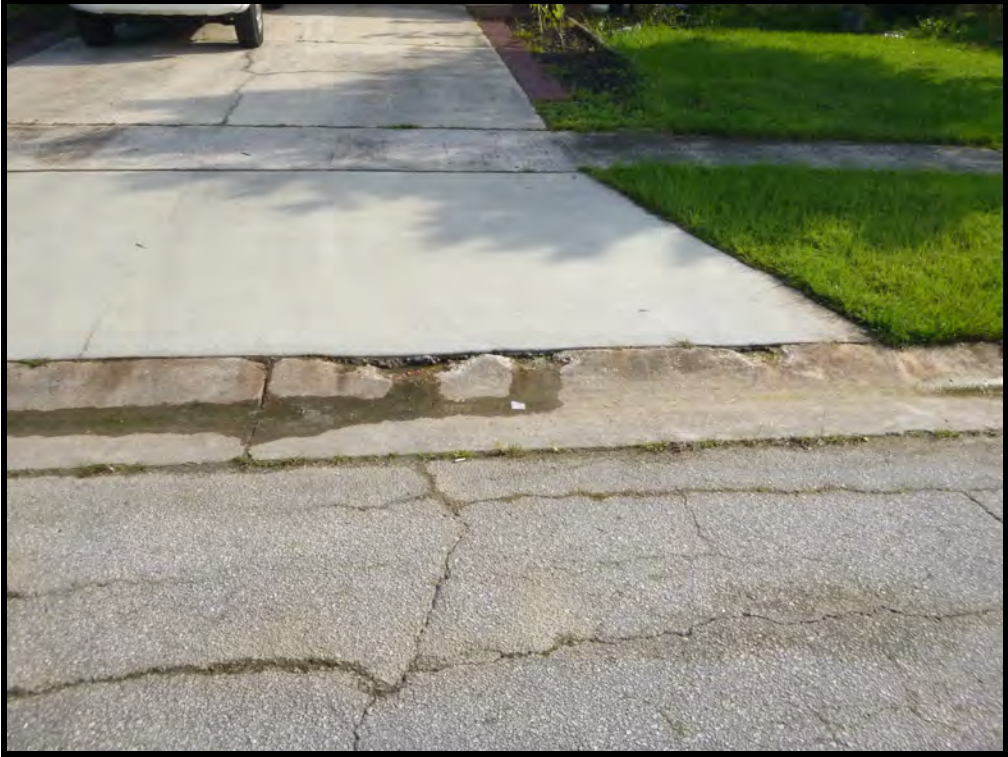
Photo #3. Seepage on Jepson Street

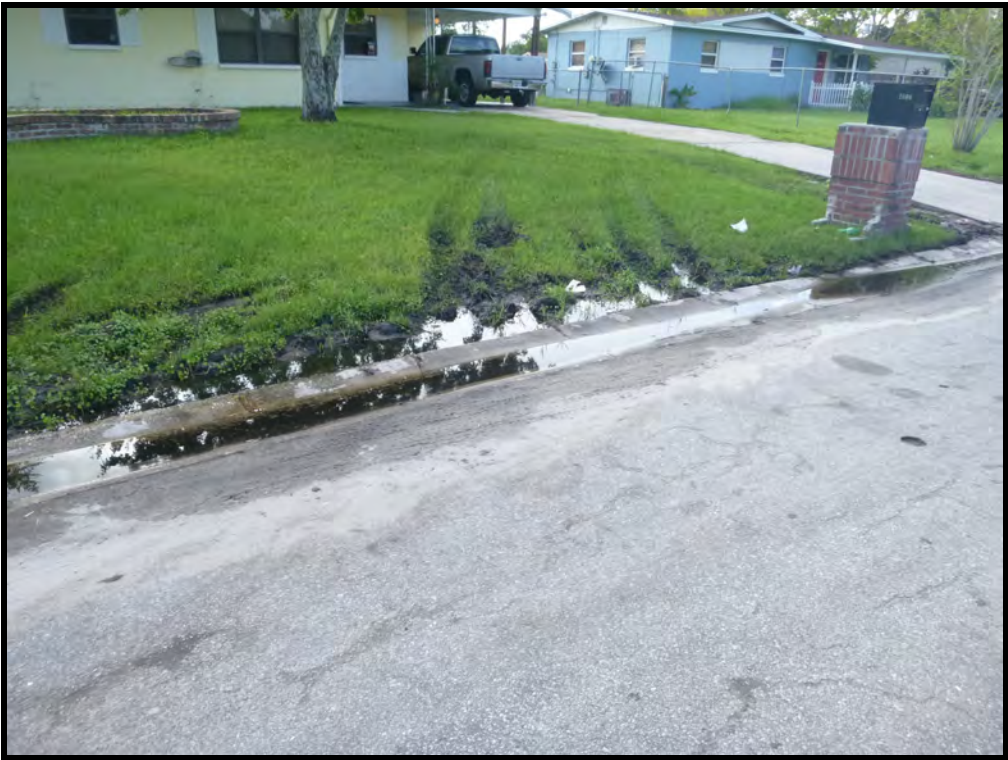
Photo #4. Seepage on Roberta Avenue
