BATES ROAD OVER CRANE STRAND CANAL BRIDGE DEFICIENCIES REPAIRS

BATES ROAD OVER CRANE STRAND CANAL BRIDGE NO. 754003 DEFICIENCY REPAIRS

Subject: **BATES ROAD BRIDGE REPAIR**
Field Inspection Report
Orange County, Florida
Inwood Project No. ORC-018-40
GEC Project No. 4299G

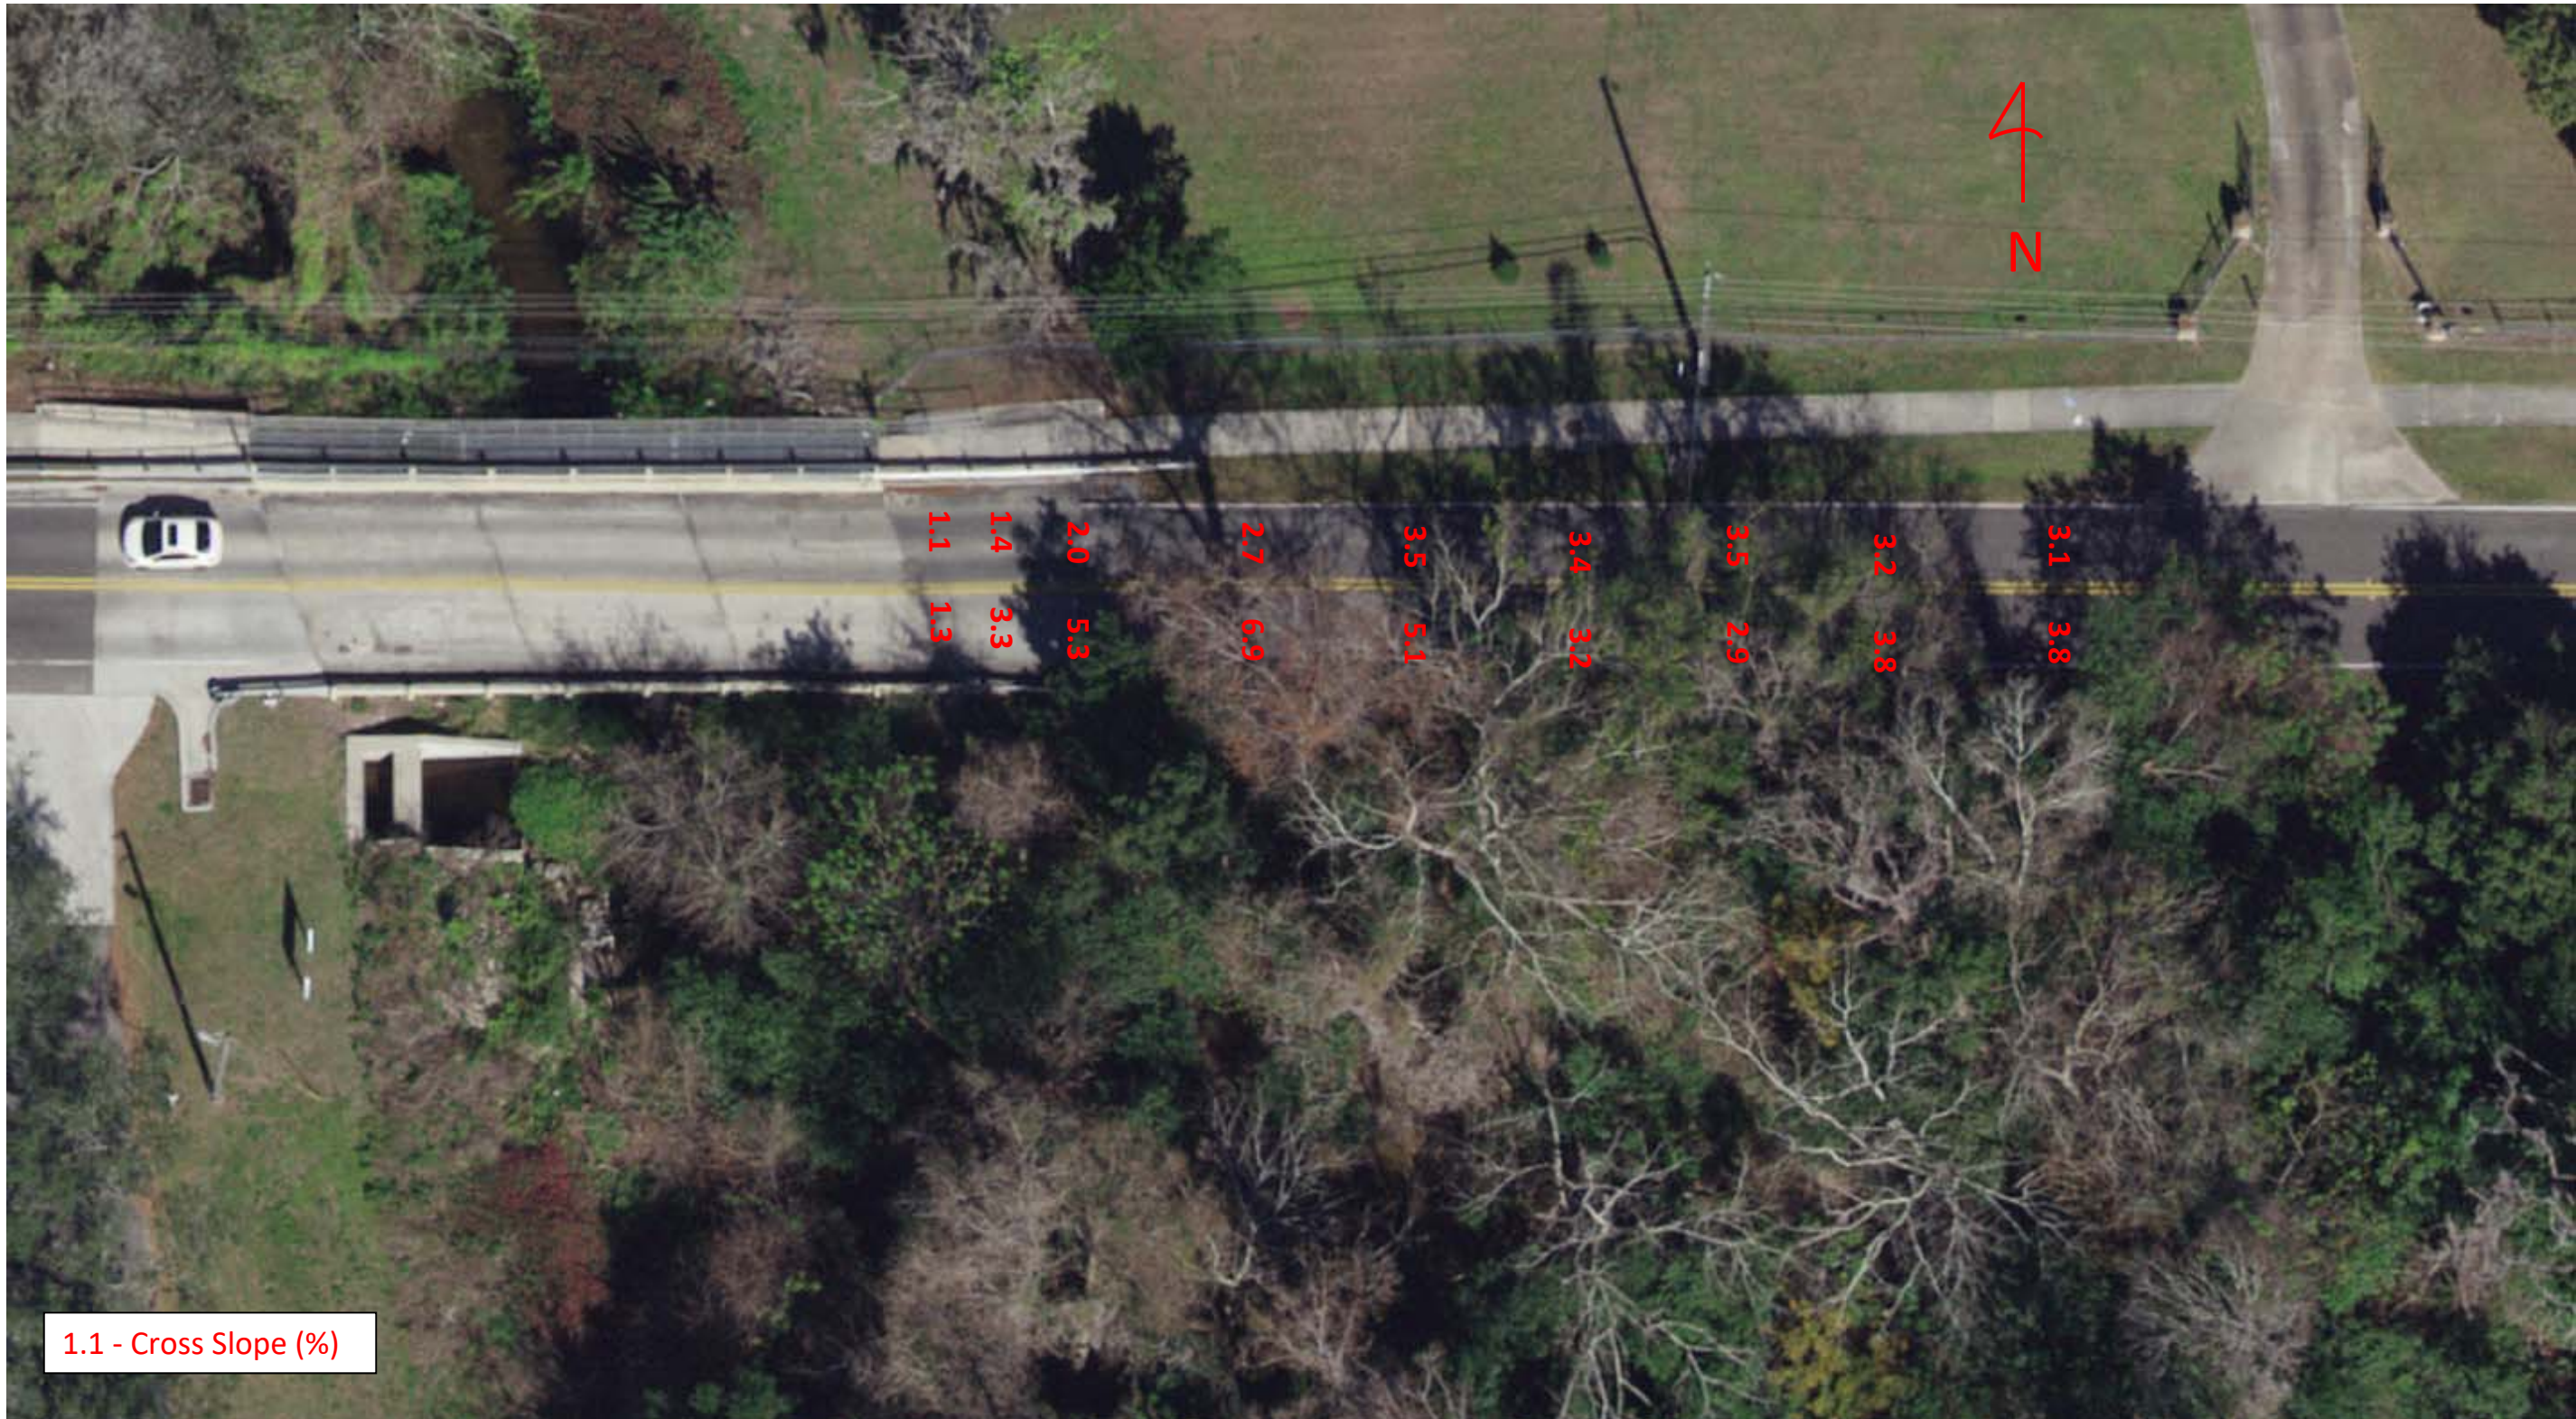
| Client Name: Inwood and Orange County | Project Name: Bates Road Bridge Repair | Project Location: Orange County, Florida | GEC Project No.: 4299G |

- Apparent approach slab settlement to the south relative to the existing bridge deck.
- Settlement of the asphalt toward the south directly adjacent to the approach slab.
- Longitudinal cracking along the eastbound travel lane east of the bridge.
- Longitudinal cracking along the westbound travel lane west of the bridge.
- Washout beneath the bridge wrap-around concrete slab on the southeast corner of the existing bridge.

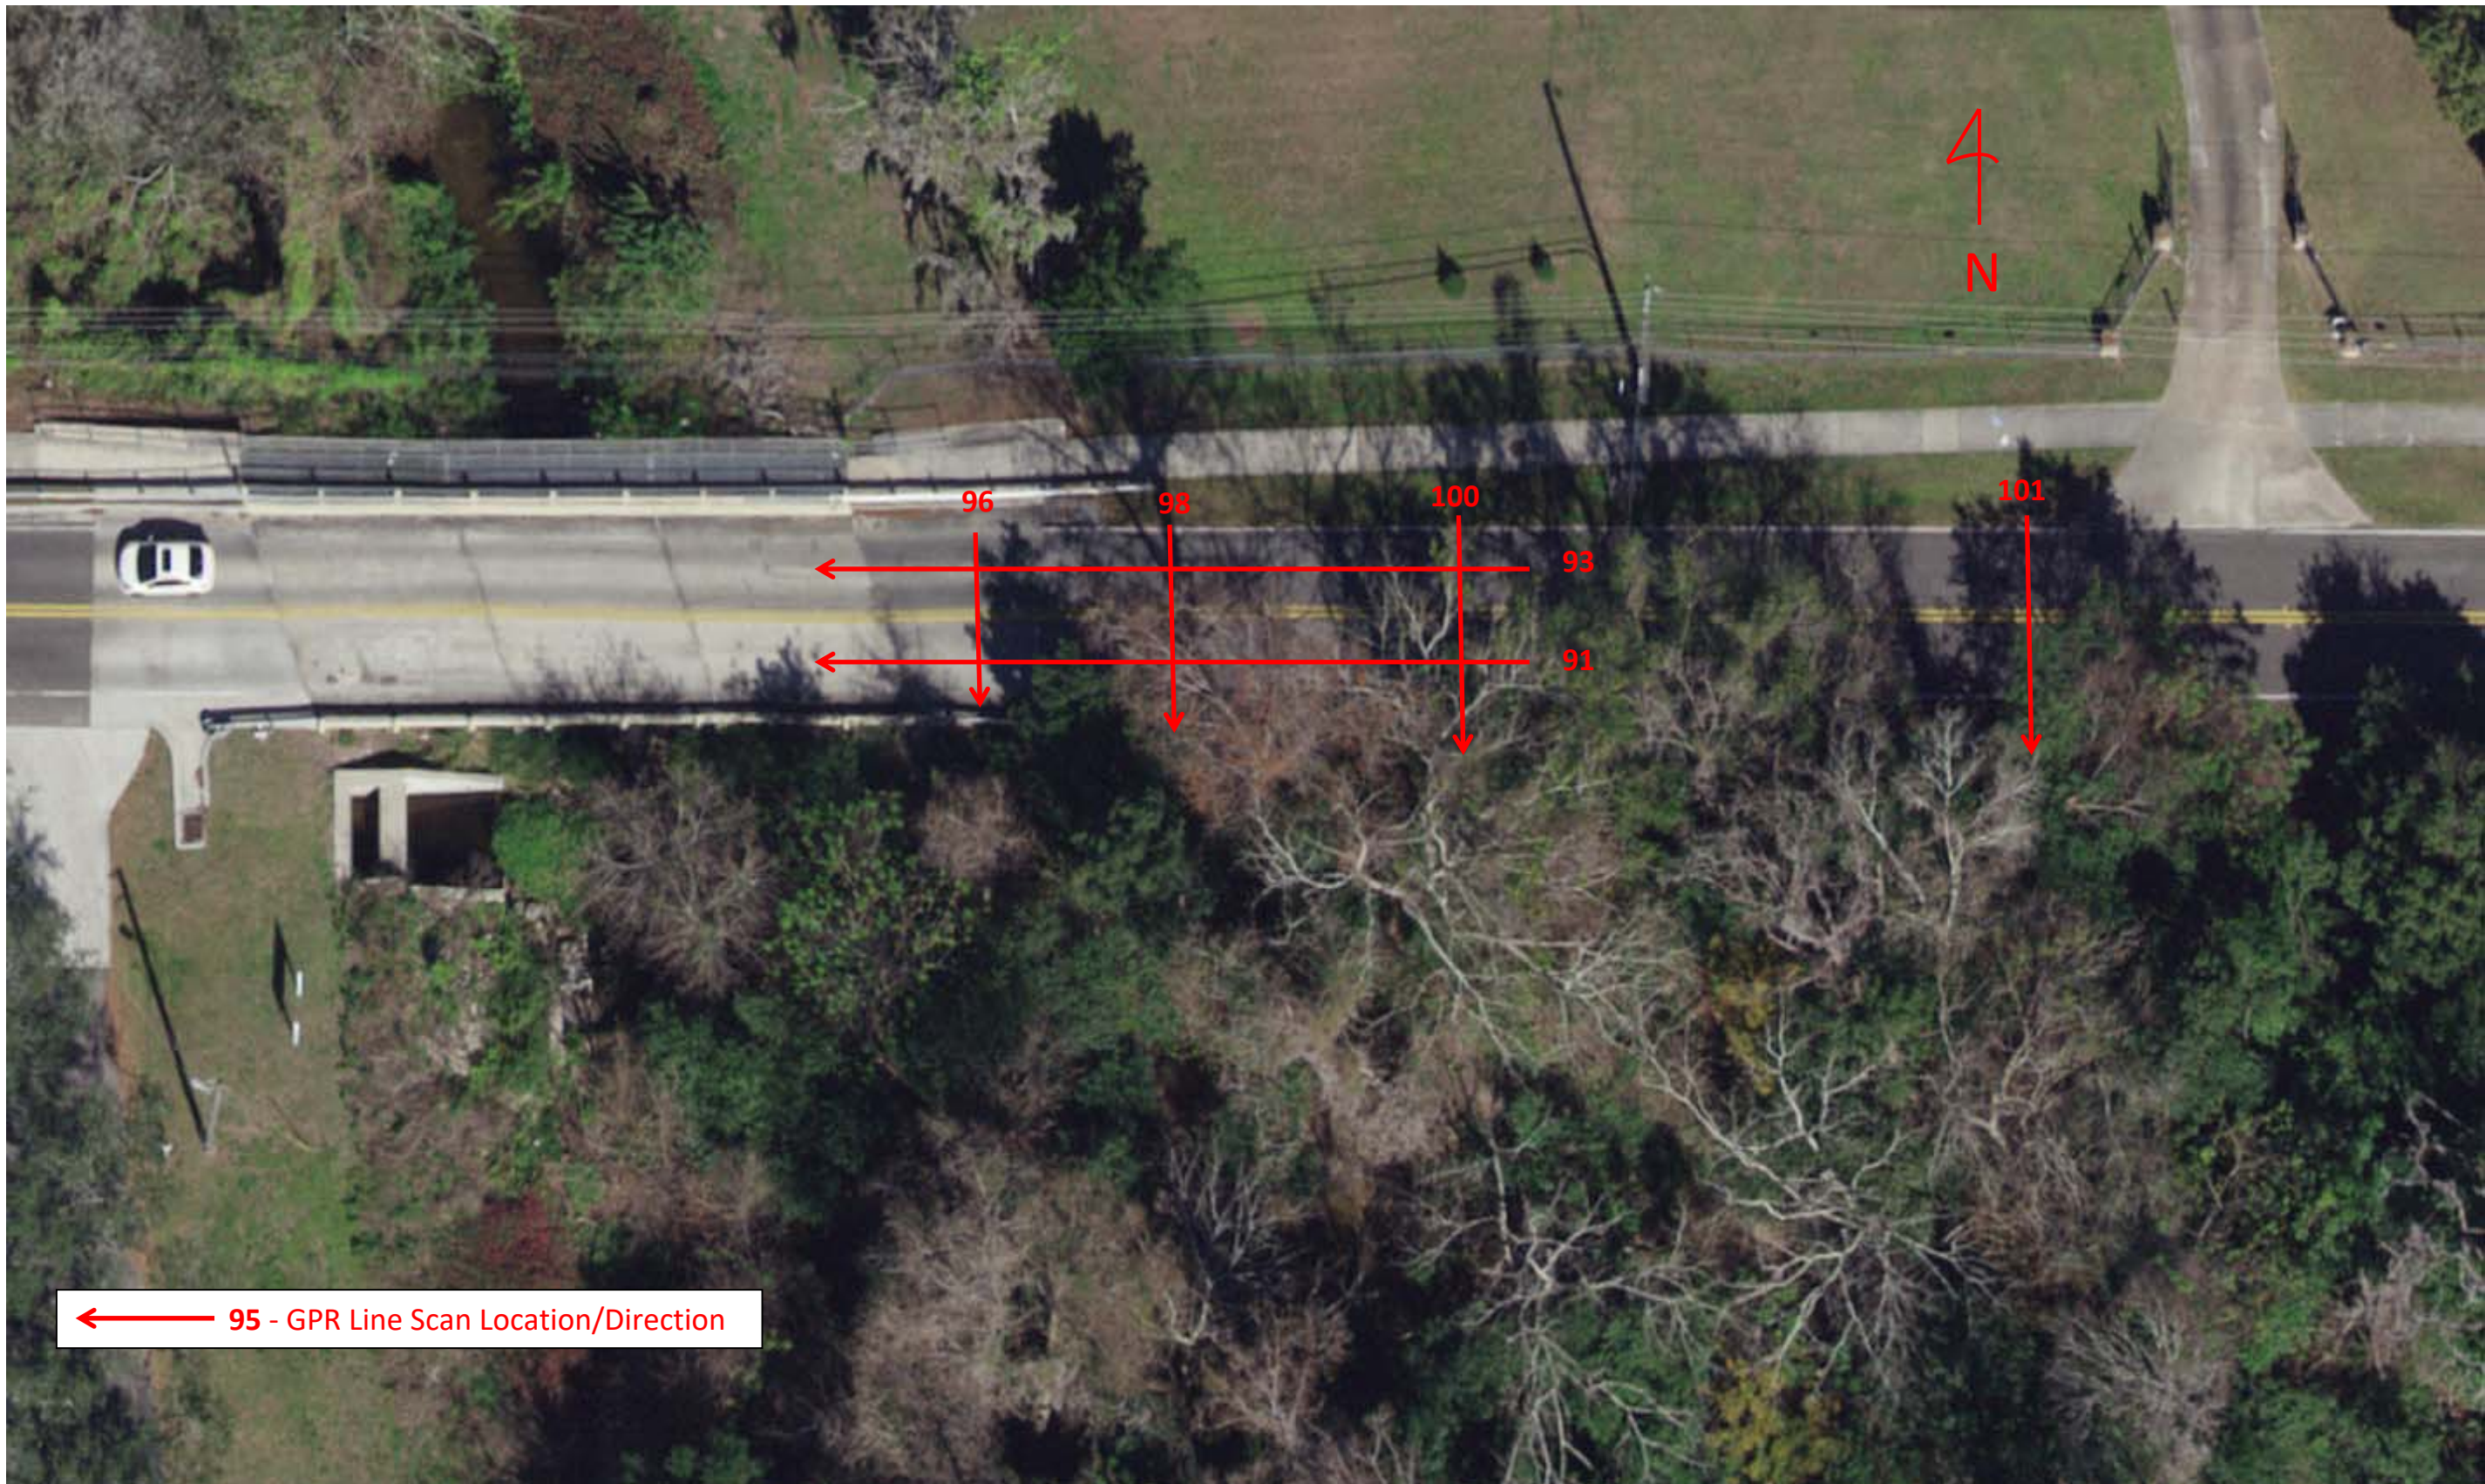
| Client Name: Inwood and Orange County | Project Name: Bates Road Bridge Repair | Project Location: Orange County, Florida | GEC Project No.: 4299G |

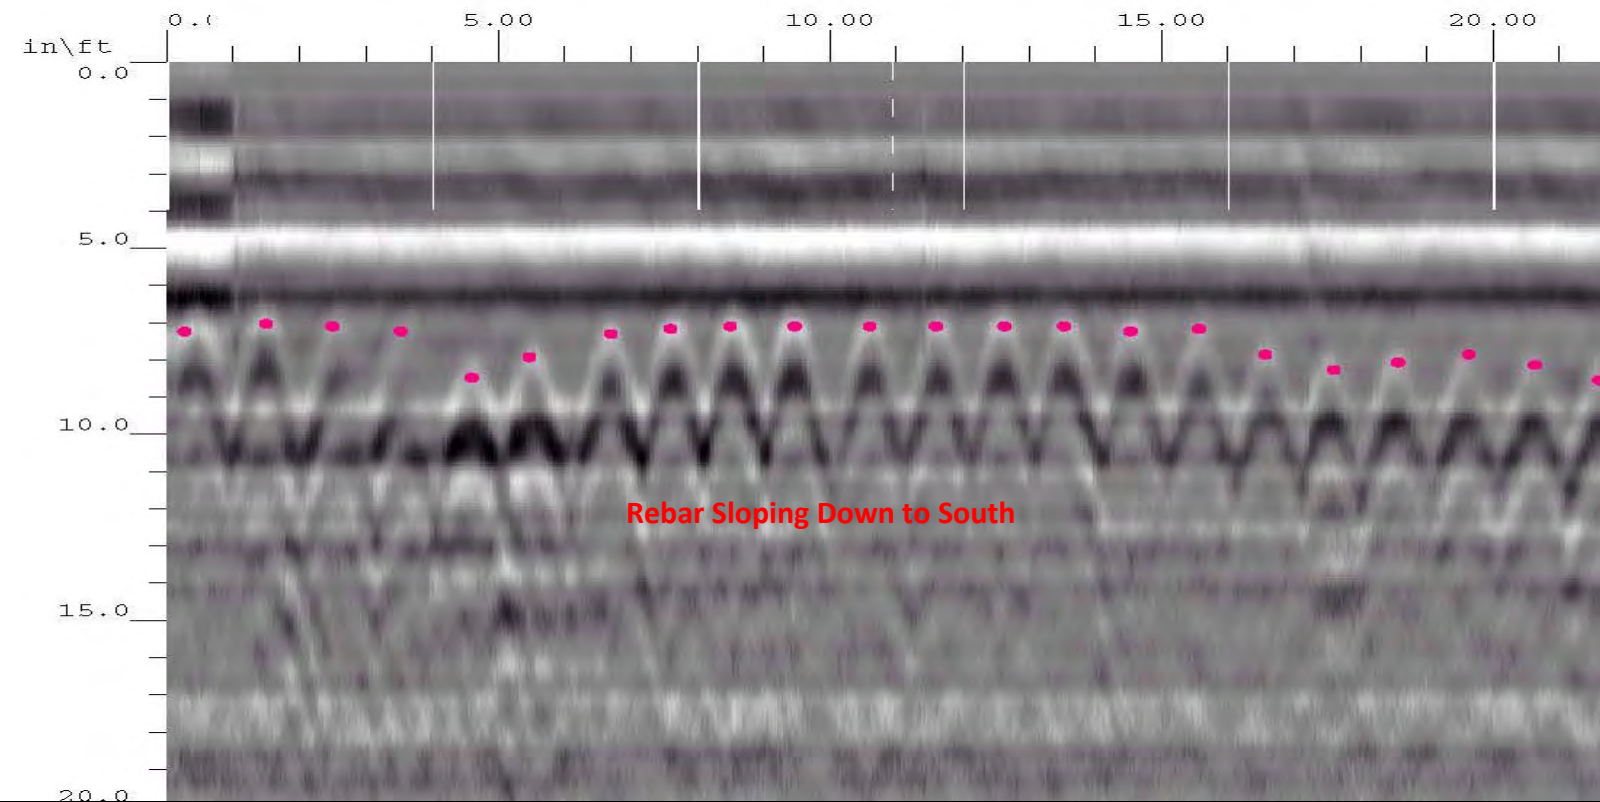
Scan: 96
Date: 2/6/19

Scan Description:
Horizontal linescan conducted with the 900 MHz antenna from north to south across the Bates Road travel lanes. Scan began approximately 8 feet east of the bridge deck, within the approach slab.

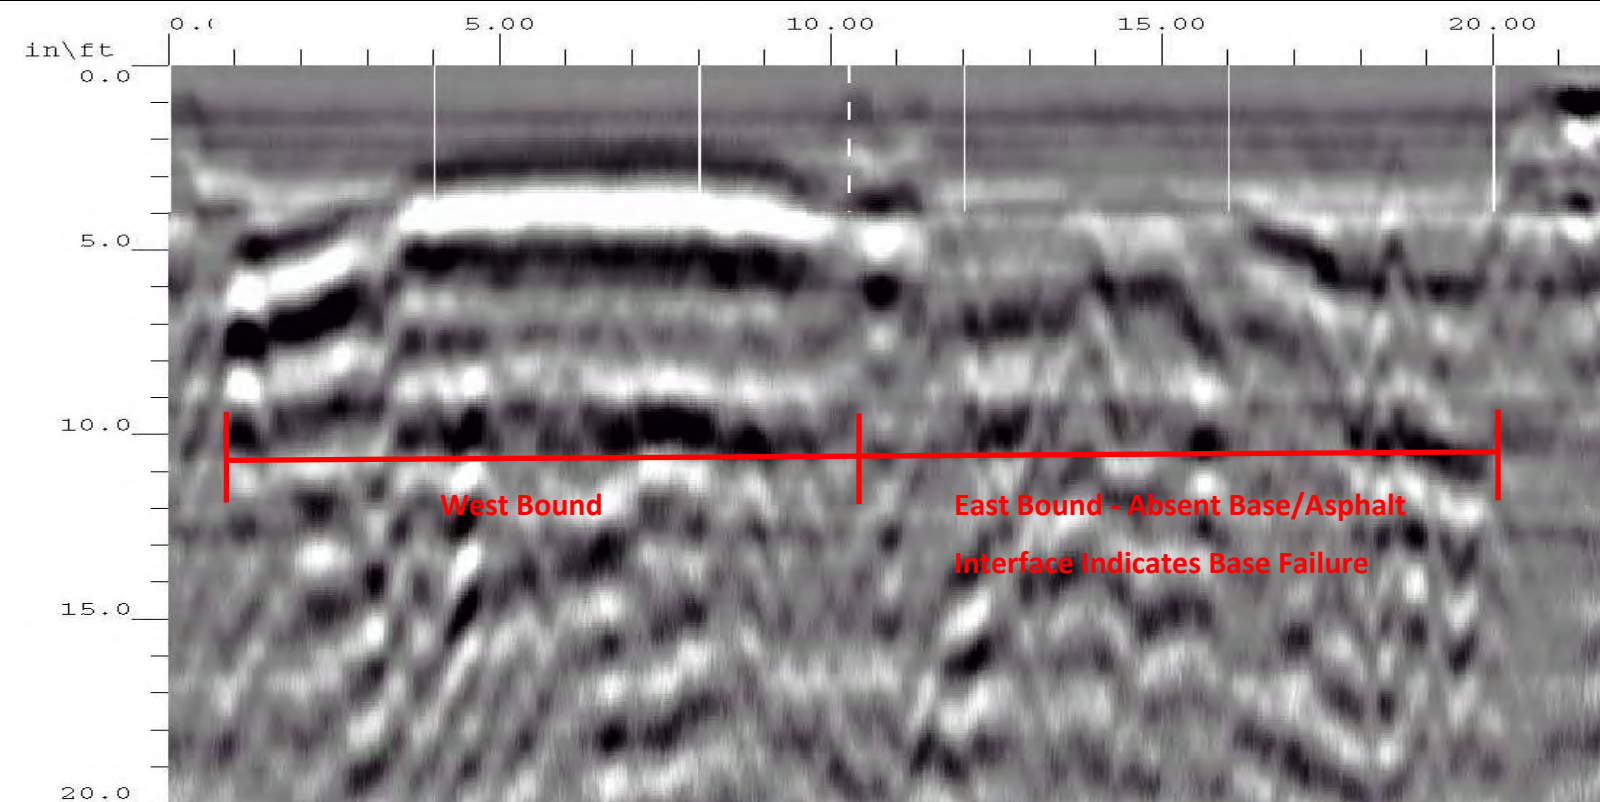
Scan: 98
Date: 2/6/19

Scan Description:
Horizontal linescan conducted with the 900 MHz antenna from north to south across the Bates Road travel lanes. Scan began approximately 25 feet east of the approach slab.

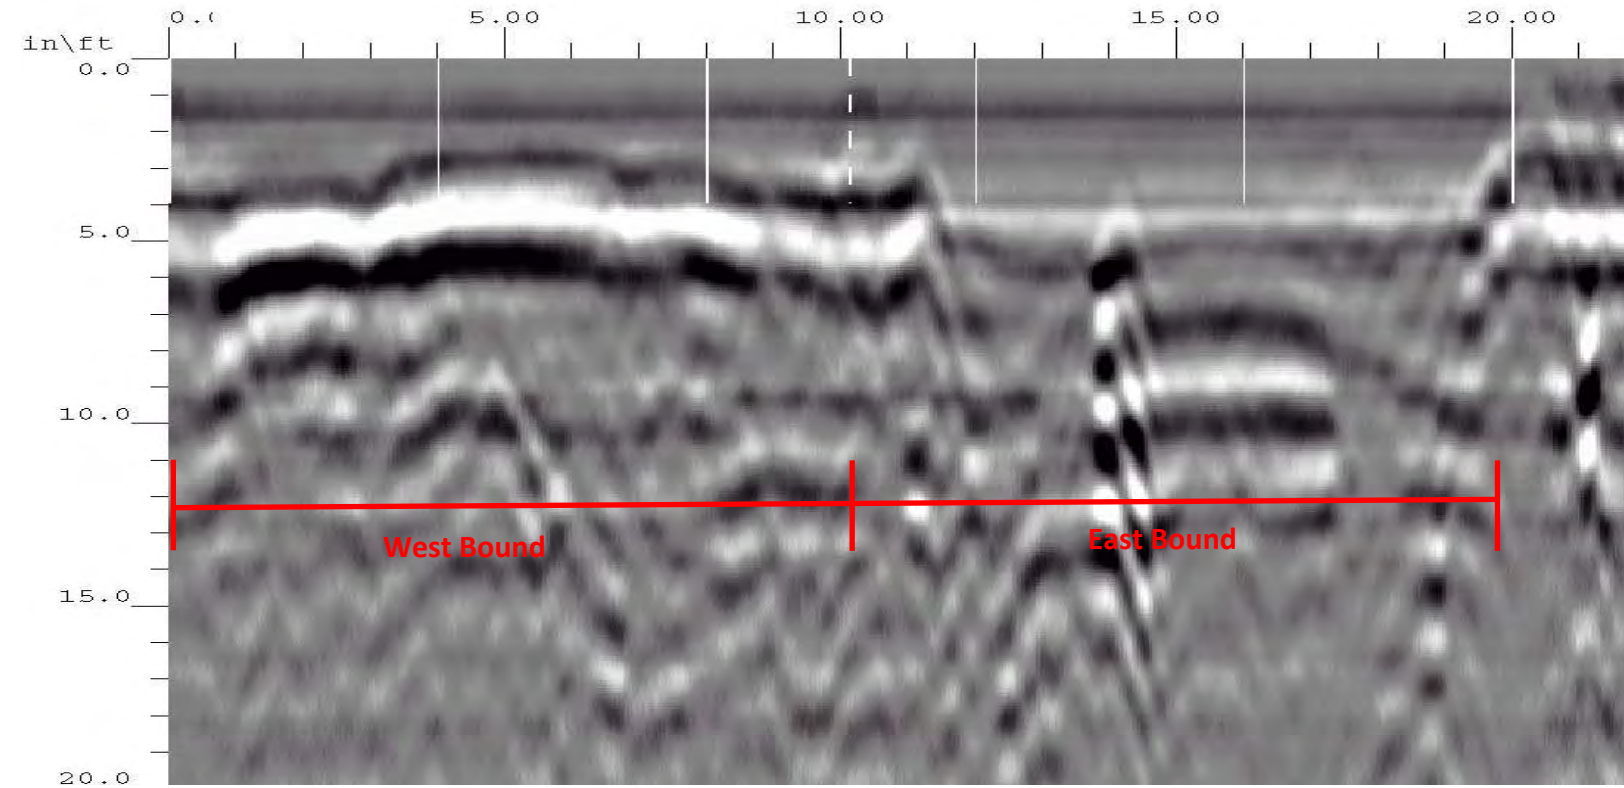
Scan: 100
Date: 2/6/19

Scan Description:
 Horizontal linescan conducted with the 900 MHz antenna from north to south across the Bates Road travel lanes. Scan began approximately 60 feet east of the approach slab.

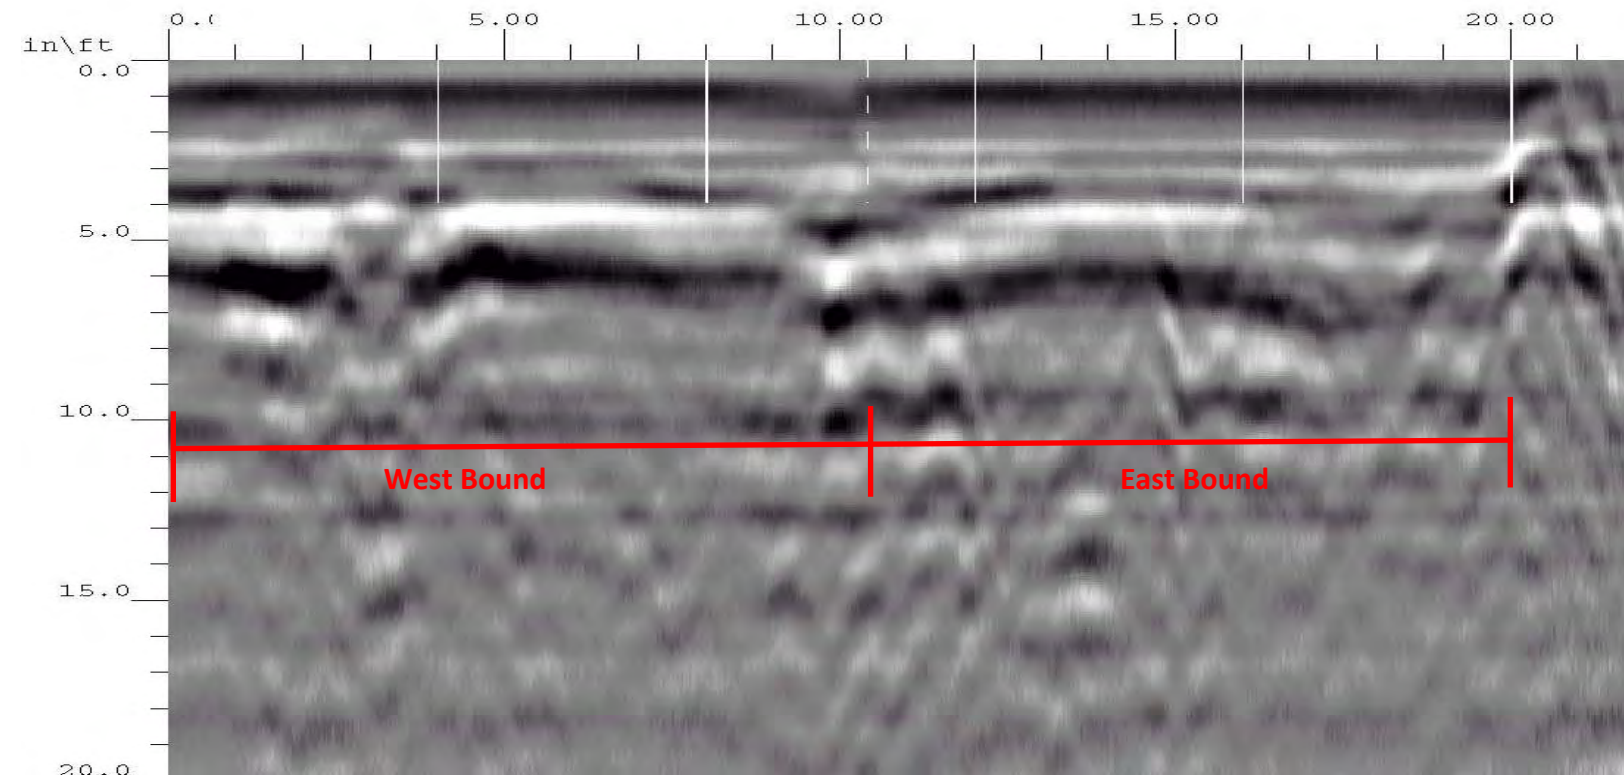
Scan: 101
Date: 2/6/19

Scan Description:
 Horizontal linescan conducted with the 900 MHz antenna from north to south across the Bates Road travel lanes. Scan began approximately 120 feet east of the approach slab.

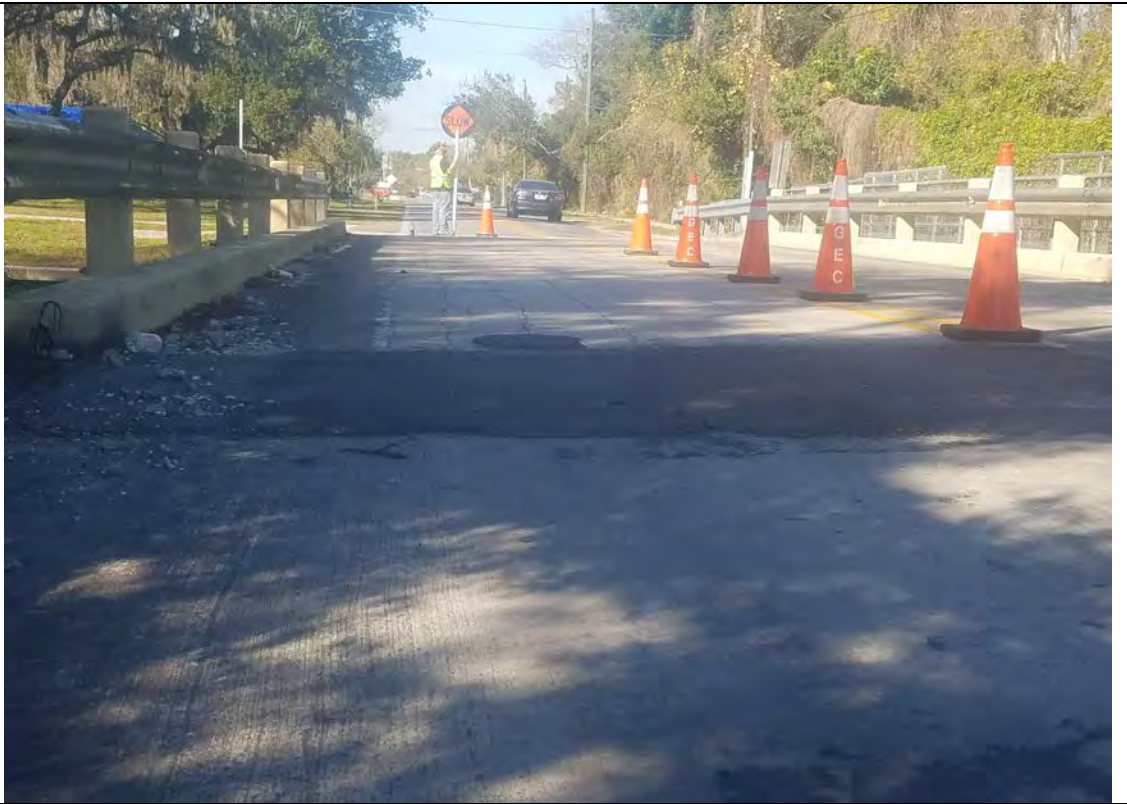
| Photo: 1 | Date: 2/6/19 |

Looking west at approach slab/bridge deck with asphalt patch.

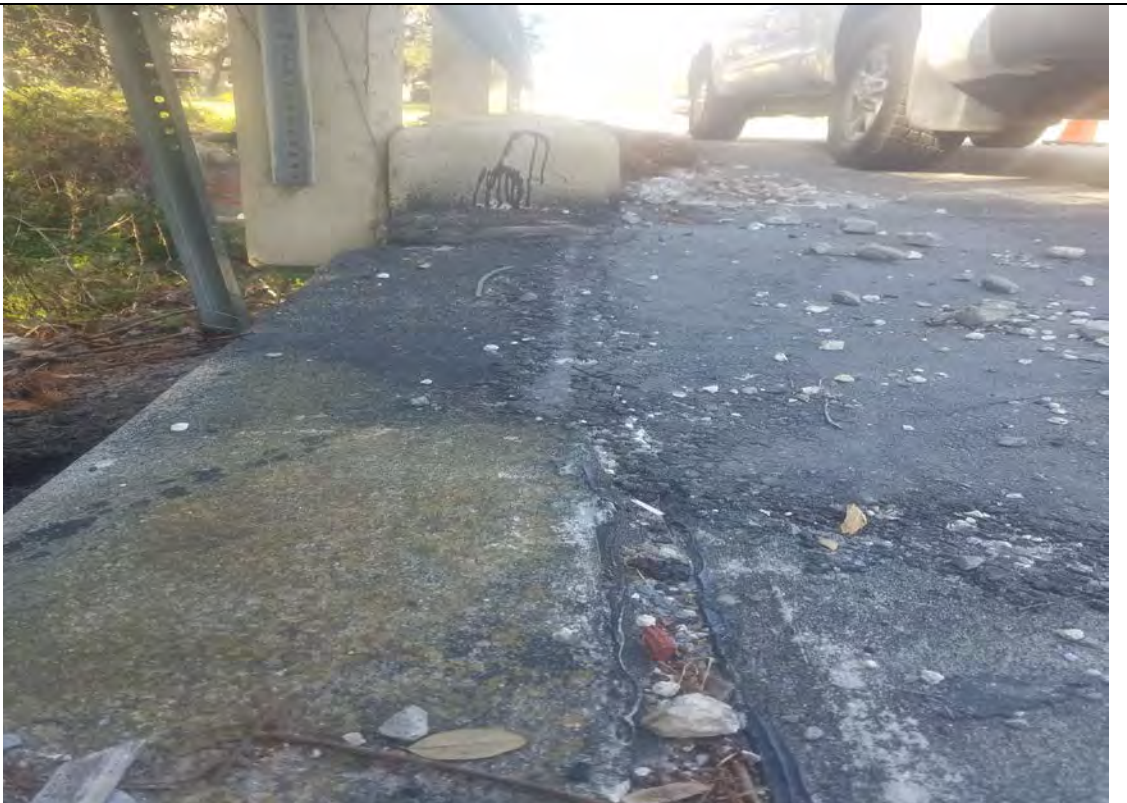
| Photo: 2 | Date: 2/6/19 |

Looking west at differential elevation between bridge and approach slab.

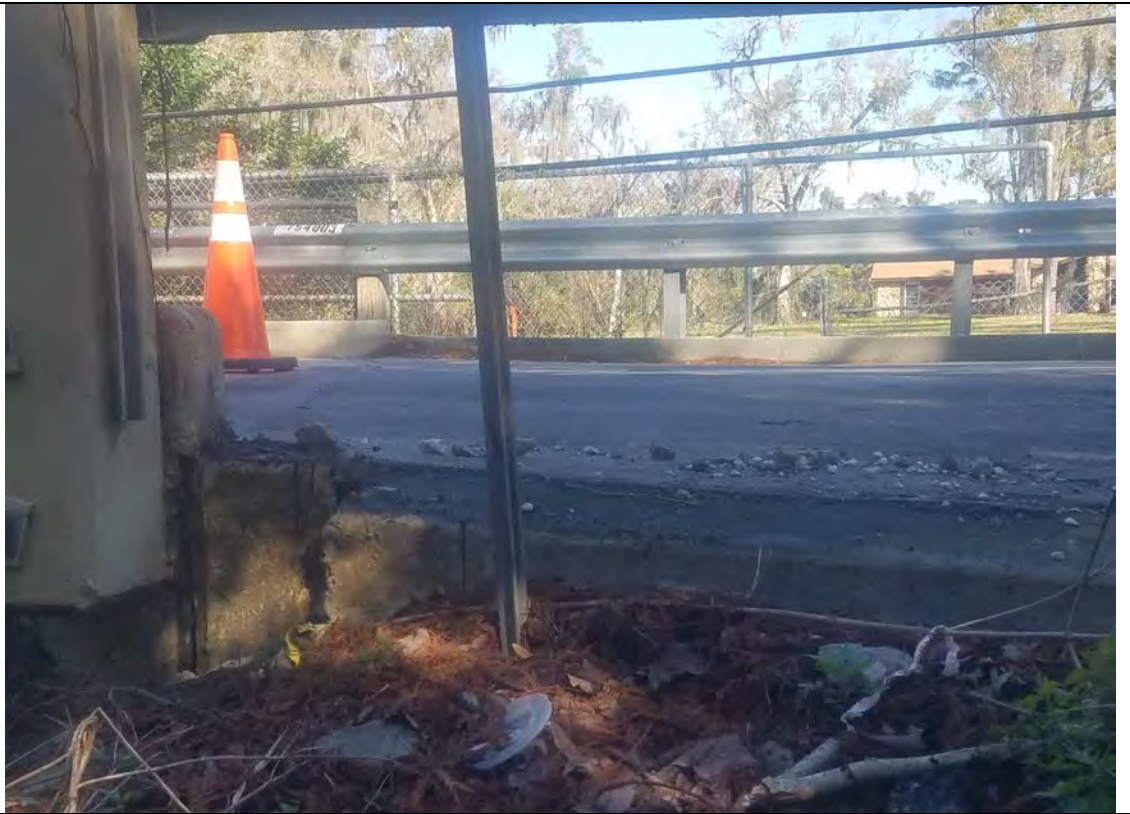
| Photo: 3 | Date: 2/6/19 |

| Description: Looking north at differential elevation between bridge and approach slab. | |

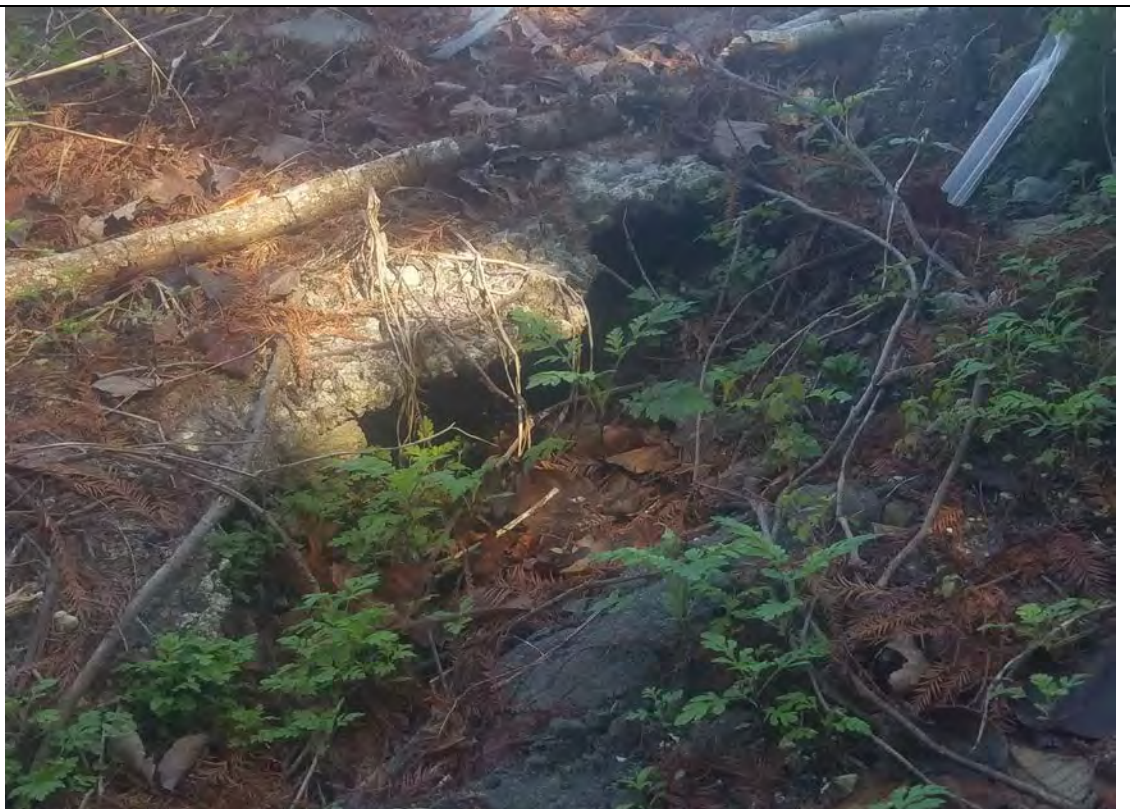
| Photo: 4 | Date: 2/6/19 |

| Description: Looking north at washout of concrete wrap-around slab on the southeast corner of the existing bridge. | |
