PARK MANOR ESTATES SECTIONS 11-12 UNDERDRAIN IMPROVEMENTS

TECHNICAL PROVISIONS

ORANGE COUNTY, FLORIDA

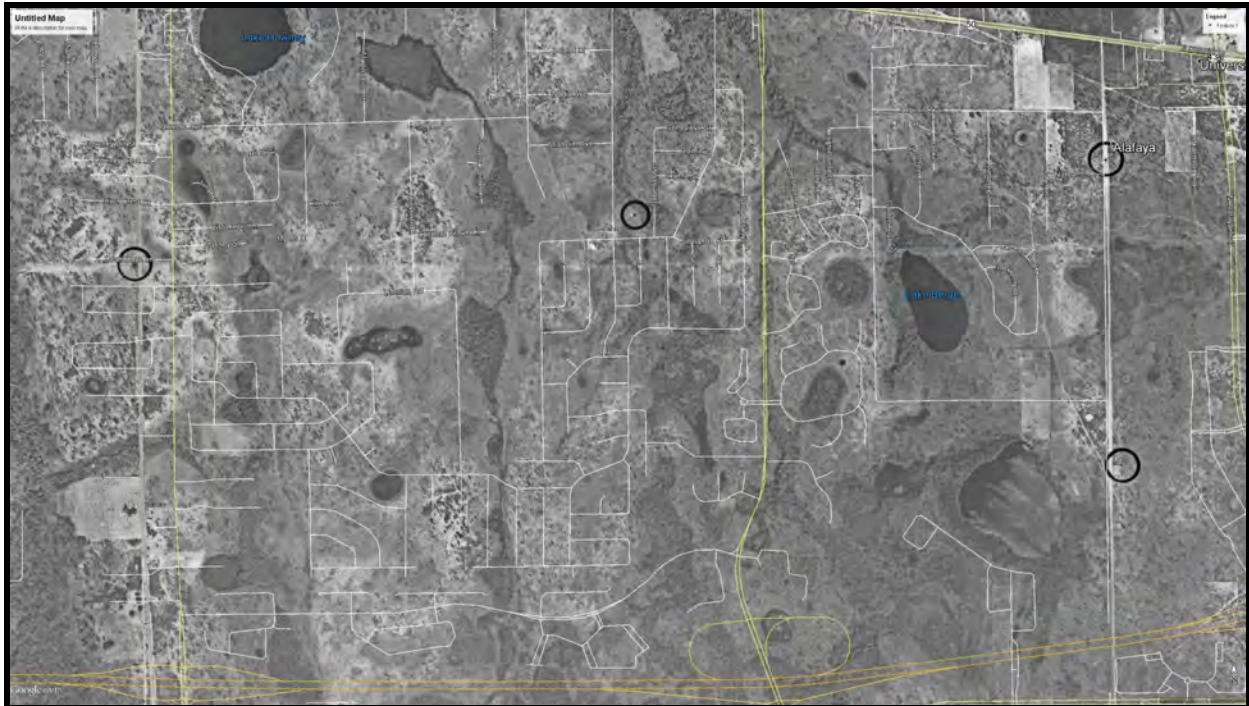
Exhibit 2. Park Manor and vicinity on 1947 Aerial Image. Note the wetland strands.

Exhibit 2 shows the historical wetlands which were impacted during the development of the subdivision and seepage in these areas are more prevalent since there is a natural tendency to re-establish their predevelopment flow paths following intense rainfall events. A magnified version of this image is shown with the site boundaries in Figure 1.2.a

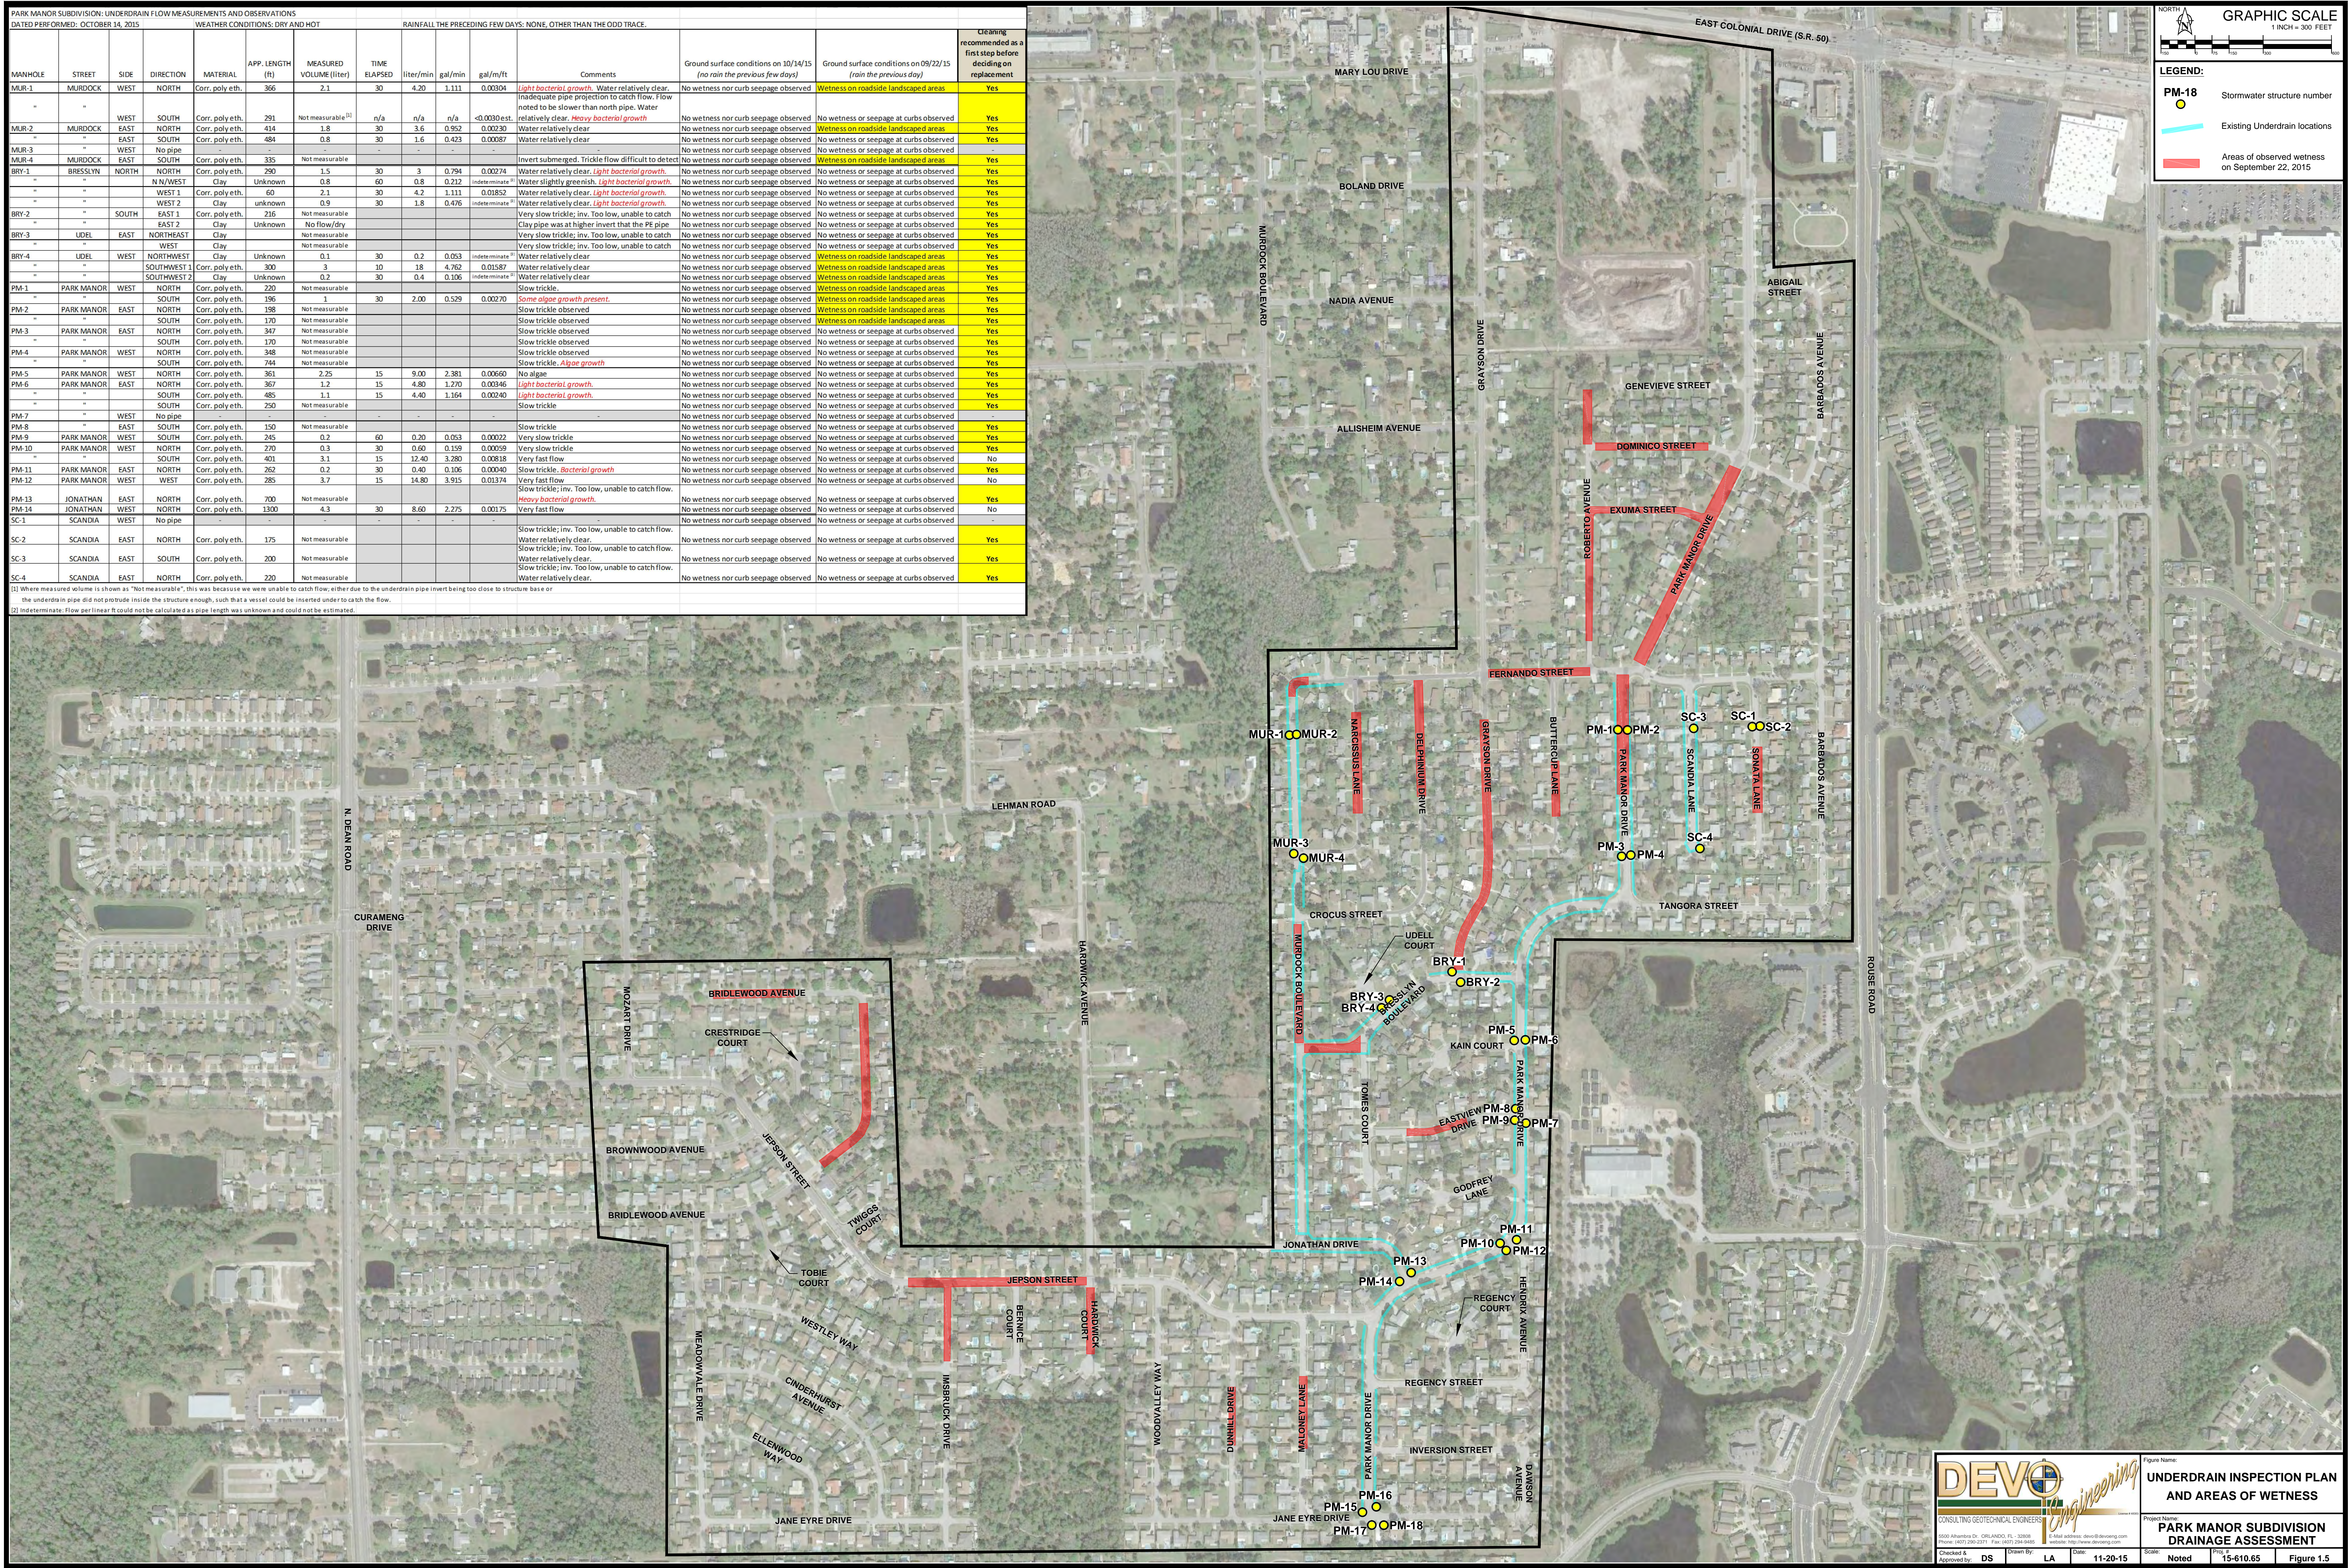
Checked & Approved by: **DS** Drawn by: **LA** Date: **11-20-15** Scale: **Noted** Plot: **15-610.65** Figure: **1.5**

- Several of the roadway gutter drains showed wetness at the joints and in the adjacent landscaped areas, as shown on Figure 1.5. Selected photos of the wetness observed are included in Appendix A.
