ORANGE COUNTY UTILITIES DEPARTMENT ENGINEERING DIVISION
9150 CURRY FORD ROAD ORLANDO, FL. 32825

GRAVITY R/R PACKAGE NO. 19
SA F3146 UNIVERSITY ACRES (2)

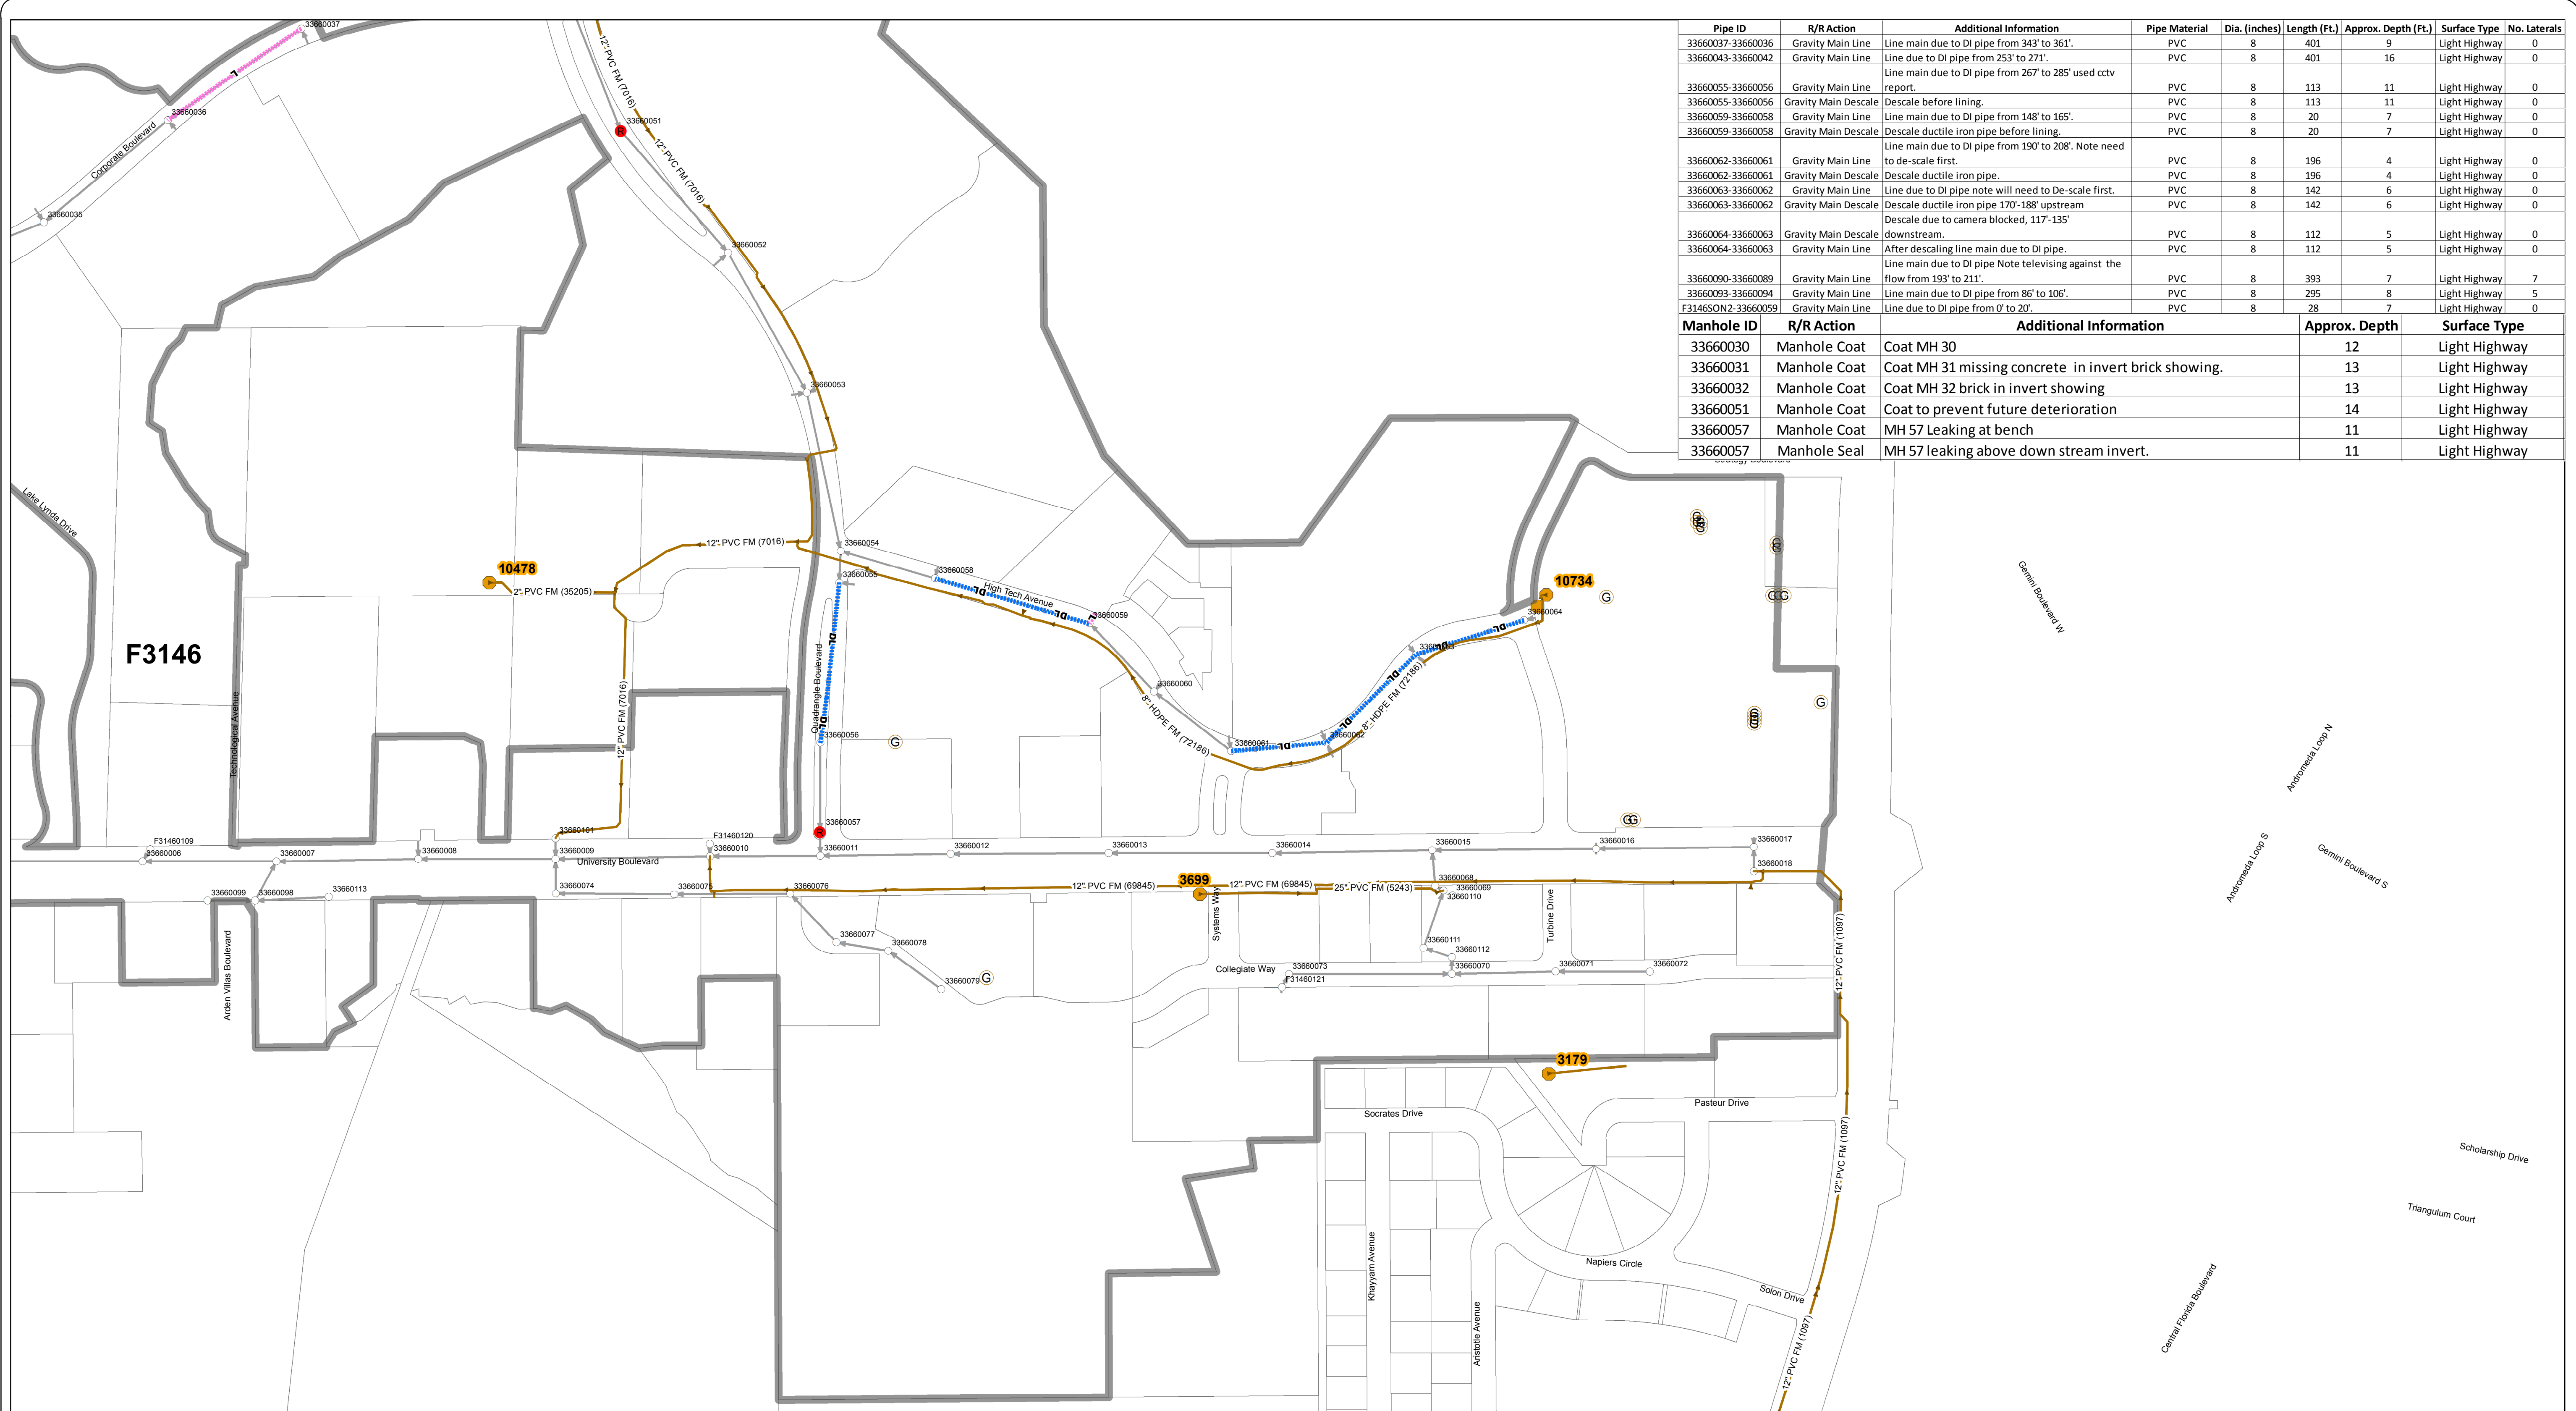
SCALE: 1" = 200'
DRAWING NO.: **C-14**
SHEET 25 OF 47

Pipe ID	R/R Action	Additional Information	Pipe Material	Dia. (Inches)	Length (Ft.)	Approx. Depth (Ft.)	Surface Type	No. Laterals
33660037-33660036	Gravity Main Line	Line main due to DI pipe from 343' to 361'.	PVC	8	401	9	Light Highway	0
33660043-33660042	Gravity Main Line	Line due to DI pipe from 253' to 271'.	PVC	8	401	16	Light Highway	0
33660055-33660056	Gravity Main Line	Line main due to DI pipe from 267' to 285' used cctv report.	PVC	8	113	11	Light Highway	0
33660055-33660056	Gravity Main Descale	Descale before lining.	PVC	8	113	11	Light Highway	0
33660059-33660058	Gravity Main Line	Line main due to DI pipe from 148' to 165'.	PVC	8	20	7	Light Highway	0
33660059-33660058	Gravity Main Descale	Descale ductile iron pipe before lining.	PVC	8	20	7	Light Highway	0
33660062-33660061	Gravity Main Line	Line main due to DI pipe from 190' to 208'. Note need to de-scale first.	PVC	8	196	4	Light Highway	0

33660062-33660061	Gravity Main Descale	Descale ductile iron pipe.	PVC	8	196	4	Light Highway	0
33660063-33660062	Gravity Main Line	Line due to DI pipe note will need to De-scale first.	PVC	8	142	6	Light Highway	0
33660063-33660062	Gravity Main Descale	Descale ductile iron pipe 170'-188' upstream	PVC	8	142	6	Light Highway	0
33660064-33660063	Gravity Main Descale	Descale due to camera blocked, 117'-135' downstream.	PVC	8	112	5	Light Highway	0
33660064-33660063	Gravity Main Line	After descailing line main due to DI pipe.	PVC	8	112	5	Light Highway	0
33660090-33660089	Gravity Main Line	Line main due to DI pipe Note televising against the flow from 193' to 211'.	PVC	8	393	7	Light Highway	7
33660093-33660094	Gravity Main Line	Line main due to DI pipe from 86' to 106'.	PVC	8	295	8	Light Highway	5
F3146SON2-33660059	Gravity Main Line	Line due to DI pipe from 0' to 20'.	PVC	8	28	7	Light Highway	0

Manhole ID	R/R Action	Additional Information	Approx. Depth	Surface Type
33660030	Manhole Coat	Coat MH 30	12	Light Highway
33660031	Manhole Coat	Coat MH 31 missing concrete in invert brick showing.	13	Light Highway
33660032	Manhole Coat	Coat MH 32 brick in invert showing	13	Light Highway
33660051	Manhole Coat	Coat to prevent future deterioration	14	Light Highway
33660057	Manhole Coat	MH 57 Leaking at bench	11	Light Highway
33660057	Manhole Seal	MH 57 leaking above down stream invert.	11	Light Highway

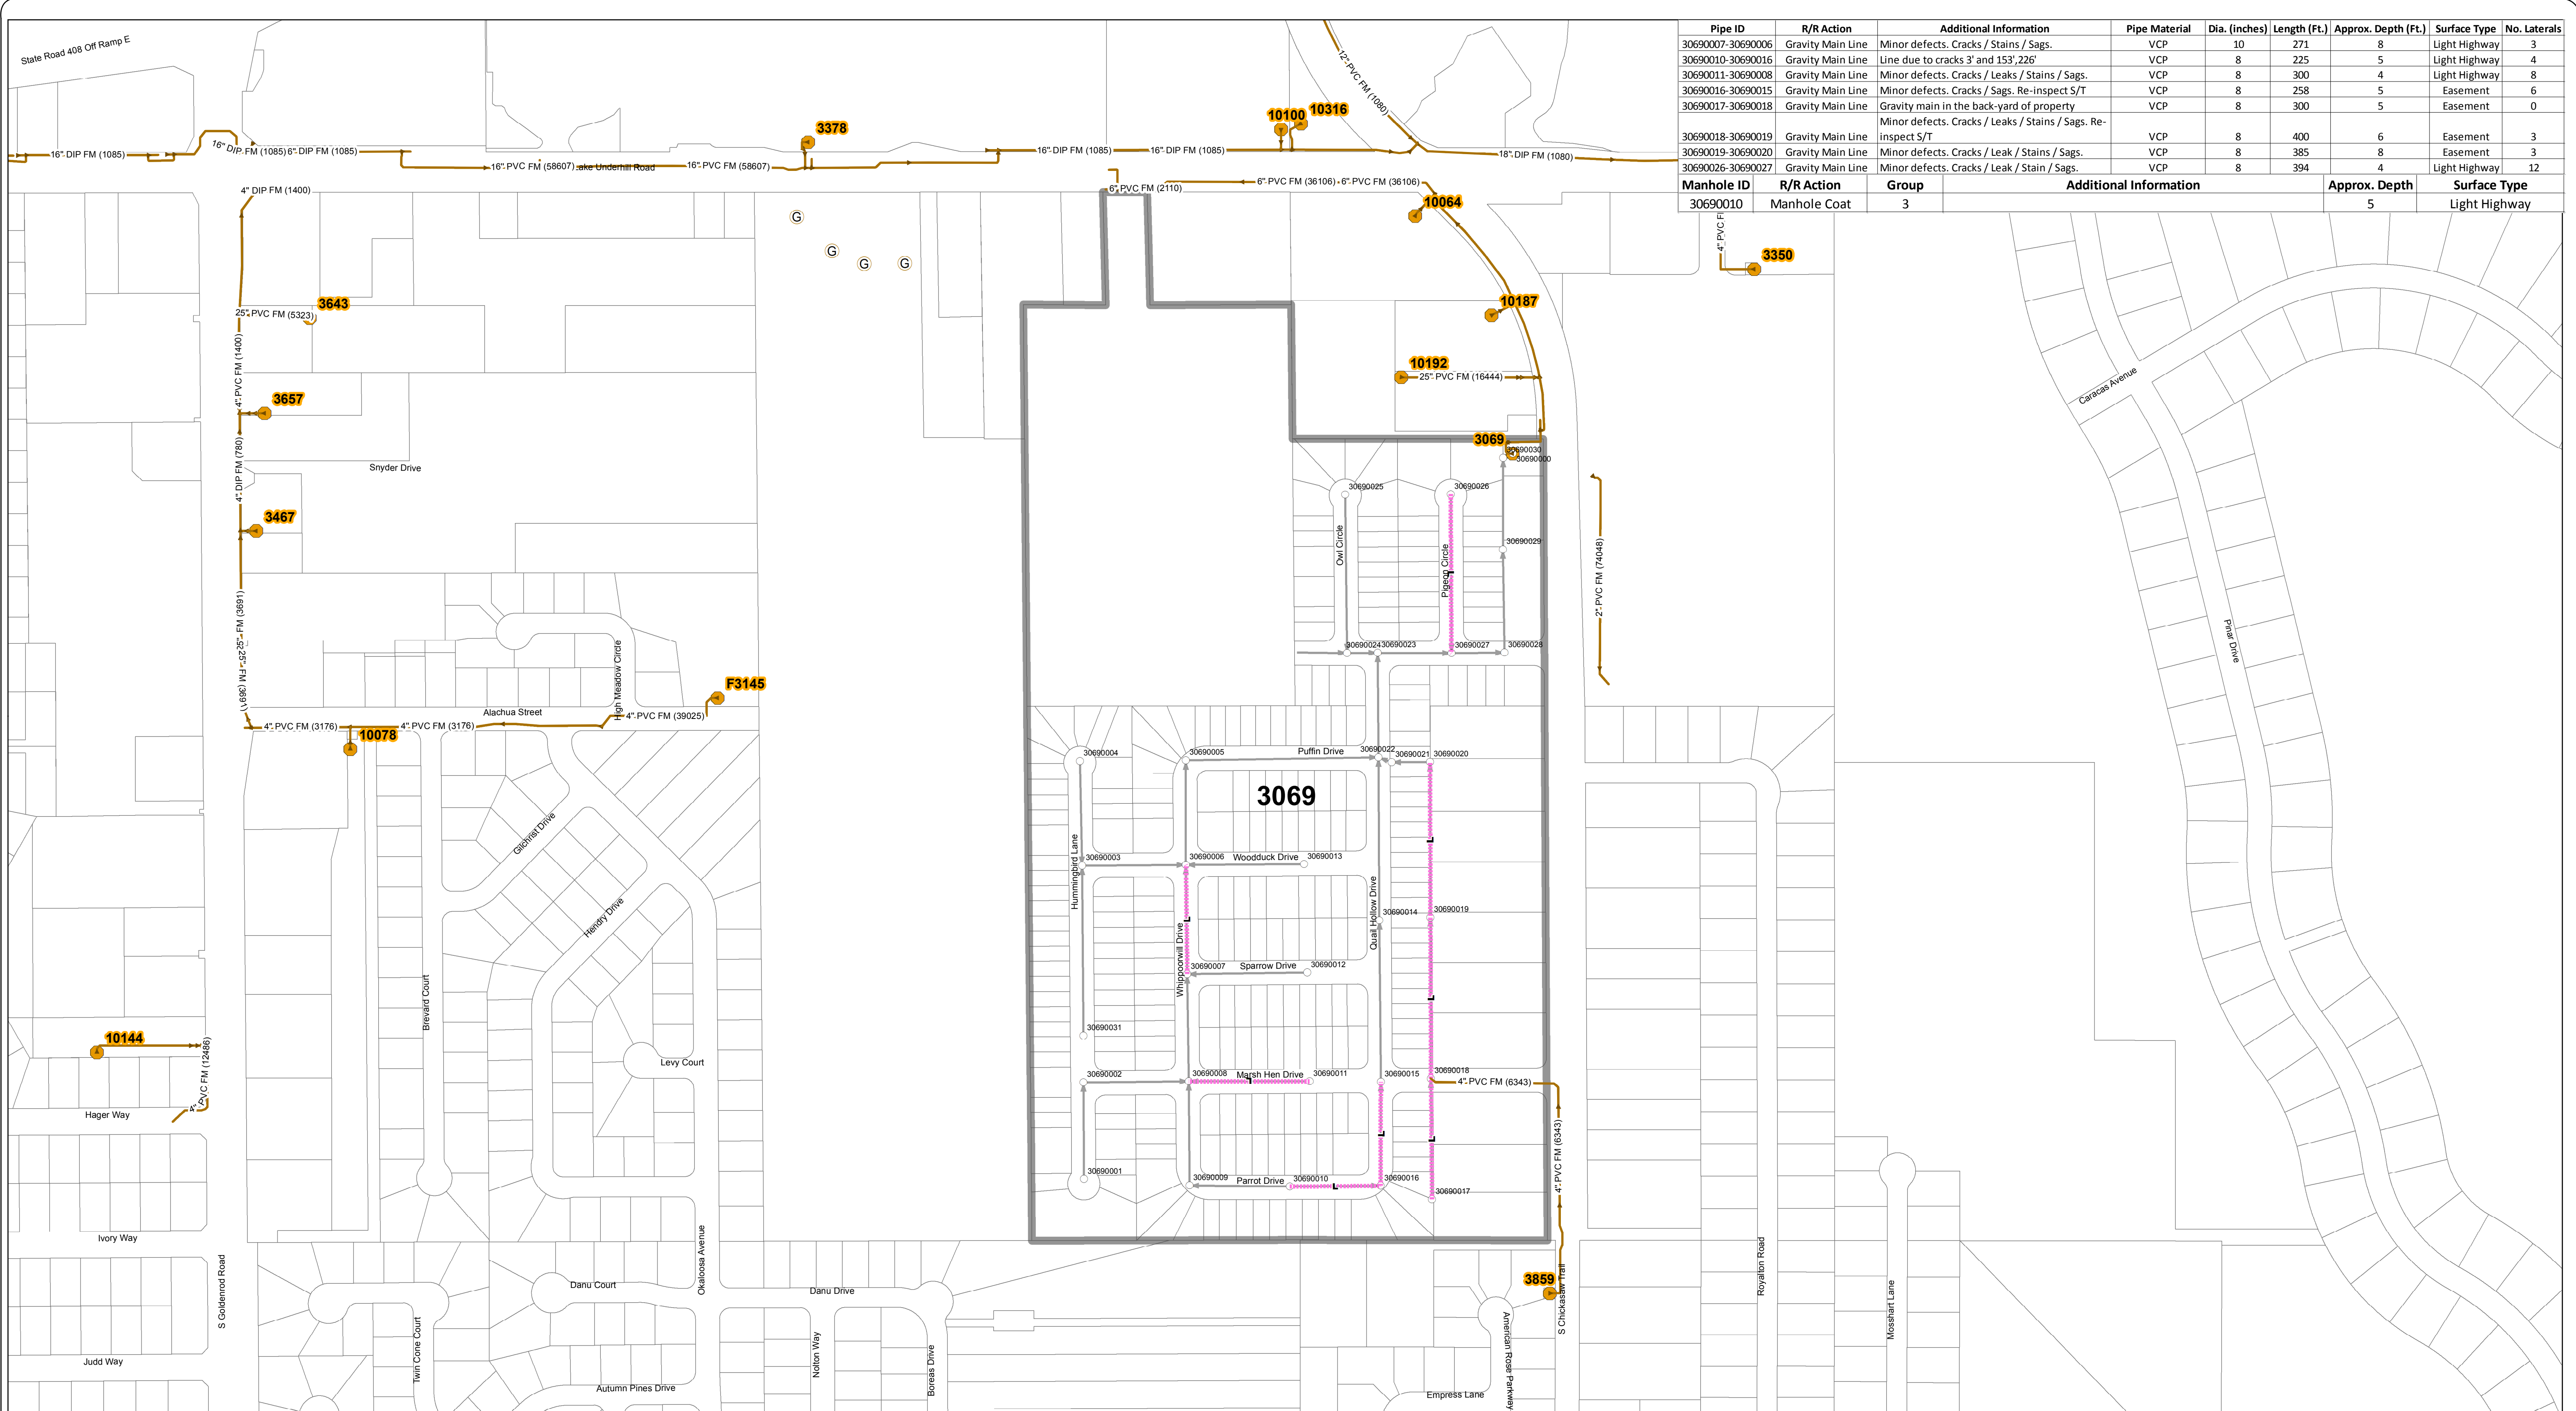
OCU FILE No. 82146	SCALE: 1" = 200'
DESIGN BY:	DRAWING NO.:
DRAWN BY: KM	C-17
CHECKED BY: SJR	SHEET 28 OF 47
CAD FILE:

Pipe ID	R/R Action	Additional Information	Pipe Material	Dia. (inches)	Length (Ft.)	Approx. Depth (Ft.)	Surface Type	No. Laterals
30690007-30690006	Gravity Main Line	Minor defects. Cracks / Stains / Sags.	VCP	10	271	8	Light Highway	3
30690010-30690016	Gravity Main Line	Line due to cracks 3' and 153', 226'	VCP	8	225	5	Light Highway	4
30690011-30690008	Gravity Main Line	Minor defects. Cracks / Leaks / Stains / Sags.	VCP	8	300	4	Light Highway	8
30690016-30690015	Gravity Main Line	Minor defects. Cracks / Sags. Re-inspect S/T	VCP	8	258	5	Easement	6
30690017-30690018	Gravity Main Line	Gravity main in the back-yard of property	VCP	8	300	5	Easement	0
30690018-30690019	Gravity Main Line	Minor defects. Cracks / Leaks / Stains / Sags. Re-inspect S/T	VCP	8	400	6	Easement	3
30690019-30690020	Gravity Main Line	Minor defects. Cracks / Leak / Stains / Sags.	VCP	8	385	8	Easement	3
30690026-30690027	Gravity Main Line	Minor defects. Cracks / Leak / Stain / Sags.	VCP	8	394	4	Light Highway	12

Manhole ID	R/R Action	Group	Additional Information	Approx. Depth	Surface Type
30690010	Manhole Coat	3		5	Light Highway

GRAVITY R/R PACKAGE NO. 20
SA 3069 QUAIL HOLLOW

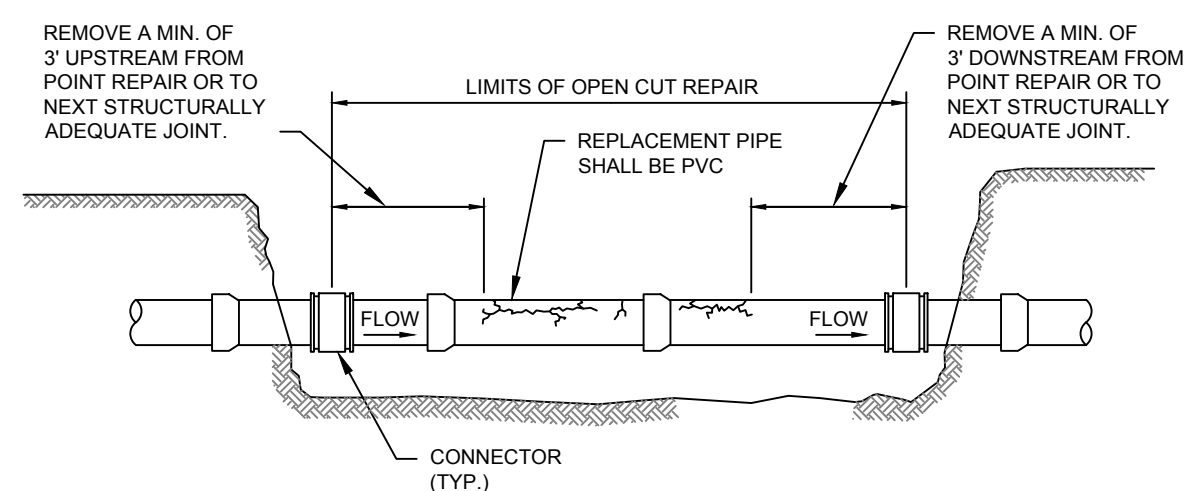
APPENDIX A STANDARD DRAWINGS GRAVITY R/R
DATE: August 2012 POINT REPAIR FIGURE A-601

1. LATERAL REPAIR NEEDED WITHIN THE EXTENTS OF A PIPE REPLACEMENT, SHALL OCCUR AFTER NEW PIPE IS INSTALLED.
2. PAVEMENT RESTORATION SHALL BE IN ACCORDANCE WITH FIGURES A-702 AND A-703.

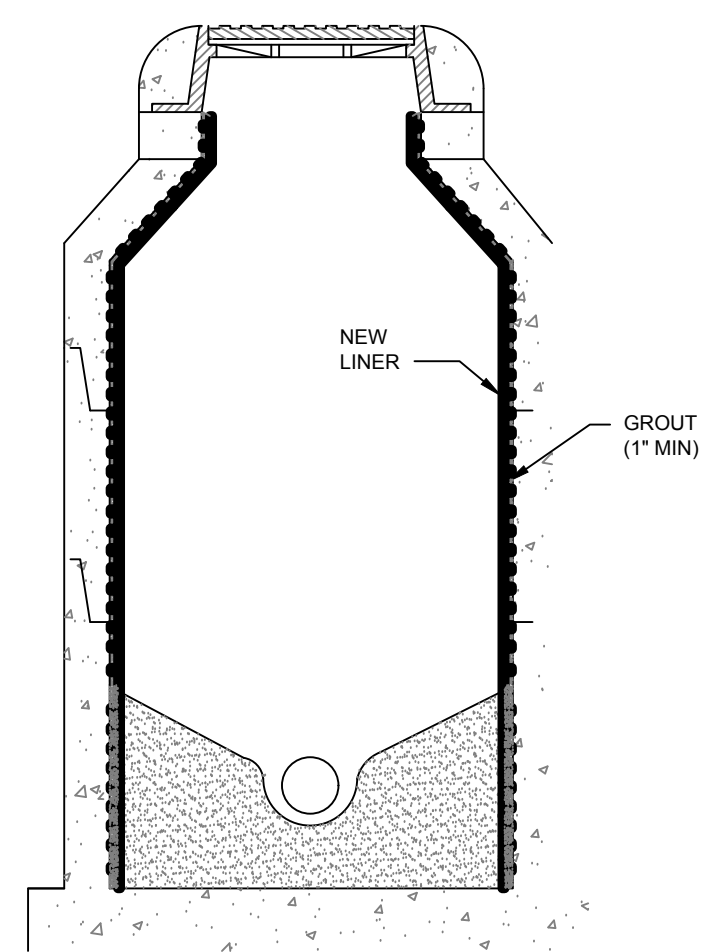
APPENDIX A STANDARD DRAWINGS GRAVITY R/R
DATE: February 2013 MANHOLE LINING FIGURE A-602

1. LINERS SHALL BE HDPE, OR REINFORCED PLASTIC AND INSTALLED IN ACCORDANCE WITH THE MANUFACTURERS RECOMMENDATIONS.
2. PREPARE STRUCTURE INTERIOR, PRESSURE WASH OR SANDBLAST TO REMOVE ALL SCALE, LOOSE MATERIAL, GREASE AND SLUDGE BUILD UP IN ACCORDANCE WITH SPECIFICATION SECTION 09900.
3. ACTIVE LEAKS SHALL BE REPAIRED WITH HYDRAULIC MORTAR. ALL OTHER STRUCTURAL REPAIRS DEEMED NECESSARY SHALL BE PERFORMED PRIOR TO INSTALLING LINER.

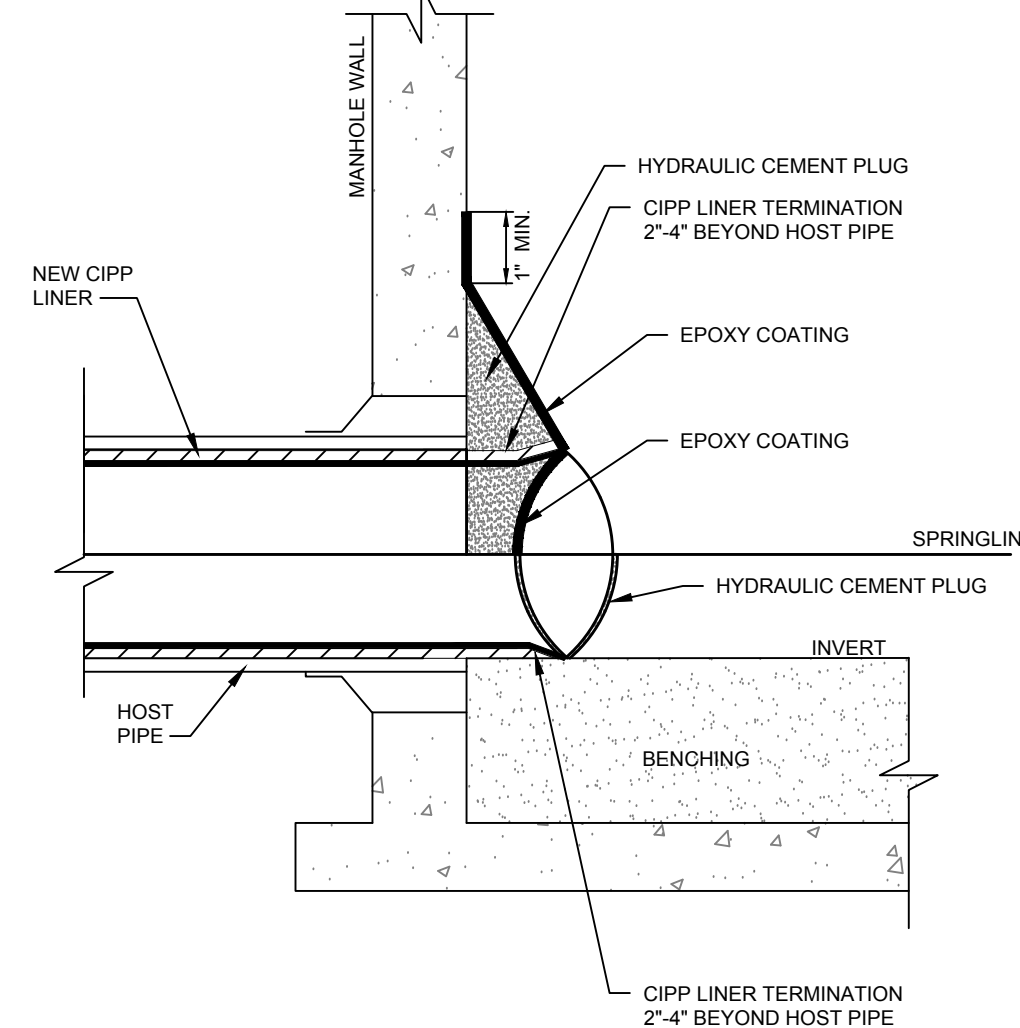
APPENDIX A STANDARD DRAWINGS GRAVITY R/R
DATE: April 1, 2016 LINER TERMINATION AT MANHOLE FIGURE A-603

1. CONTRACTOR SHALL REPAIR DETERIORATION ON INSIDE CIRCUMFERENCE OF PIPE WALL TO FORM A SMOOTH SURFACE FOR THE END OF CIPP LINER.
2. IF POLYETHYLENE IS USED FOR INTERIOR OF LINING, CONTRACTOR SHALL ABRASE THE POLYETHYLENE LAYER PRIOR TO APPLYING THE EPOXY.
3. COMPLETE MANHOLE REHABILITATION PRIOR TO PIPE LINING.
4. EPOXY COATING PER APPENDIX D OF ORANGE COUNTY UTILITIES STANDARDS AND CONSTRUCTION MANUAL.
5. CONTRACTOR TO INSTALL EPOXY COATING PER MANUFACTURERS INSTRUCTIONS.

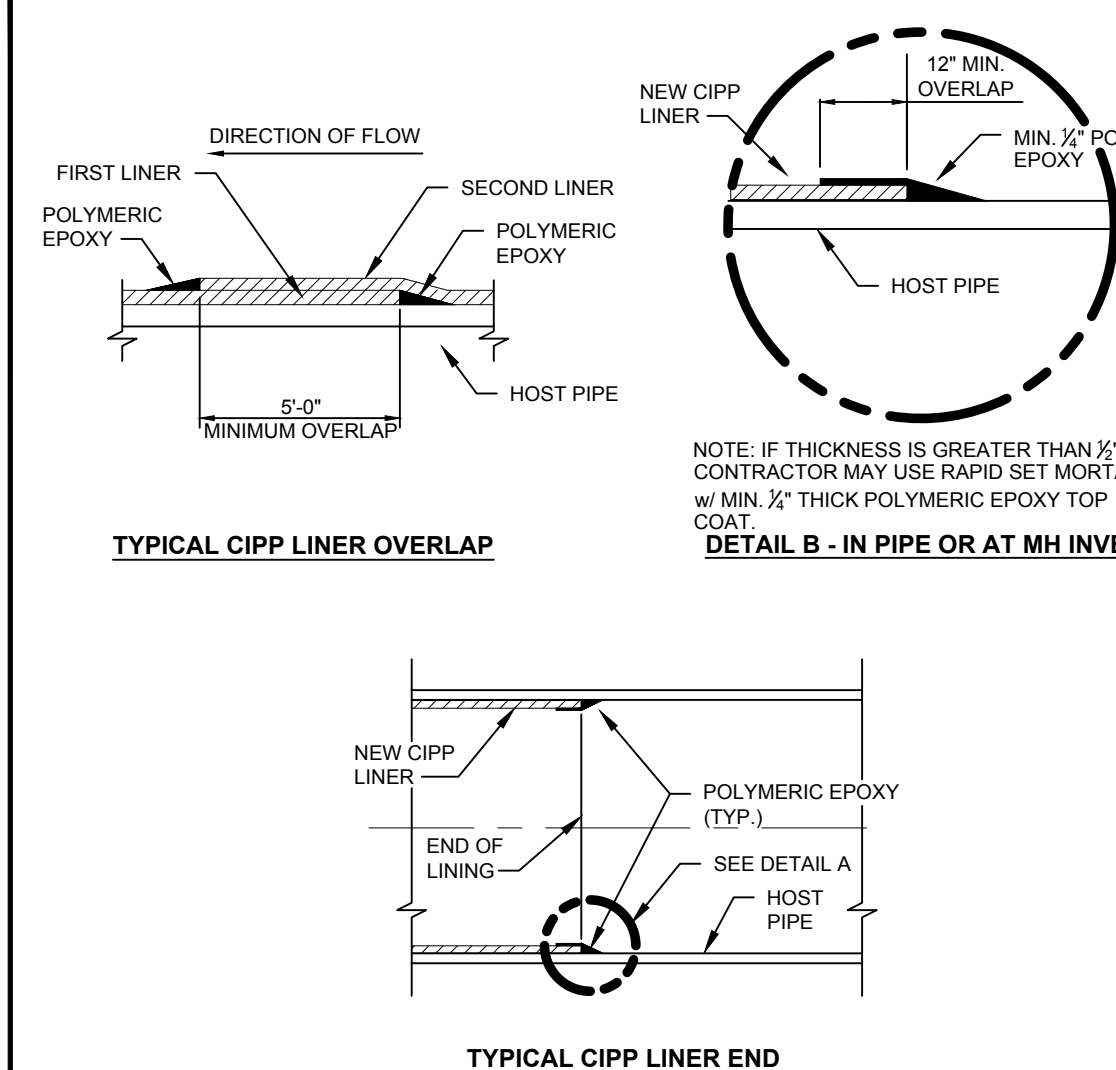
APPENDIX A STANDARD DRAWINGS GRAVITY R/R
DATE: August 2012 LINER TERMINATION IN SANITARY SEWER FIGURE A-604

1. CONTRACTOR SHALL REPAIR DETERIORATION ON INSIDE CIRCUMFERENCE OF PIPE WALL TO FORM A SMOOTH SURFACE FOR THE END OF CIPP LINER.
2. POLYMERIC EPOXY SHALL BE RAVEN 405 OR AQUATAPOXY A-6 EPOXY MORTAR SYSTEMS, BY RAVEN LINING SYSTEMS OR APPROVED EQUIVALENT.
3. IF POLYETHYLENE IS USED FOR INTERIOR OF LINING, CONTRACTOR SHALL ABRASE THE POLYETHYLENE LAYER PRIOR TO APPLYING THE EPOXY.

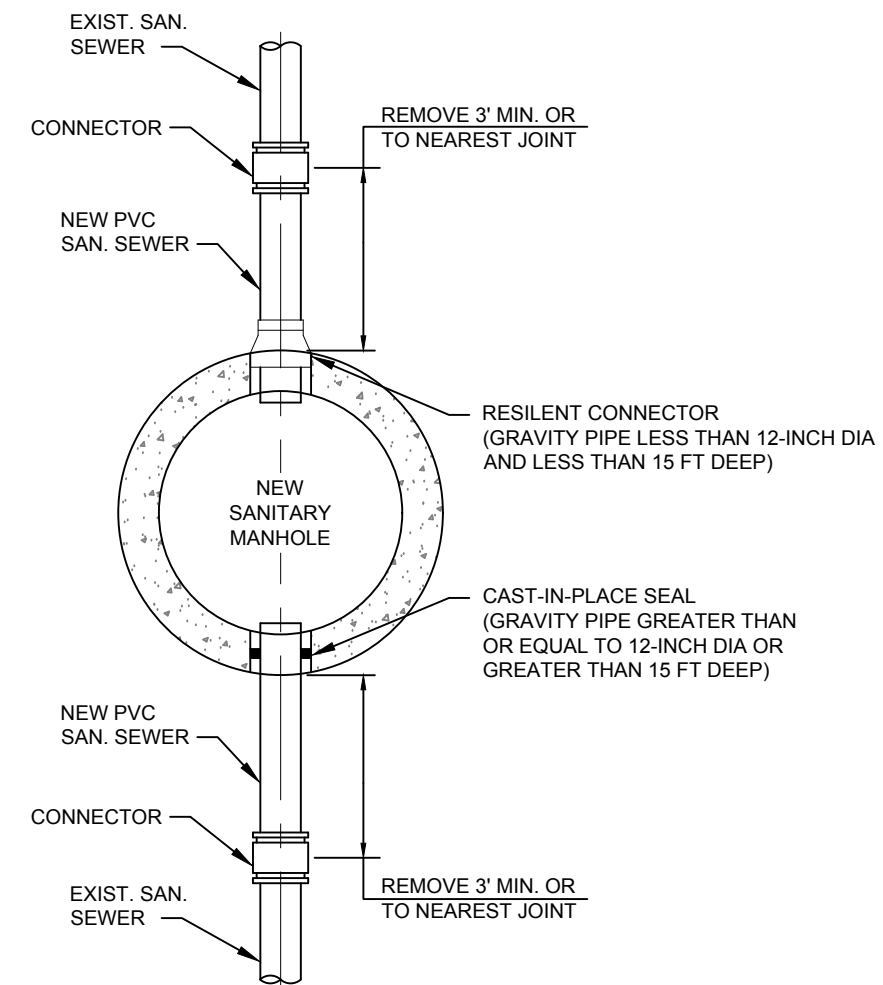
APPENDIX A STANDARD DRAWINGS GRAVITY R/R
DATE: August 2012 MANHOLE REPLACEMENT FIGURE A-606

1. NEW MANHOLE SHALL BE CONSTRUCTED IN ACCORDANCE WITH STANDARD DETAIL "PRECAST CONCRETE MANHOLE - FIGURE A301".

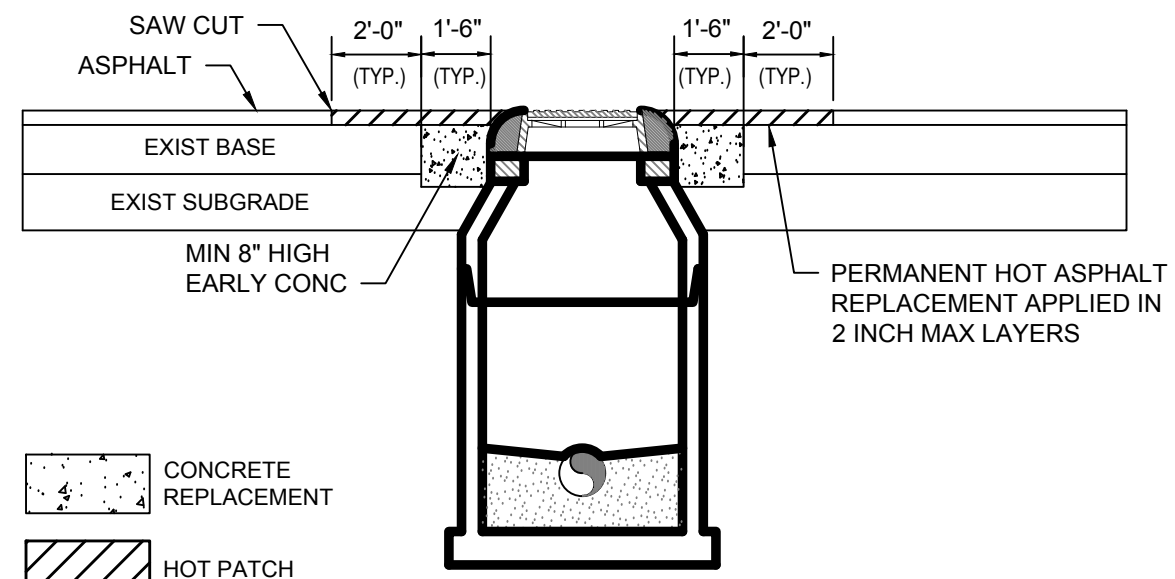
APPENDIX A STANDARD DRAWINGS GRAVITY R/R
DATE: August 2012 **ASPHALT PAVEMENT RESTORATION AT MANHOLE LINER INSTALLATION FRAME AND COVER REPLACEMENT** FIGURE A-609

- BASE REPLACEMENT SHALL BE 3000 PSI HIGH EARLY STRENGTH CONCRETE.
- ASPHALTIC CONCRETE SURFACE MATERIAL SHALL BE REPLACED WITH THE SAME TYPE OF MATERIAL THAT EXISTED AT THE TIME OF REMOVAL.
- MINIMUM ASPHALTIC CONCRETE SURFACE OVERLAY THICKNESS SHALL BE (1'-5") INCHES, TO MATCH EXIST ASPHALT THICKNESS.
- ALL JOINT CUTS SHALL BE MECHANICALLY SAW-CUT.
- SUB-GRADE TO BE COMPACTED TO 98% MAX. DENSITY AS DETERMINED BY AASHTO T-180.
- CUT AREA TO BE PLATED OR PROTECTED ON DAY OF POUR.

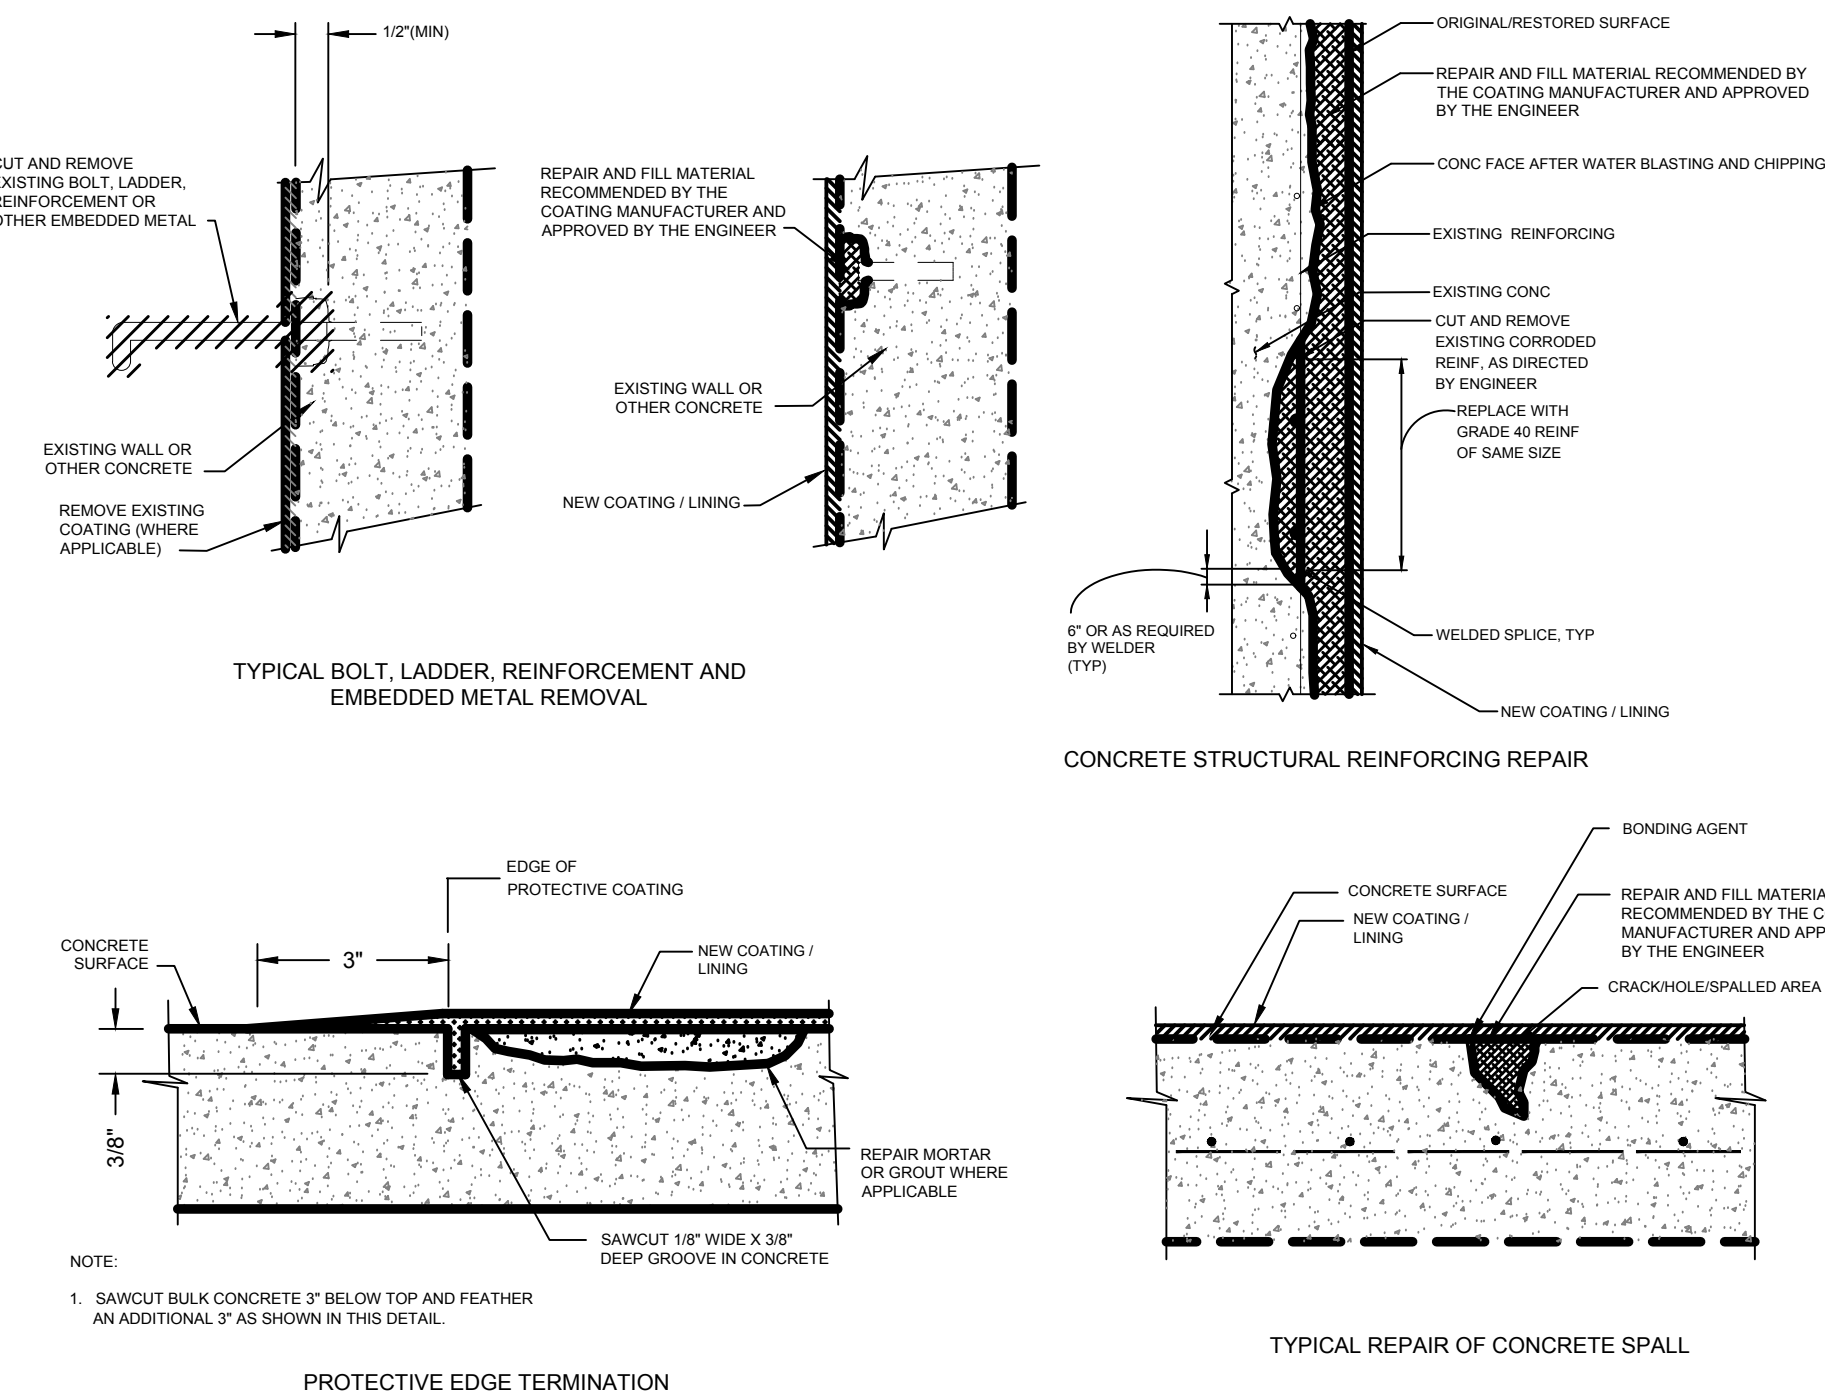
APPENDIX A STANDARD DRAWINGS GRAVITY R/R
DATE: August 2012 **CONCRETE RESTORATION AT MANHOLE OR WETWELL** FIGURE A-610

- WHERE "TIE TO EXISTING STRUCTURE" IS INDICATED, CONTRACTOR SHALL STRAIGHTEN AND SANDBLAST REINFORCEMENT AND SPLICE WITH NEW REINFORCEMENT AS DETAILED ON THE DRAWINGS OR AS DIRECTED BY THE ENGINEER. IF CONDITIONS WARRANT WELDING OF REINFORCING, WELDING WILL BE SUBJECT TO ENGINEER'S APPROVAL.

- STRUCTURAL DIMENSIONS RELATED TO OR CONTROLLED BY EXISTING STRUCTURES SHALL BE VERIFIED IN FIELD BY THE CONTRACTOR PRIOR TO CONCRETE WORK.

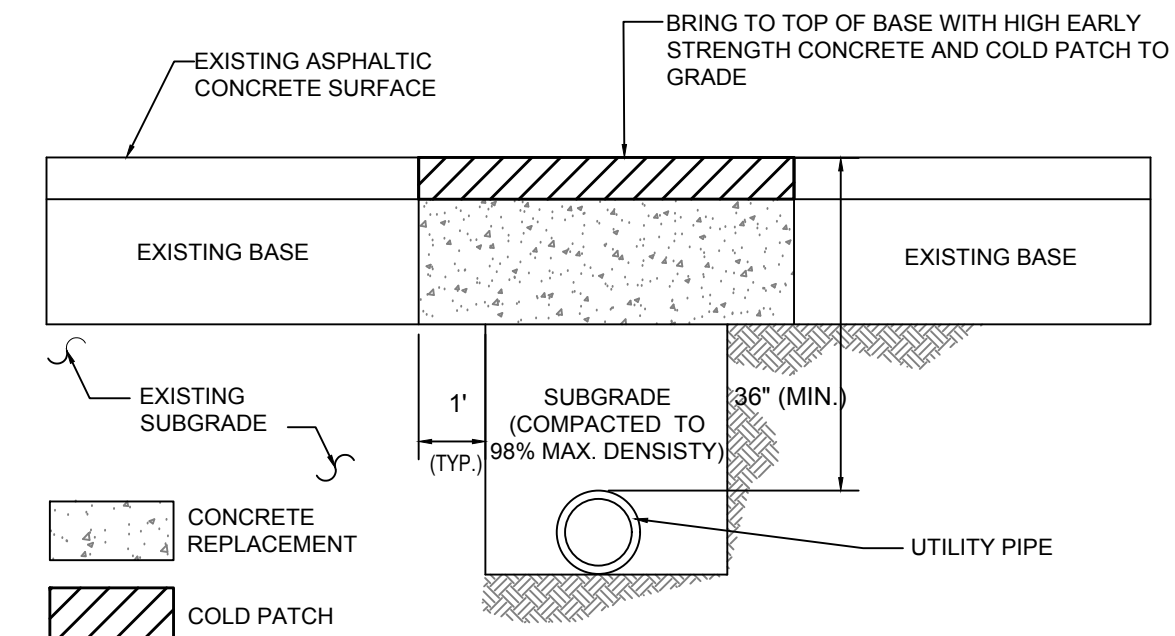
APPENDIX A STANDARD DRAWINGS GRAVITY R/R
DATE: August 1, 2006 **TEMPORARY ASPHALT PAVEMENT RESTORATION** FIGURE A703

- BASE REPLACEMENT SHALL BE 3000 PSI HIGH EARLY STRENGTH CONCRETE.
- ASPHALTIC CONCRETE SURFACE MATERIAL SHALL BE REPLACED WITH THE SAME TYPE OF MATERIAL THAT EXISTED AT THE TIME OF REMOVAL.
- MINIMUM ASPHALTIC CONCRETE SURFACE OVERLAY THICKNESS SHALL BE (1'-5") INCHES.
- ALL JOINT CUTS SHALL BE MECHANICALLY SAW-CUT.
- SUB-GRADE TO BE COMPACTED TO 98% MAX. DENSITY AS DETERMINED BY AASHTO T-180. CUT TO BE REPLACED WITH 3000 PSI HIGH EARLY CONCRETE TO TOP OF EXISTING BASE. CUT AREA TO BE PLATED OR PROTECTED ON DAY OF POUR. TEMPORARY COLD PATCH TO BE APPLIED AND BROUGHT TO GRADE NEXT DAY.

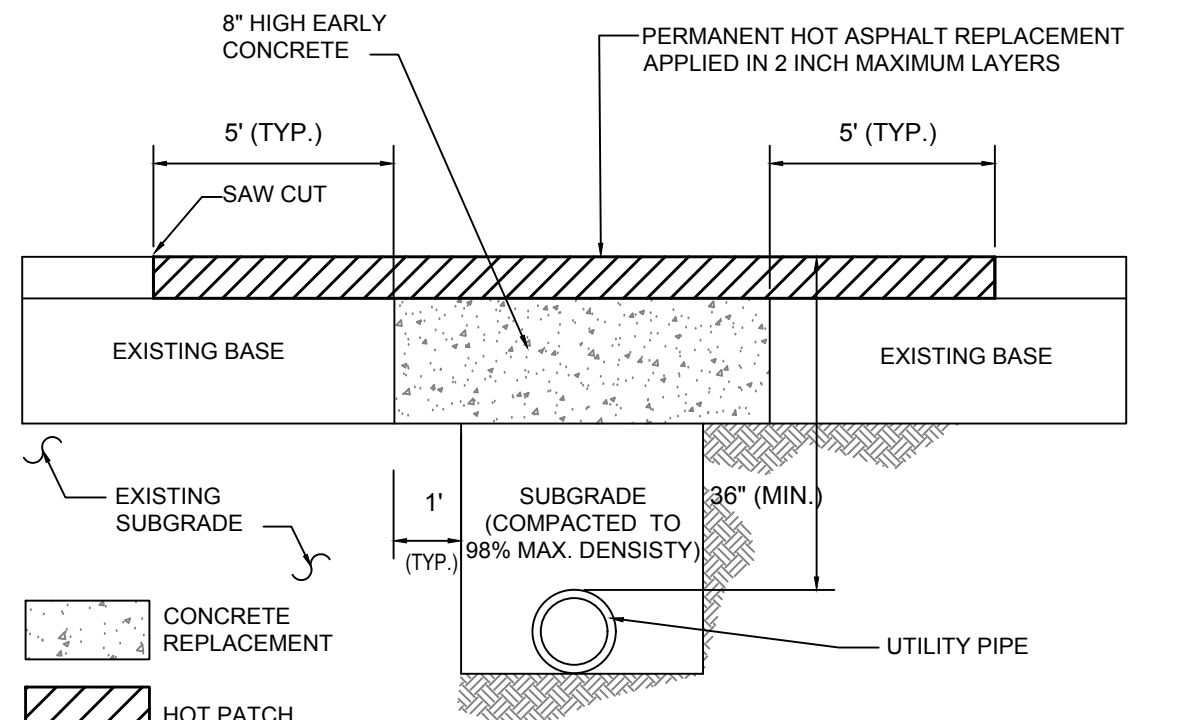
APPENDIX A STANDARD DRAWINGS GRAVITY R/R
DATE: August 1, 2006 **PERMANENT ASPHALT PAVEMENT RESTORATION** FIGURE A702

- BASE REPLACEMENT SHALL BE 3000 PSI HIGH EARLY STRENGTH CONCRETE.
- ASPHALTIC CONCRETE SURFACE MATERIAL SHALL BE REPLACED WITH THE SAME TYPE OF MATERIAL THAT EXISTED AT THE TIME OF REMOVAL.
- MINIMUM ASPHALTIC CONCRETE SURFACE OVERLAY THICKNESS SHALL BE (1'-5") INCHES, OR AS APPROVED BY THE COUNTY ENGINEER.
- ALL JOINT CUTS SHALL BE MECHANICALLY SAW-CUT.
- SUB-GRADE TO BE COMPACTED TO 98% MAX. DENSITY AS DETERMINED BY AASHTO T-180. CUT TO BE REPLACED WITH 3000 PSI HIGH EARLY CONCRETE TO TOP OF EXISTING BASE. CUT AREA TO BE PLATED OR PROTECTED ON DAY OF POUR. EXISTING SURFACE TO BE SAW CUT TO AN AREA 5 FEET BEYOND BASE CUT.

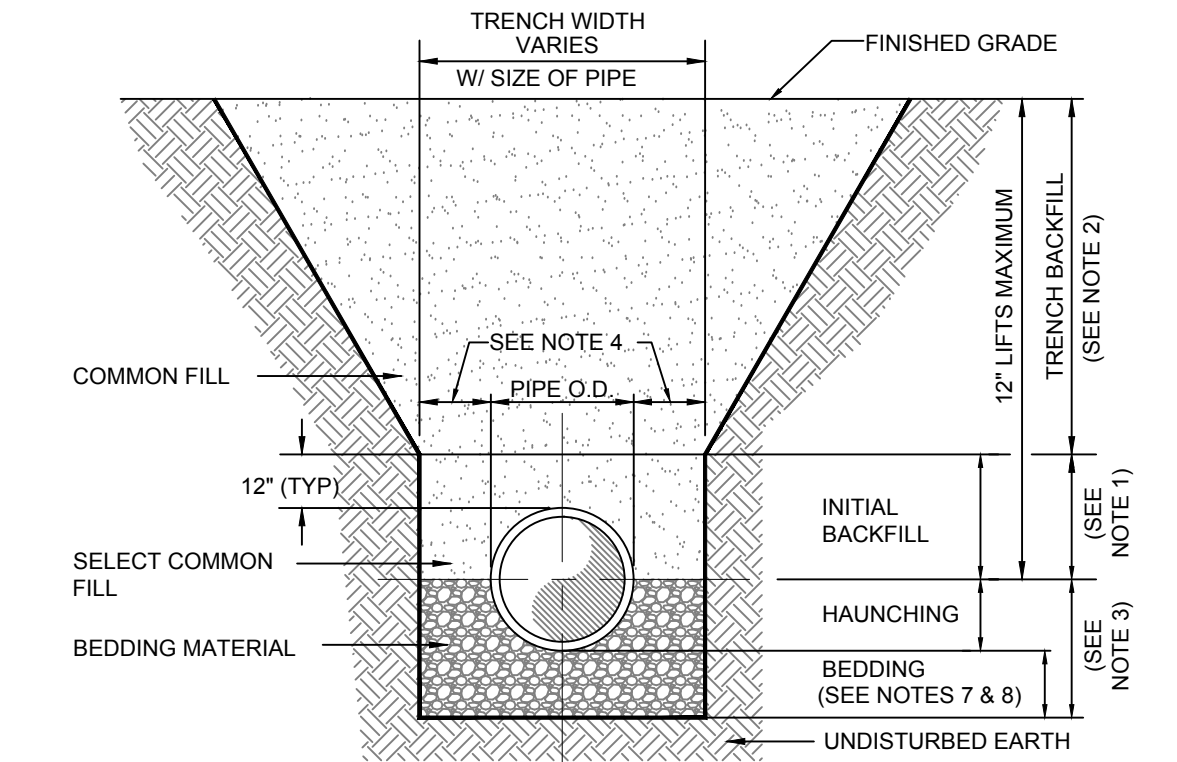
APPENDIX A STANDARD DRAWINGS GENERAL
DATE: February 11, 2011 **BEDDING AND TRENCHING - TYPE A** FIGURE A101

- NOTES:
- INITIAL BACKFILL: SELECT COMMON FILL COMPACTED TO 95% (98% UNDER PAVEMENT) OF THE MAXIMUM DENSITY AS PER AASHTO T-180.
 - TRENCH BACKFILL: COMMON FILL COMPACTED TO 95% (98% UNDER PAVEMENT) OF THE MAXIMUM DENSITY AS PER AASHTO T-180.

- TYPE A BEDDING MATERIAL SHALL CONFORM TO FDOT NO. 57 AGGREGATE.
 - 15" MAX. (12" MIN.) FOR PIPE DIAMETER LESS THAN 24" AND 24" MAX (12" MIN) FOR PIPE DIAMETER 24" AND LARGER.

- DEPTH FOR REMOVAL OF UNSUITABLE MATERIAL SHALL GOVERN DEPTH OF BEDDING ROCK BELOW THE PIPE. UTILITIES SHALL DETERMINE IN THE FIELD REQUIRED REMOVAL OF UNSUITABLE MATERIAL TO REACH SUITABLE FOUNDATION.

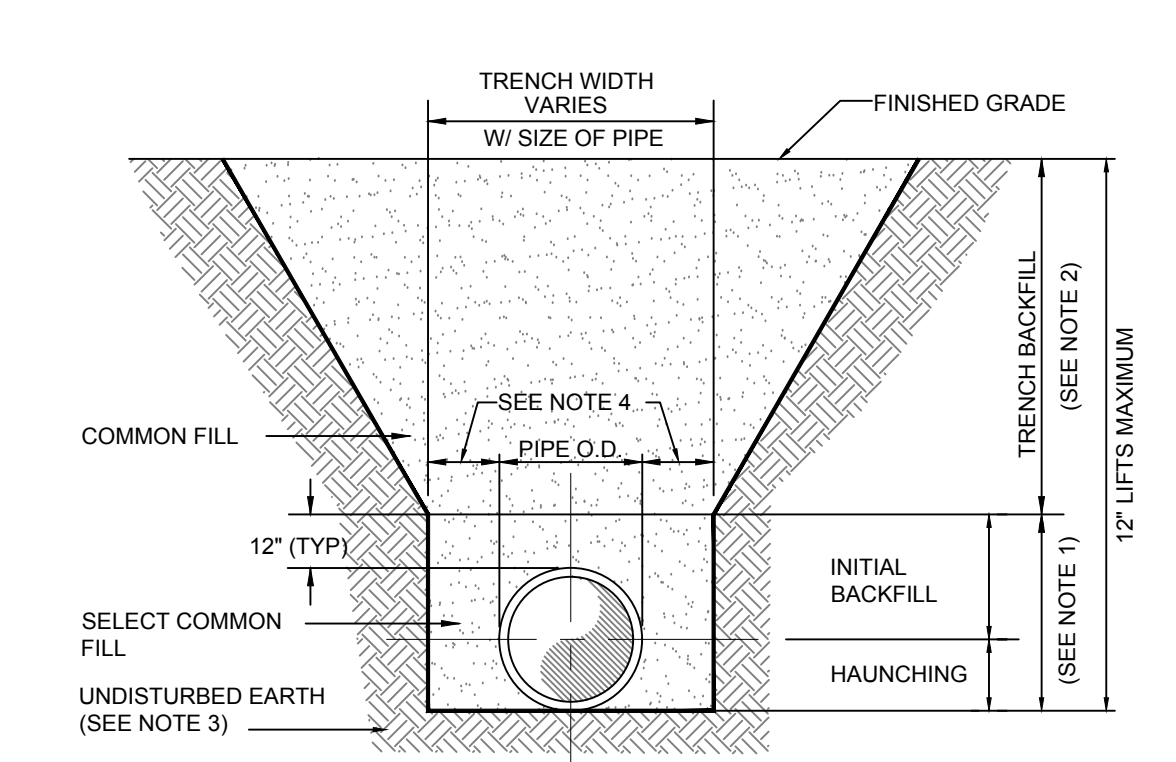
APPENDIX A STANDARD DRAWINGS GENERAL
DATE: February 11, 2011 **BEDDING AND TRENCHING - TYPE B** FIGURE A102

- NOTES:
- INITIAL BACKFILL AND HAUNCHING: SELECT COMMON FILL COMPACTED TO 95% (98% UNDER PAVEMENT) OF THE MAXIMUM DENSITY AS PER AASHTO T-180.
 - TRENCH BACKFILL: COMMON FILL COMPACTED TO 95% (98% UNDER PAVEMENT) OF THE MAXIMUM DENSITY AS PER AASHTO T-180.

- PIPE BEDDING UTILIZING SELECT COMMON FILL OR BEDDING ROCK IN ACCORDANCE WITH TYPE A BEDDING AND TRENCHING DETAIL MAY BE REQUIRED AS DIRECTED BY UTILITIES.

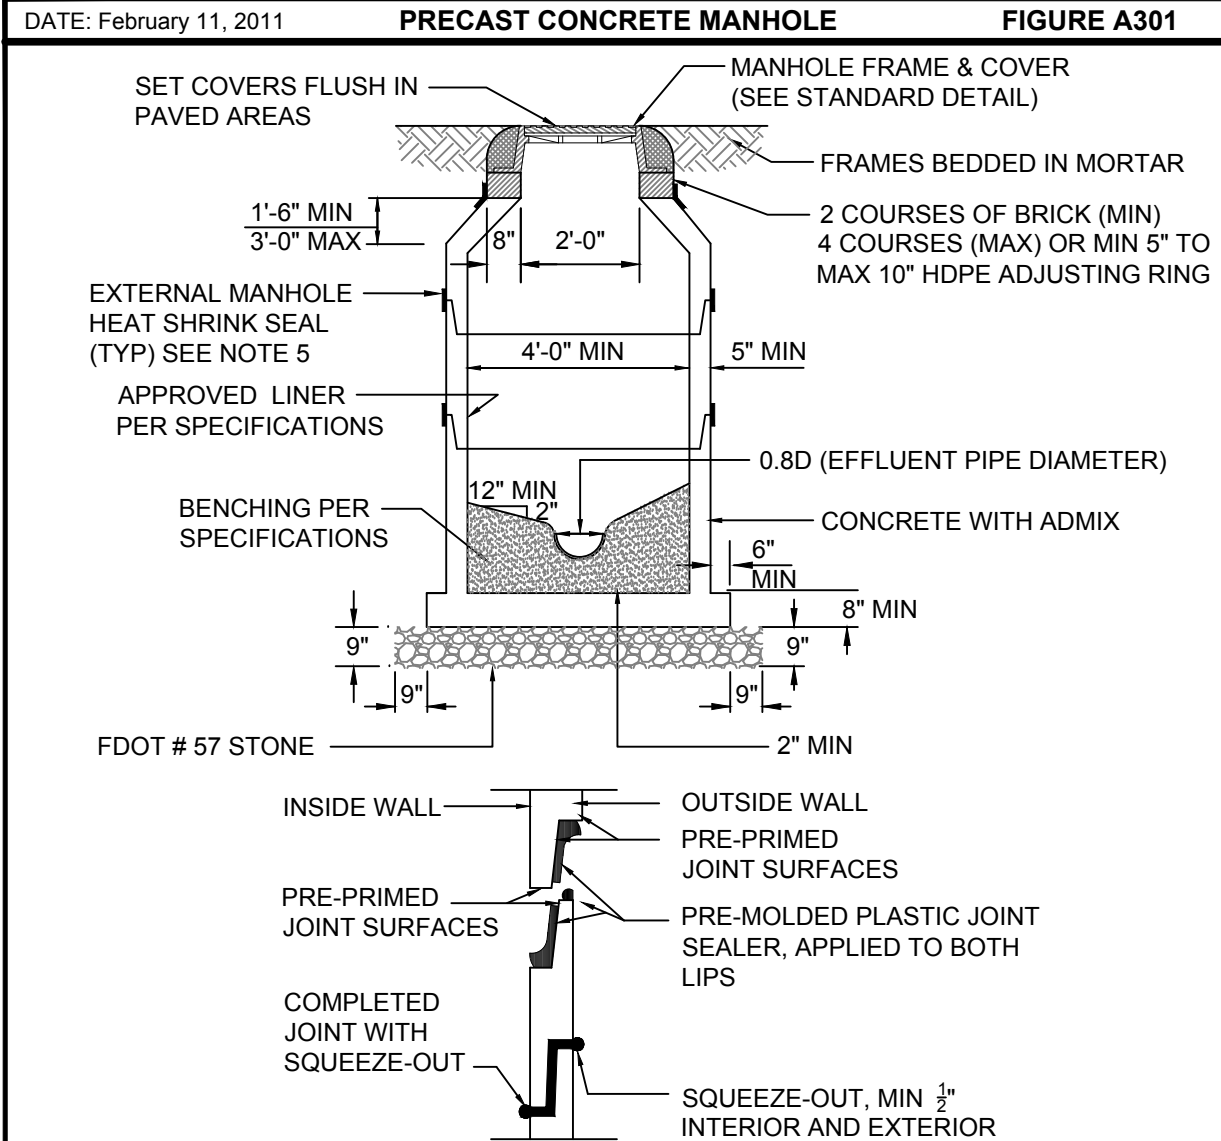
APPENDIX A STANDARD DRAWINGS GENERAL
DATE: February 11, 2011 PRECAST CONCRETE MANHOLE FIGURE A301

- NOTES:
- DROP CONNECTIONS ARE REQUIRED WHENEVER INVERT OF INFLUENT SEWER IS 24" OR MORE ABOVE THE INVERT OF THE MANHOLE. SEE MANHOLE CONNECTION DETAIL.
 - ECCENTRIC CONE DESIGN MAY BE USED FOR CONFLICT RESOLUTION WITH OCU APPROVAL.
 - A FLOW CHANNEL SHALL BE CONSTRUCTED INSIDE MANHOLE TO DIRECT INFLUENT INTO FLOW STREAM.
 - LIFT HOLES THROUGH STRUCTURE ARE NOT PERMITTED.
 - WRAP TIGHTLY AROUND CASTING JOINTS AND APPLY HIGH INTENSITY PROPANE TORCH TO EFFECTIVELY SEAL THEM FROM GROUND WATER INFILTRATION.
 - HDPE ADJUSTING RINGS MAY BE SUBSTITUTED FOR BRICK RISERS.
 - SECTION HEIGHTS VARY AS REQUIRED, AND AS AVAILABLE, FROM APPROVED MANUFACTURERS LISTED IN APPENDIX D.
