ORANGE COUNTY UTILITIES DEPARTMENT ENGINEERING DIVISION
9150 CURRY FORD ROAD ORLANDO, FL. 32825

GRAVITY R/R PACKAGE NO. 19
SA F3146 UNIVERSITY ACRES (2)

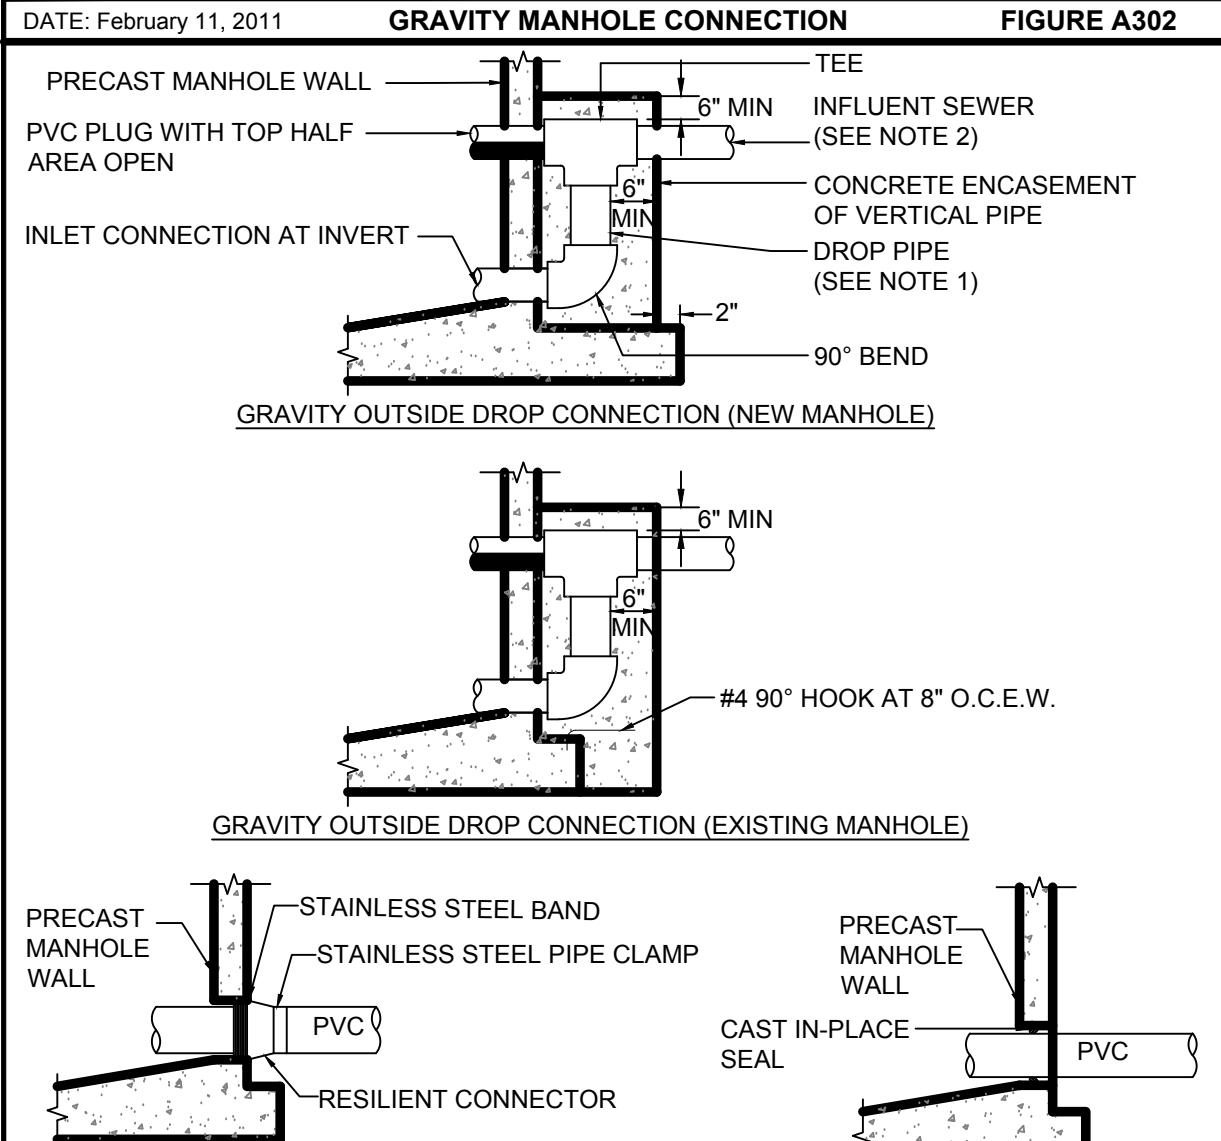
APPENDIX A STANDARD DRAWINGS GENERAL
DATE: February 11, 2011 GRAVITY MANHOLE CONNECTION FIGURE A302

- NOTES:
- DROP PIPE AND FITTINGS SHALL BE OF EQUAL SIZE AND MATERIAL AS THE INFLUENT SEWER.
 - AN OUTSIDE DROP CONNECTION SHALL BE REQUIRED FOR ALL INFLUENT LINES WHICH HAVE AN INVERT 2' OR MORE ABOVE THE MANHOLE INVERT.
 - CONTRACTOR TO COORDINATE THE PRESENCE OF UTILITIES INSPECTOR DURING CORING AND CONNECTIONS TO EXISTING MANHOLES.

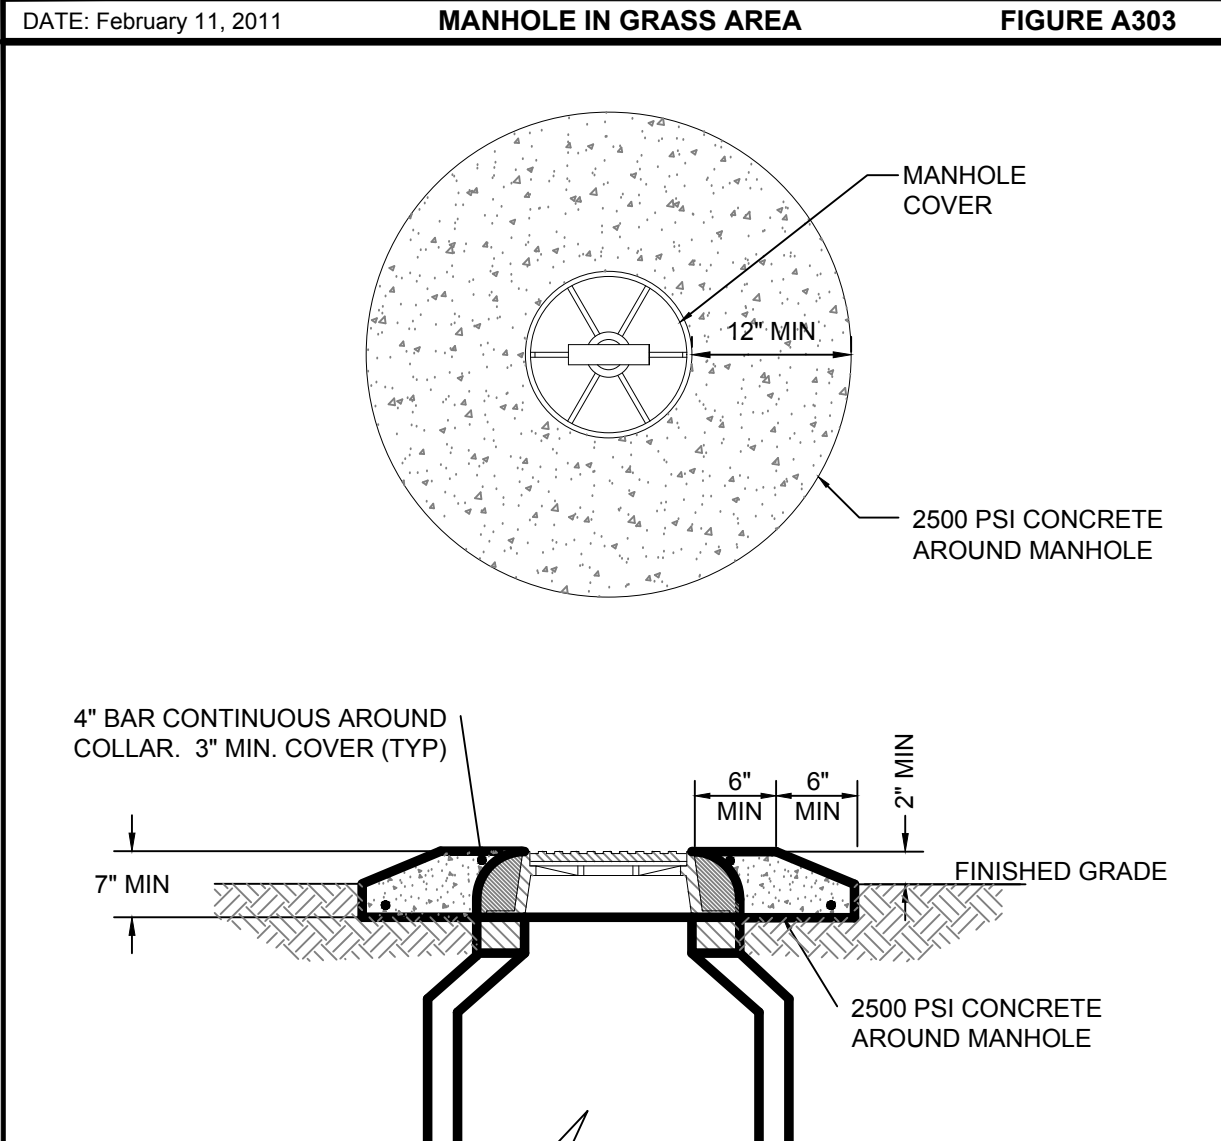
APPENDIX A STANDARD DRAWINGS GENERAL
DATE: February 11, 2011 MANHOLE IN GRASS AREA FIGURE A303

- NOTES:
- CLEARANCE OF 30" FREE FROM OBSTRUCTIONS IN ALL DIRECTIONS.
 - AREAS SUPPORTING CONCRETE COLLAR OR SLAB SHALL BE PROPERLY COMPACTED.
 - TOP OF MANHOLE SHALL BE 2" ABOVE FINISHED GRADE, CROWN OF ADJACENT ROADWAY, OR 100 YEAR FLOOD ELEVATION, WHICHEVER IS GREATER.

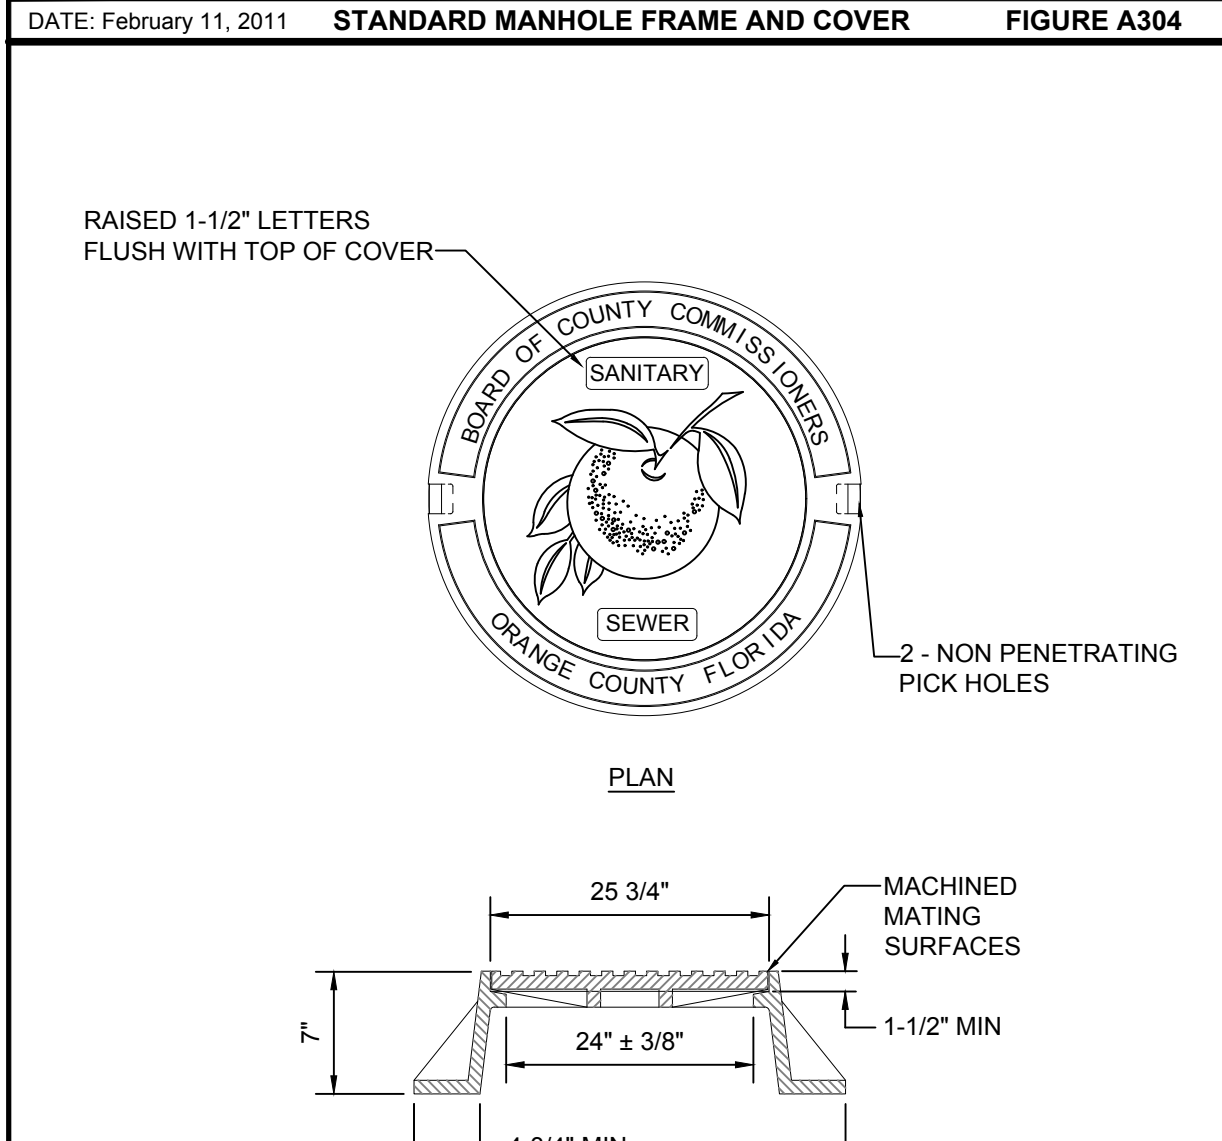
APPENDIX A STANDARD DRAWINGS GENERAL
DATE: February 11, 2011 STANDARD MANHOLE FRAME AND COVER FIGURE A304

- NOTES:
- ONLY APPLIES TO UTILITIES OWNED AND MAINTAINED MANHOLES. "ORANGE COUNTY" SHALL NOT APPEAR ON PRIVATE MANHOLES.

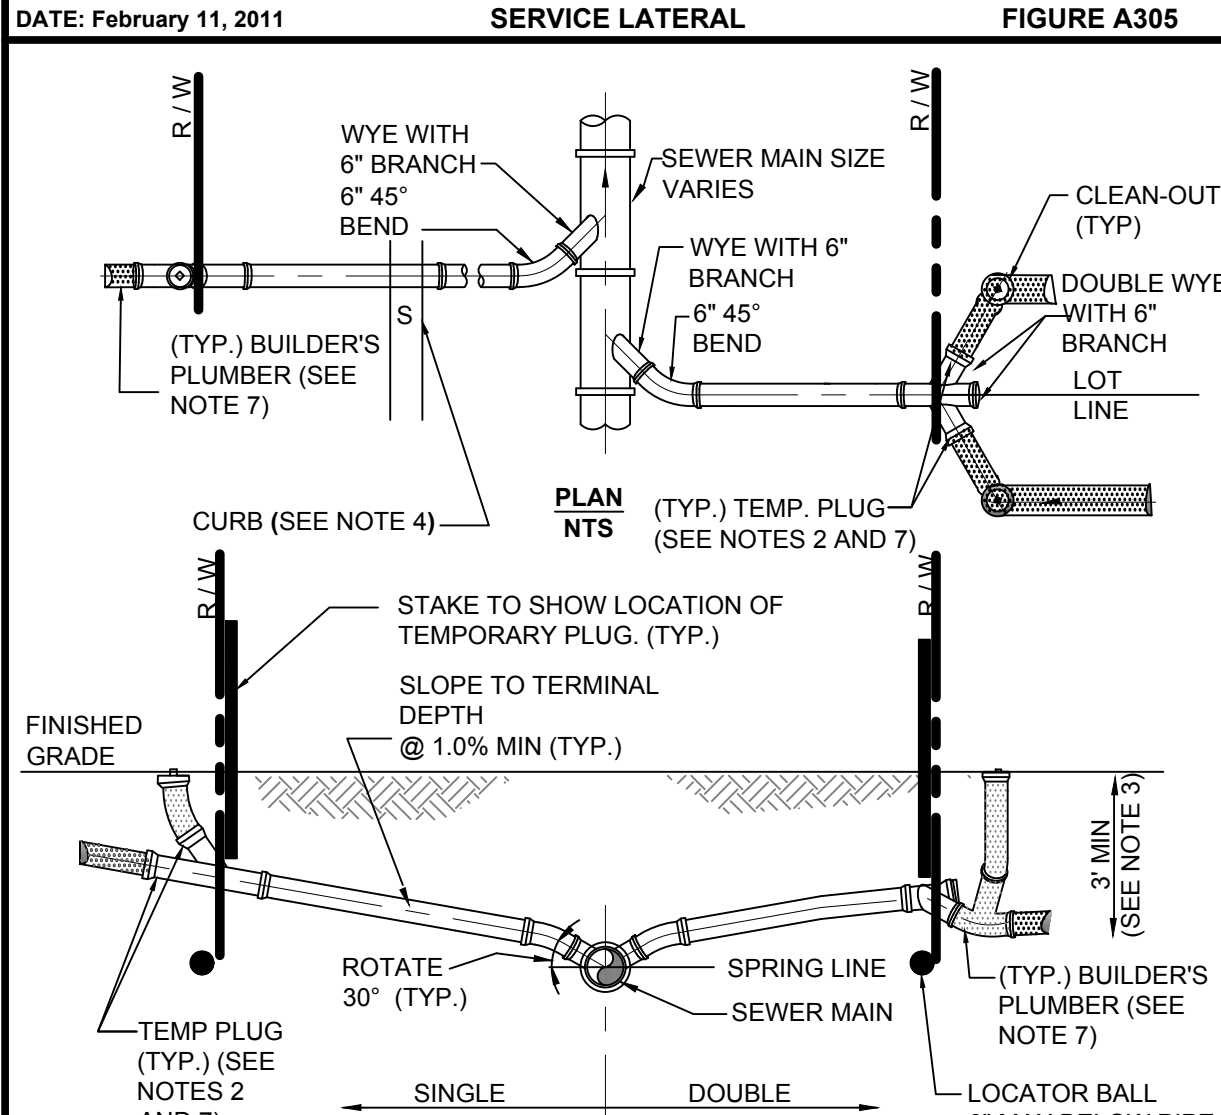
APPENDIX A STANDARD DRAWINGS GENERAL
DATE: February 11, 2011 SERVICE LATERAL FIGURE A305

- NOTES:
- INVERT OF SERVICE LATERAL SHALL NOT ENTER SEWER MAIN BELOW SPRING LINE.
 - SERVICE LATERAL SHALL BE CAPPED BY DEVELOPER'S SITE-WORK CONTRACTOR.
 - WYE TO BE NO SHALLOWER THAN 3- FEET AND NO DEEPER THAN 5- FEET.
 - LOCATOR BALLS TO BE INSTALLED BY DEVELOPER'S SITE-WORK CONTRACTOR, ONE PER SERVICE.
 - ALL FITTINGS SHOWN ARE TO BE INSTALLED.
 - SERVICE CONNECTIONS SHALL BE PERMANENTLY MARKED BY CUTTING AN "S" IN THE CURB DIRECTLY OVER THE LATERAL.
 - BUILDER'S PLUMBER WILL REMOVE PLUG, INSTALL CLEANOUT, AND CONNECT SERVICE LATERAL TO HOUSE.

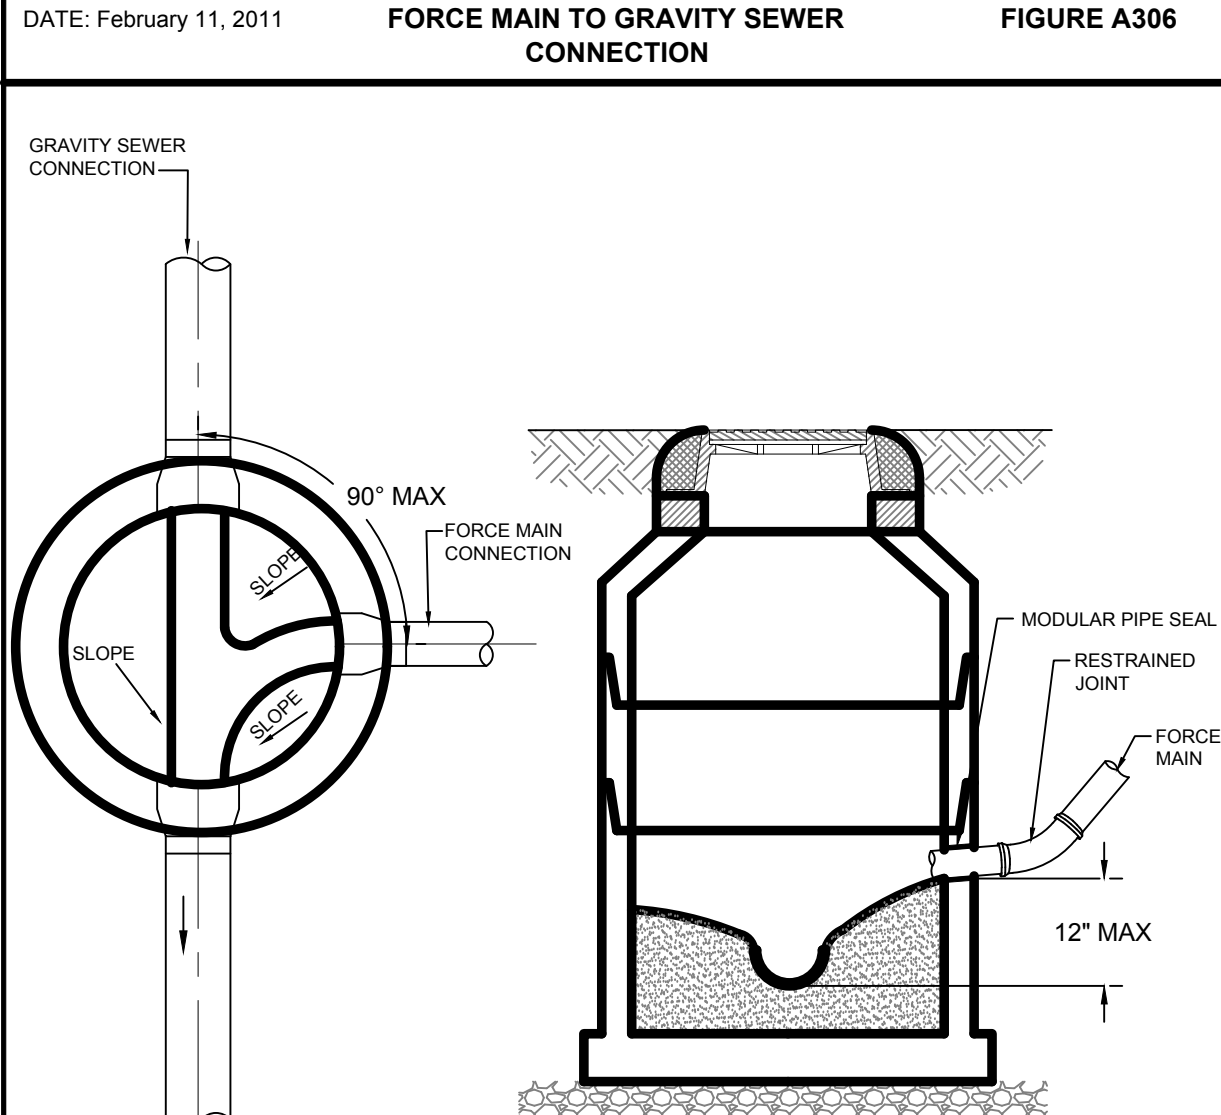
APPENDIX A STANDARD DRAWINGS GENERAL
DATE: February 11, 2011 FORCE MAIN TO GRAVITY SEWER CONNECTION FIGURE A306

- NOTES:
- FORCE MAIN ORIENTED TO FACILITATE FLOW AND SHALL ENTER MANHOLE WITHIN 1' ABOVE INVERT OF THE EFFLUENT PIPE.
 - BENCH AS REQUIRED FOR NEW FORCE MAIN.
 - MANHOLE RECEIVING FORCE MAIN AND NEXT MANHOLE SHALL BE LINED. FOR CONNECTIONS TO EXISTING MANHOLES, MANHOLE RECEIVING FORCE MAIN AND NEXT MANHOLE SHALL BE COATED OR LINED PER APPENDIX D.
 - CONTRACTOR TO COORDINATE THE PRESENCE OF UTILITIES INSPECTOR DURING CORING AND CONNECTIONS TO EXISTING MANHOLES.
